## Updates to Increase Top Speed

<b>Classification</b>	Repair Bulletin	<b>Section/Group</b>	40 - Rear Drive Unit	<b>Country/Region</b>	All
<b>Year</b>	2014-2015	<b>Model</b>	Model S	<b>Version</b>	85, P85D

This Service Bulletin supersedes SB-15-40-001, dated 19-May-15. Each content change is marked by a vertical line in the left margin. Discard the previous version and replace it with this one.

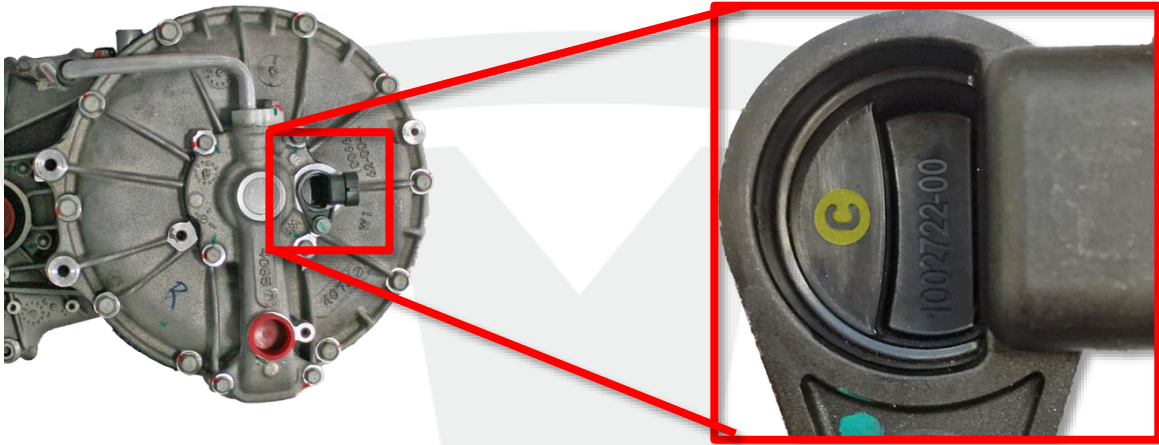
**Figure 1 (Revision level highlighted)**

Some vehicles do not have the drive unit sensor or bootloader necessary to exceed 125 or 130 mph (200 or 210 km/h).

1. Remove the mid aero shield (refer to Service Manual procedure 12030502).
2. Use a mirror or borescope to check the part number on the rear drive unit motor speed sensor (Figure 1).
  - If the part number is 1002722-00-B, replace the speed sensor with revision C or later (refer to Service Manual procedure 40102002), then continue to step 3.
  - If the part number is 1002722-00-C or later, continue to step 3.

Upon customer complaint, check the part number of the motor speed sensor on the rear drive unit and replace the sensor, if necessary. Perform a drive unit bootloader update.
