Resecure Light/Rain Sensor

Classification	Campaign Bulletin	Section/Group	10 - Body	Country/Region	United States
Year	2016	Model	Model X	Version	All

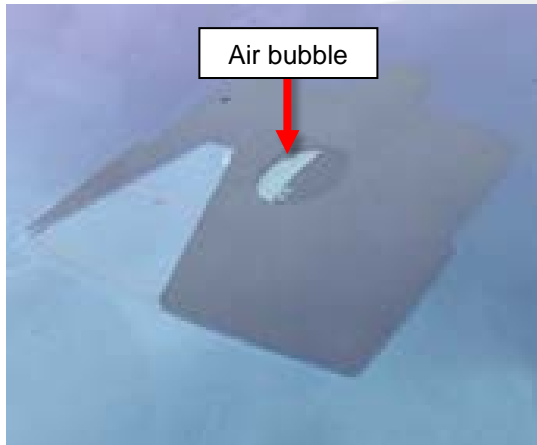
Some Model X vehicles might have a light/rain sensor that is not fully secured to the bracket on the windshield. This condition might cause incorrect functionality of the windshield wipers in "Auto Wipe" mode. Wiper function in "slow" and "fast" modes is not affected.

✘ Figure 1
(Sensor not fully secure)

Inspect the light/rain sensor for correct installation. Resecure the light/rain sensor to the windshield bracket, if necessary.

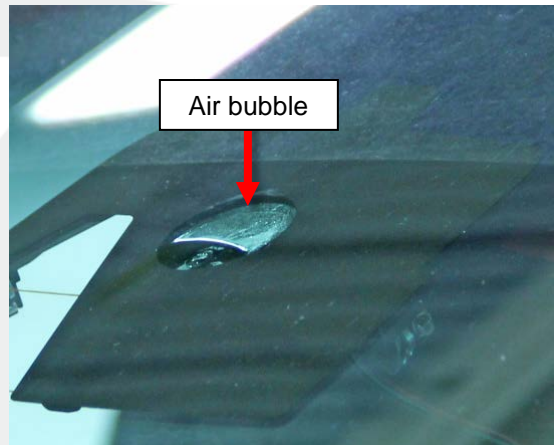
✘ Figure 2
(Sensor not fully secure)

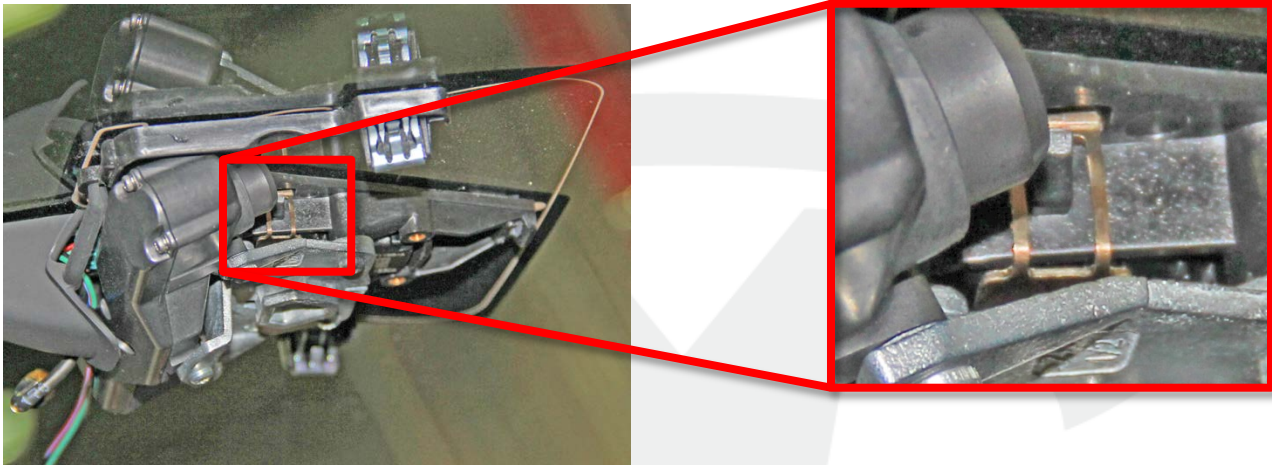
Figure 4

5. Inspect the spring clip (Figure 4) on each side of the light/rain sensor:
 - If either spring clip is not secured to the plastic tab on the windshield bracket, ensure that there are no obstructions pulling the sensor away from the windshield then resecure the spring clip and continue this procedure.
 - If both spring clips are secured to the plastic tabs on the windshield bracket, ensure that there are no obstructions pulling the sensor away from the windshield then skip to step 7.
