Replace Rear Door Primary Struts

Classification Campaign Bulletin **Section/Group** 11 - Closures **Country/Region** United States

Year 2016 **Model** Model X **Version** All

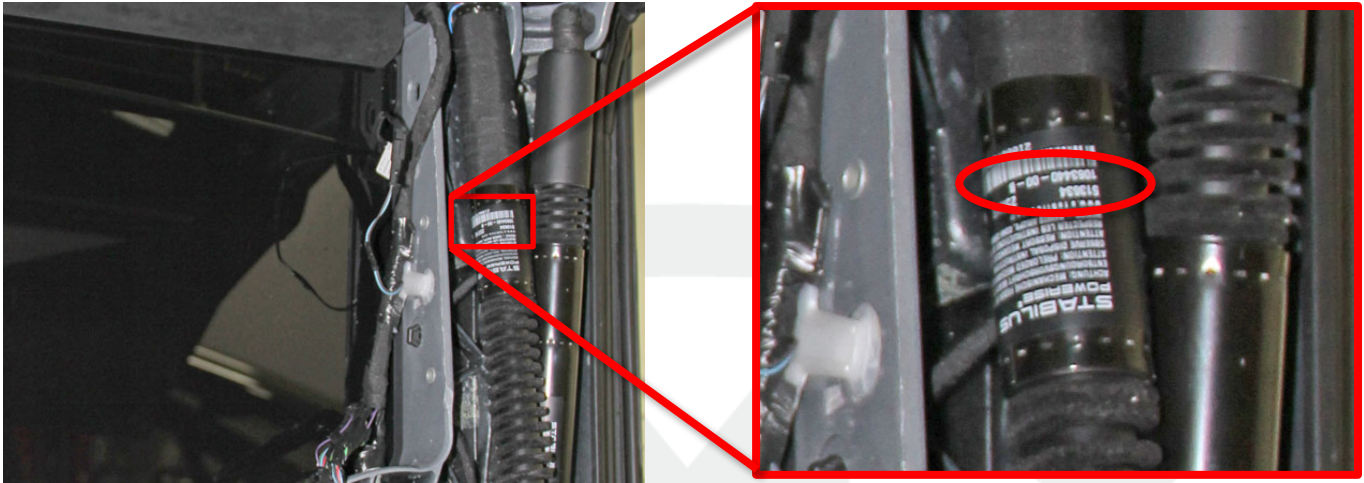
Figure 3

The rear door primary struts on some Model X vehicles are susceptible to a groaning or creaking noise when the doors are opening or closing.

5. Inspect the revision level of the front primary strut (Figure 3):

- If it is revision "C" or later, reinstall the front upper bracket. Continue this procedure.
- If it is revision "B" or earlier, replace the forward primary strut (refer to Service Manual procedure 11331002).
