Install Foam Tape Around Rear Door Ultrasonic Sensors

Classification Campaign Bulletin **Section/Group** 11 - Closures **Country/Region** United States

Year 2016 **Model** Model X **Version** All

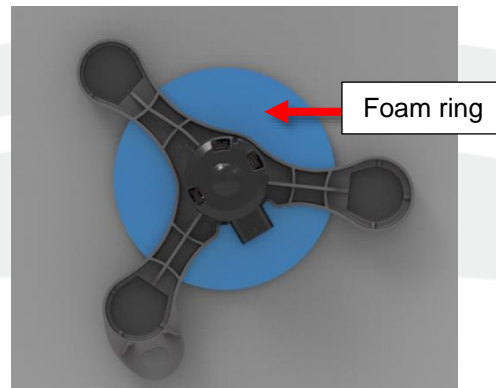
Figure 1

1. Remove the LH rear door closeout panel (refer to Service Manual procedure 11701401).
2. Check for the presence of a foam ring around the ultrasonic sensor (Figure 1).
 - If there is a foam ring, no further work is needed. Reinstall the parts that were removed for access and discontinue this procedure.
 - If there is no foam ring, continue to the “Foam Tape Installation” section of this document.
