## Secure 2<sup>nd</sup> Row Seat Latching Cables

**Classification** Campaign Bulletin    **Section/Group** 13 - Seats    **Country/Region** United States

**Year** 2016    **Model** Model X    **Version** All

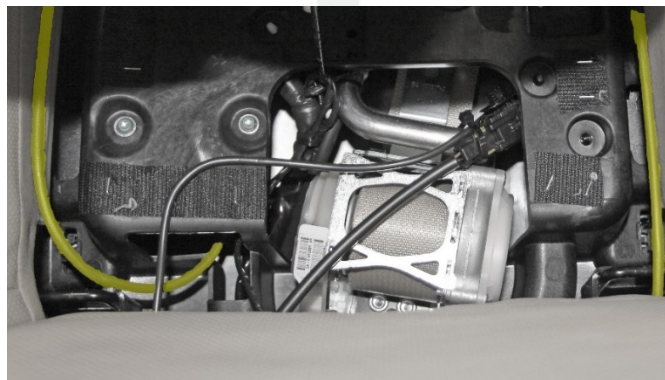
On some vehicles, the latching cables inside the LH and RH 2nd row seats are not secured, and may be visible to occupants during some seat use cases.

2. Identify the seat latching cables (Figure 4).

Figure 4 (Latching cables highlighted)

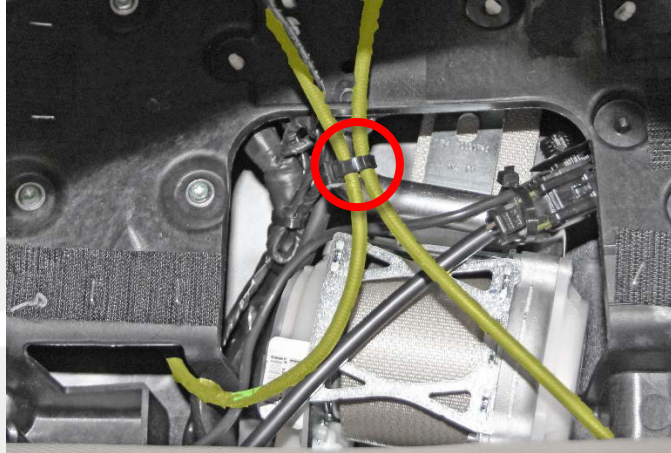
**Figure 5 (Latching cables highlighted)**

3. Gently pull both latching cables toward the center of the seat, then use a cable tie to loosely secure the latching cables together (Figure 5).

**⚠ CAUTION:** Do not fully tighten the cable tie.
