Kinked Rear HVAC Drain Hose

Classification Campaign Bulletin Section/Group 18 - Thermal Country/Region United States

Year 2016 Model Model X Version All

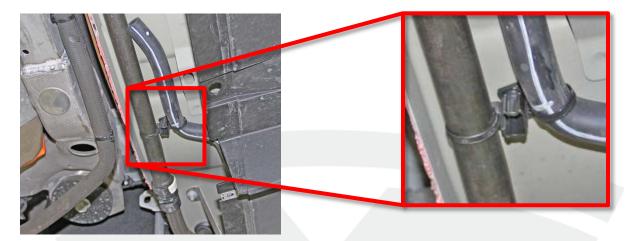
Figure 6

NOTE: The cable tie for the drain hose and the barrel clip for the coolant hose share the same stud.

10. Reinstall the barrel clip that secures the coolant hose to the stud on the body (Figure 6).
