# Install Conductive Tape on HV Junction Box and Chargers to Reduce Radio Noise

<b>Classification</b>	Repair Bulletin	<b>Section/Group</b>	21 - Infotainment	<b>Country/Region</b>	All
<b>Year</b>	2012-2015	<b>Model</b>	Model S	<b>Version</b>	All except 70D, 85D

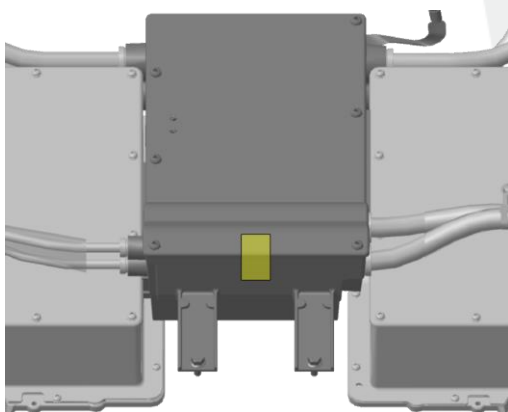
Figure 1 (1<sup>st</sup> generation; conductive tape highlighted)

1. Test drive the vehicle with the radio tuned to an FM station between 102.5-103.5 MHz to confirm the customer's complaint of radio noise.
2. Remove the 2<sup>nd</sup> row seat cushion:
  - Vehicles with standard 2<sup>nd</sup> row seating: Refer to Service Manual procedure 13021101.
  - Vehicles with executive 2<sup>nd</sup> row seating: Refer to Service Manual procedure 13020702.
3. If the vehicle already has conductive tape applied to the charger(s) and HVJB, reinstall the 2<sup>nd</sup> row seat cushion and discontinue this procedure.
4. Use alcohol wipes to thoroughly clean the HVJB cover, the top of the charger(s), and the top of the relay box (if equipped). Allow the alcohol to fully dry before continuing.
5. Apply conductive tape over the joint between the HVJB cover and HVJB enclosure:
  - At the front of the HVJB (Figures 1 and 2):

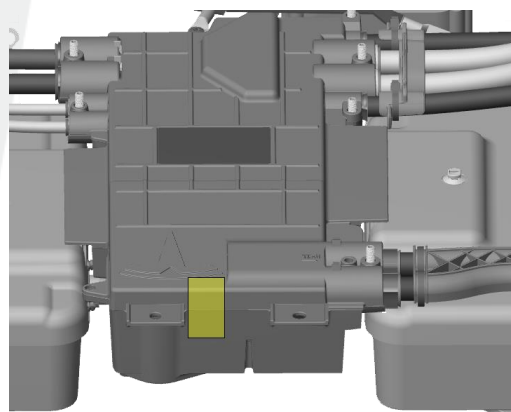
Figure 2 (2<sup>nd</sup> generation; conductive tape highlighted)

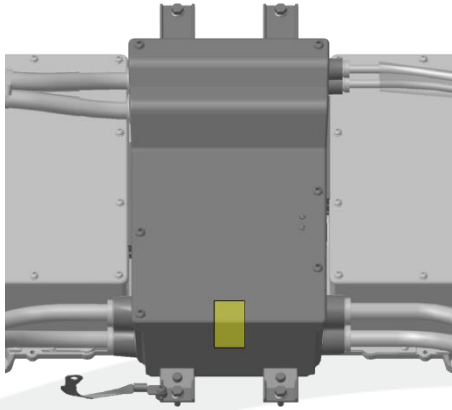
**Figure 3 (1<sup>st</sup> generation; conductive tape highlighted)**

- At the rear of the HVJB (Figures 3 and 4):

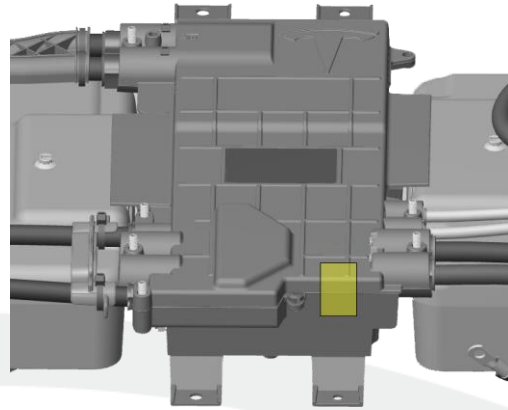
**Figure 4 (2<sup>nd</sup> generation; conductive tape highlighted)**

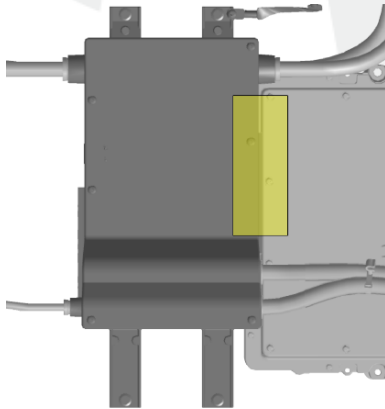
**Figure 5 (1<sup>st</sup> generation; conductive tape highlighted)**

6. Apply conductive tape over the joint between the master charger and the HVJB (Figures 5 and 6). Ensure that the tape has enough slack to allow movement between the 2 components during normal vehicle operation.

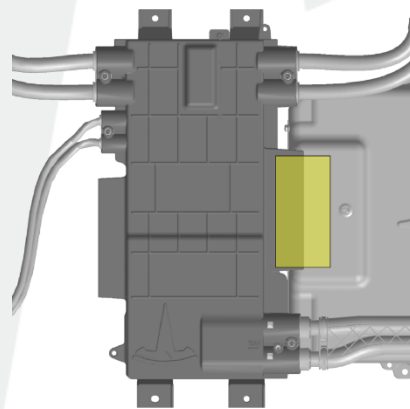
**Figure 6 (2<sup>nd</sup> generation; conductive tape highlighted)**
