Wind Noise From Front Doors And Windows

Classification	Campaign Bulletin	Section/Group	45 - Noise, Vibration & Harshness	Country/Region	All
Year	2016	Model	Model X	Version	All

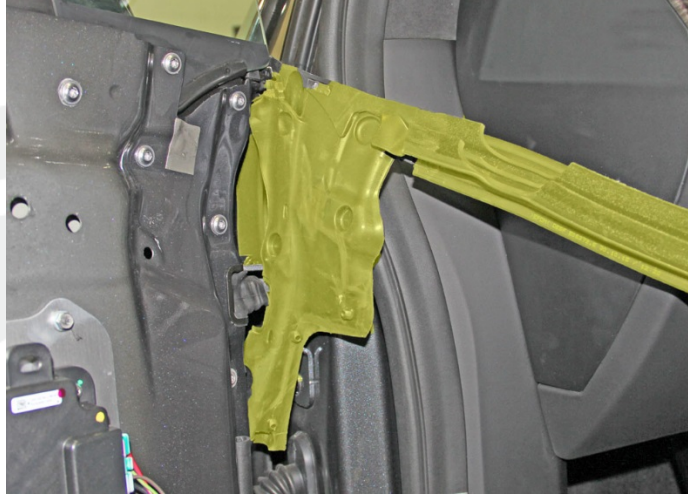
Figure 2 (Inner belt seal highlighted)

1. Remove and discard the LH front door outer belt seal (refer to Service Manual procedure 11703002).
2. Release the inner belt seal from the rear of the door to the front edge of the fixed glass, but leave the seal attached to the front of the door (Figure 2).

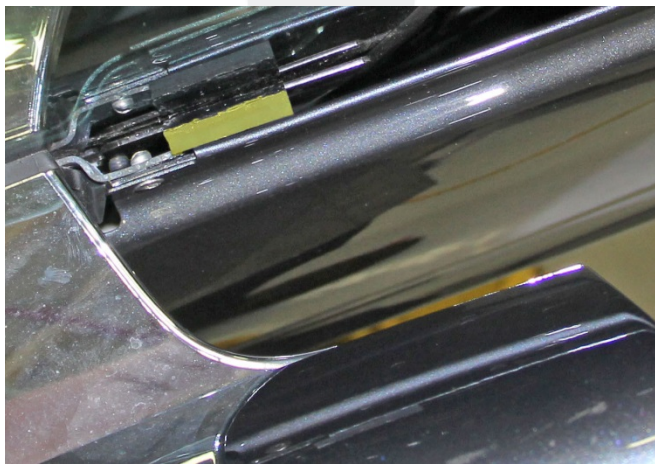
Figure 3 (Rubber spacer highlighted)

3. Remove all adhesive from the inner belt seal. Use alcohol wipes to clean the affected areas. Wipe the alcohol with a clean, dry towel immediately after application. Do not let the alcohol air dry.
4. Inspect the exterior of the door at the base of the fixed glass. If there is a rubber spacer (Figure 3), remove and discard it.

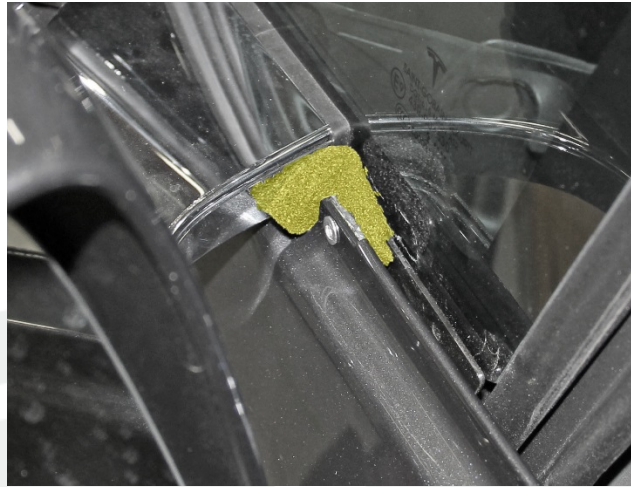
Figure 4 (Seal highlighted)

6. With the adhesive side of the seal facing inboard, install the seal at the base of the fixed glass and mirror (Figure 4). Ensure that the hole at the base of the fixed glass is completely sealed.

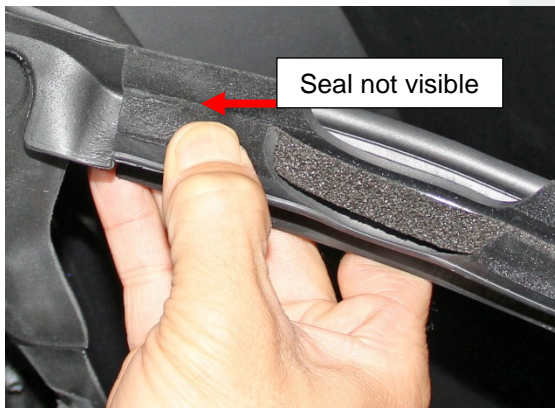
✓ **Figure 20 (Correct)**

NOTE: Ensure that the seal is as low as possible in the channel. When pressing in on the outboard side of the groove, the seal should not be visible (Figures 20 and 21).

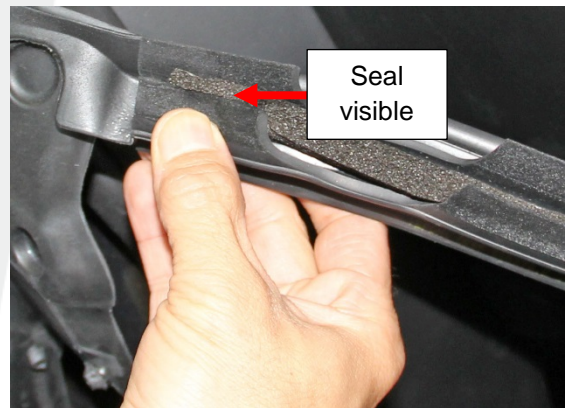
✗ **Figure 21 (Incorrect)**
