November 1, 2017

## Replace Front Body Controller Module Thermal Harness<br/>Cover<br/>ClassificationClassificationCampaign BulletinSection/Group17 - ElectricalCountry/RegionNorth AmericaYear2017ModelModel 3VersionAll

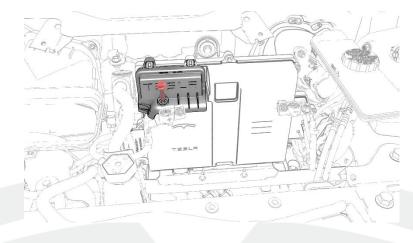
Certain Model 3 vehicles have thermal harness covers that might allow splashed water to ingress into the front body controller module, potentially resulting in diminished connection.

2. Remove the bolt that secures the thermal harness cover to the front body controller module (Figure 1).

Install an improved front body controller module thermal harness cover.

- 3. Release the clips (x2) that secure the top of the cover to the controller module, and remove and discard the cover.
- 4. Install the improved thermal harness cover onto the front body controller module, and fasten the clips at the top of the cover.
- 5. Install the bolt that secures the cover to the controller module (torque 6 Nm) (Figure 1).
- 6. Install the cabin intake duct (refer to Service Manual procedure 18108402).
