Repair Model 3 Body Side Outer In The Jack Pad Area

Classification Campaign Bulletin **Section/Group** 10 - Body **Country/Region** All

Year 2017 **Model** Model 3 **Version** All

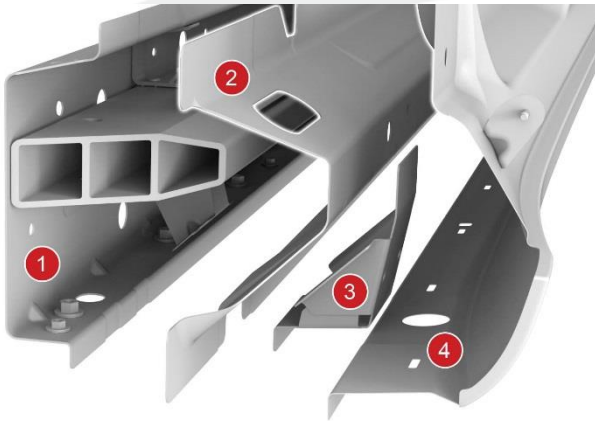
Figure 1 (Area overview)

1. Side sill inner
2. Side sill outer
3. Jack pad bracket
4. Body side outer

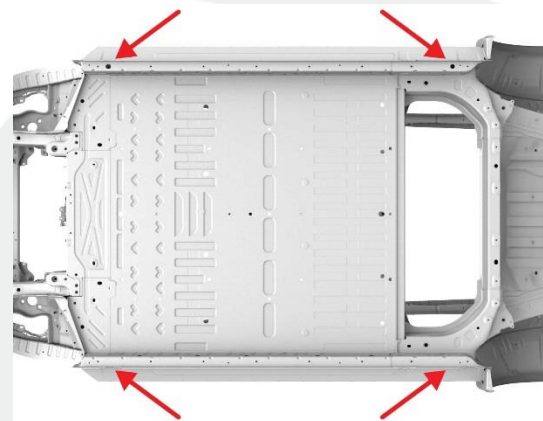
Figure 2 (Inspection area)

The body side outer might be slightly bent in the jack pad area, due to a misalignment with a fixture in manufacturing. This results in minor paint damage and could expose the body side outer to corrosion.

1. Remove the LH and RH lower rocker panel cover (refer to Service Manual procedure 12202602).
2. Remove the rubber plugs (x4) near the jack pads.
3. Inspect the underside of the body side outer in the jack pad areas on the LH and RH sides (Figure 2):
 - If there is structural or paint damage only to the body side outer (Figure 3), continue this procedure.
 - If there is damage to the side sill inner, side sill outer, or jack pad bracket, or the damage is too severe to be completed in a Service Center (Figure 4), discontinue this procedure, reinstall any component that was removed for access, and sublet the repair to a Tesla Approved Body Shop.

Inspect the vehicle in the jack pad area for damage, and repair the damage if possible. If damage cannot be repaired in a Service Center, send the vehicle to a Tesla Approved Body Shop.
