Resecure Triple Camera Windshield Bracket

Classification Campaign Bulletin **Section/Group** 15 - Interior Trim **Country/Region** All

Year 2018 **Model** Model X **Version** All

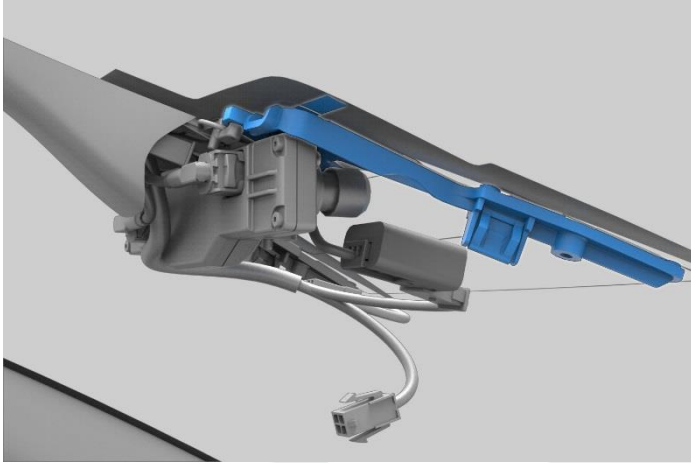
- If both sides of the bracket are flush with the windshield (Figure 3), discontinue this procedure and install all parts that were removed.
- If either side of the bracket is not flush with the windshield (Figure 4), continue to the next step.

✓ Figure 3 (RH shown, check LH also)

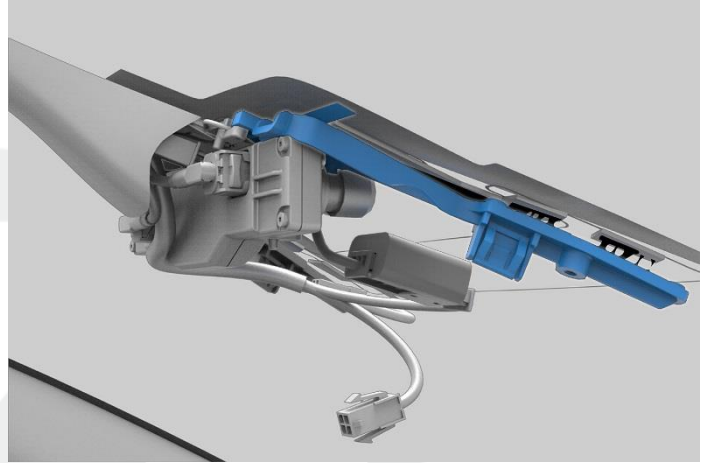
Certain Model X vehicles were manufactured with triple camera windshield brackets that were not properly secured to the windshield. The bracket may look uneven and/or move when manipulated. However, there is no effect on Autopilot functionality or rear view mirror stability.

✗ Figure 4 (RH shown, check LH also)

6. Use IPA wipes and a trim tool/pick to remove as much old adhesive as possible from under the affected side of the triple camera windshield bracket.

10. Apply a small amount of Betaseal urethane between the windshield and triple camera windshield bracket. Wipe away any excess urethane.
11. Remove the masking tape from the windshield (Figure 5). Wipe away any excess urethane.
12. While pressing the triple camera windshield bracket against the windshield, apply multiple strips of masking tape over the top of the bracket to secure it to the windshield (Figure 7). Let the urethane dry for 2 hours.
