Replace High Voltage Controller to Penthouse Cover Bolts

Classification	Campaign Bulletin	Section/Group	16 - Battery System	Country/Region	United States
Year	2017 – 2018	Model	Model 3	Version	All

On certain Model 3 vehicles, the one-time use bolts that attach the high voltage controller to the penthouse cover were not torqued to Tesla's internal specification.

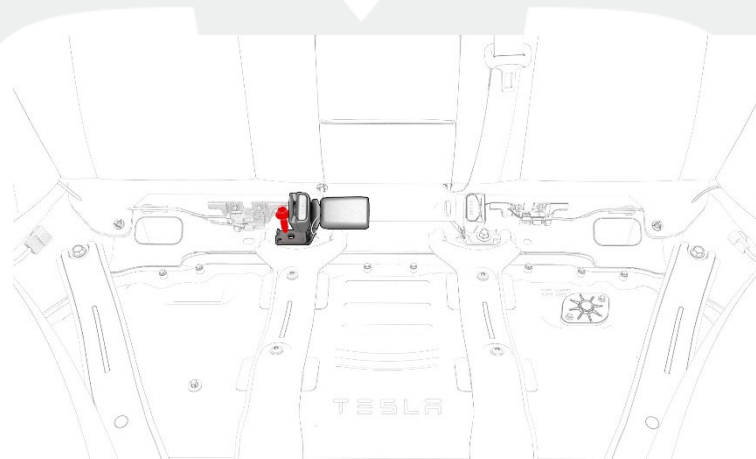
Figure 1 (Center 2nd row buckle and bolt)

1. Perform the vehicle electrical isolation procedure (refer to Service Manual procedure 17010000).
2. Remove and discard the bolt that attaches the center 2nd row buckle to the body, and then set the buckle aside (Figure 1).

9. Install the RH inner 2nd row rail (Figure 2) (refer to Service Manual procedure 13052202).
10. Install the center 2nd row buckle, and install a new bolt (torque 40 Nm) (Figure 1).
11. Connect 12V power (refer to Service Manual procedure 17010200).

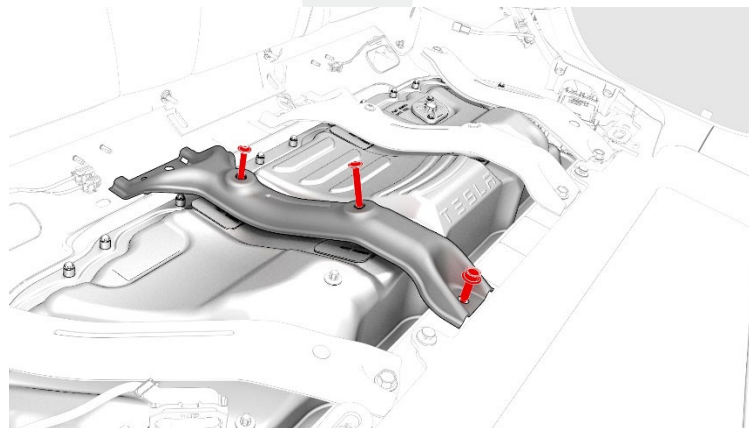
Figure 2 (RH inner 2nd row rail and bolts)

3. Remove the RH inner 2nd row rail (Figure 2) (refer to Service Manual procedure 13052202).

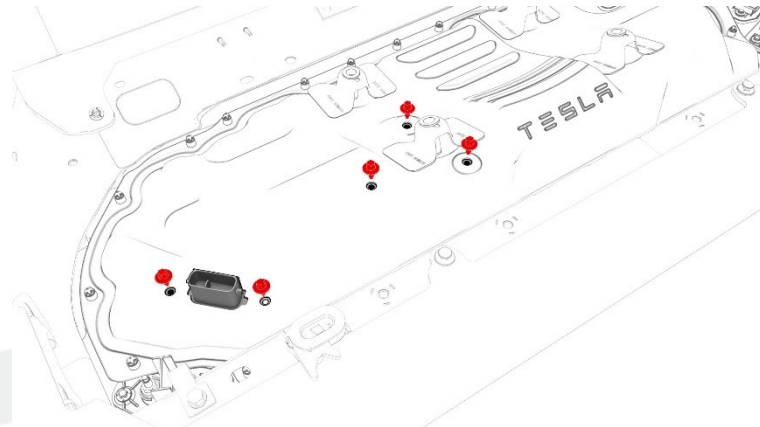
Figure 3 (Bolts that attach the high voltage controller to the penthouse cover)

4. Remove and discard the bolts that attach the high voltage controller to the penthouse cover (Figure 3).

6. Hand-tighten the new bolts that attach the high voltage controller to the penthouse cover (Figure 3).

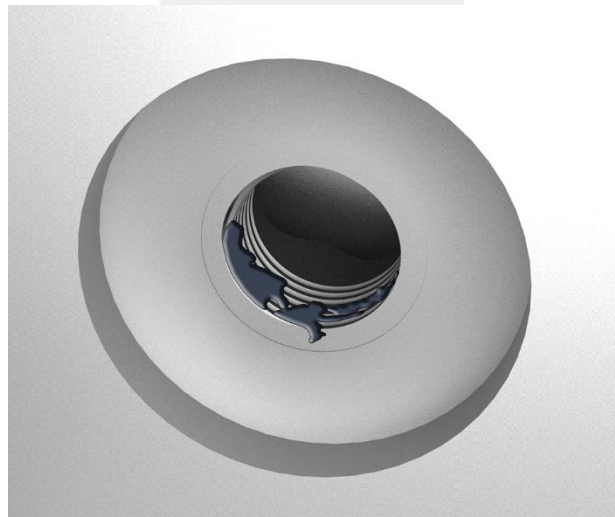
Figure 4 (High voltage controller to penthouse cover bolt hole gasket residue)

5. Inspect each of the high voltage controller to penthouse cover bolt holes (x5), and if present, remove any gasket residue (Figure 4).

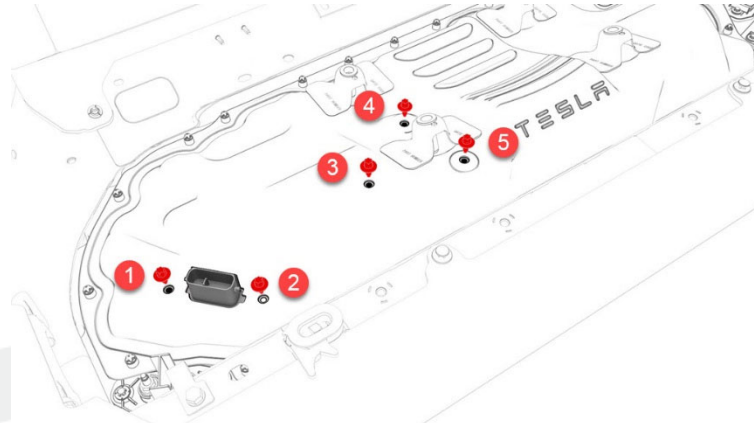
Figure 5 (Torque sequence)

7. Tighten the bolts in the sequence shown (torque 5 Nm +20°), and then mark each bolt with a paint pen (Figure 5).
