Replace Positive Busbar Nut and Additional Bolts

Classification	Campaign Bulletin	Section/Group	16 - HV Battery System	Country/Region	United States, Canada
Year	2018	Model	Model 3	Version	All

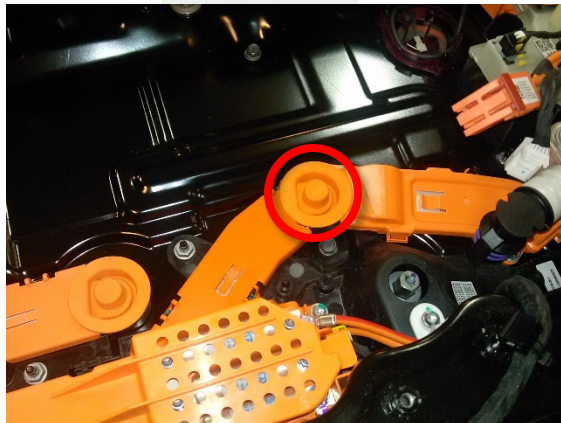
Figure 1

1. Remove the power conversion system (refer to Service Manual procedure 16301002).
2. Remove the insulator cap from the HV positive busbar joint nut (Figure 1).

6. Install the insulator cap onto the HV positive busbar joint nut (Figure 1).

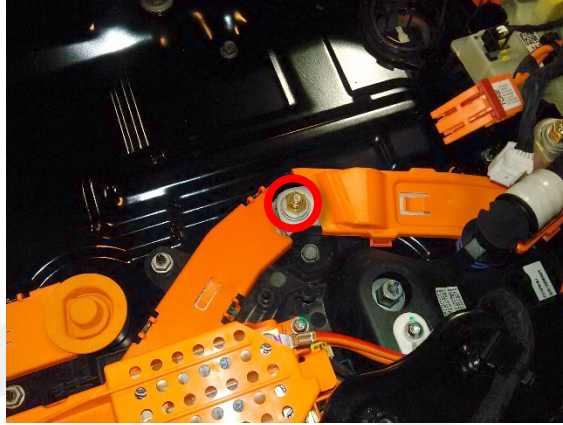
Figure 2

3. Remove and discard the nut that attaches the positive busbars at the joint (Figure 2).

4. Install a new nut to attach the positive busbars at the joint, and then mark the nut with a paint pen after it is torqued (torque 5 Nm +35°) (Figure 2).
5. Use the Hioki resistance meter to measure the resistance at the HV joint between the positive busbars (Figure 3).

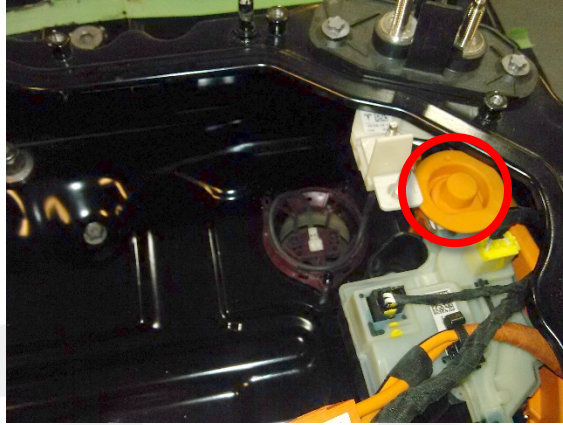
Figure 4

7. Remove the insulator cap from the HV battery positive contactor output terminal bolt (Figure 4).

11. Install the insulator cap onto the HV battery positive contactor output terminal bolt (Figure 4).
12. Release the clips that attach the fuse access insulator to the penthouse, and then remove the insulator from the penthouse (Figure 7).

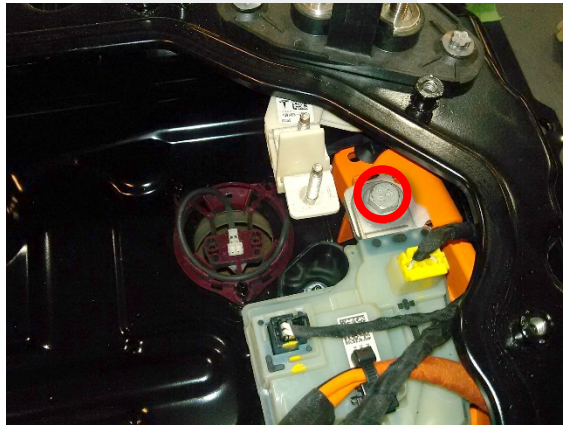
Figure 5

8. Remove and discard the bolt that attaches the HV battery positive contactor to the positive busbar (Figure 5).

9. Install a new bolt to attach the HV battery positive contactor onto the positive busbar, and then mark the bolt with a paint pen after it is torqued (torque 5 Nm +60°) (Figure 5).

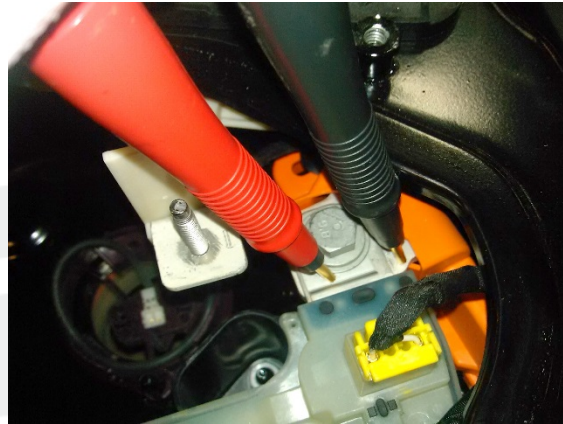
Figure 6

10. Use the Hioki resistance meter to measure the resistance at the HV joint between the HV battery positive contactor and the positive busbar (Figure 6).

NOTE: The maximum acceptable resistance is 0.060 mΩ (60 μΩ). If the resistance is above this value, escalate a Toolbox session, as appropriate.

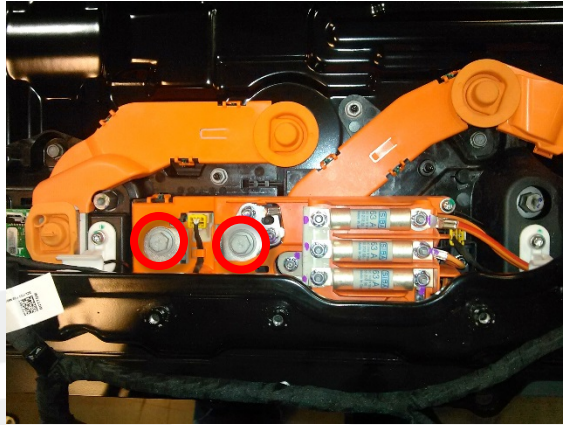
Figure 8

13. Remove and discard the bolts that attach the positive and negative busbars to the rear drive unit HV header (Figure 8).

14. Install new bolts to attach the positive and negative busbars to the rear drive unit HV header, and then mark the bolts with a paint pen after they are torqued (torque 5 Nm +60°) (Figure 8).
15. Use the Hioki resistance meter to measure the resistance at the HV joint between the rear drive unit HV header and the busbar at each bolt (Figure 9).
