Replace Front Radar Assembly For Vehicles Sold In Europe

Classification	Repair Bulletin	Section/Group	17 - Electrical	Country/Region	EMEA
Year	2016-2017	Model	Model S , Model X	Version	All

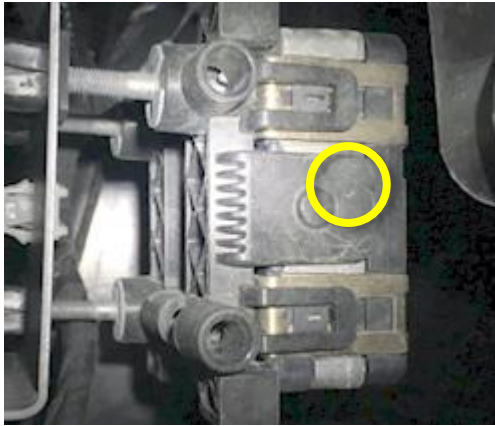
Figure 1 (Clean assembly, white residue on the radar)

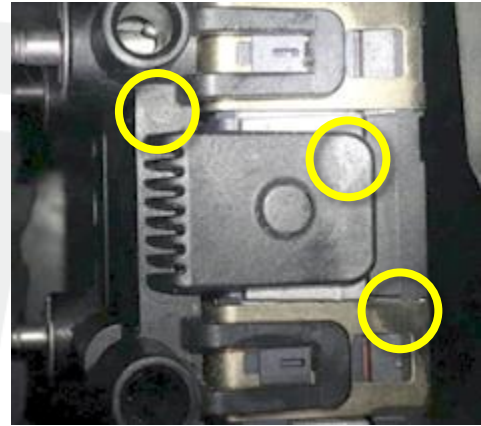
On some Model S and Model X vehicles aligned at the Tilburg Factory, some lubrication might have contacted the front radar assembly. The lubrication on the front radar assembly might result in radar calibration issues.

Figure 2 (Dirty assembly, covered in lubricant and dirt)

If diagnosis confirms that the front radar assembly has lubrication, replace the front radar assembly.

3. Replace the front radar assembly (refer to Service Manual procedure 17201502).
4. Reinstall the front fascia.
