Inspect Front Air Spring Modules

R2

Classification	Repair Bulletin	Section/Group	31 - Suspension	Country/Region	All
Year	2017 - 2018	Model	Model S	Version	All

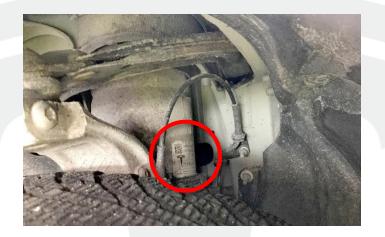
- 1. Temporarily set the air suspension to the highest setting, and then use the video scope to inspect the front air spring modules for their part numbers (Figure 1).
 - If the part number revisions are the same as those listed in this bulletin, or are a later revision, then this bulletin does not apply. Discontinue this procedure and refer to Toolbox articles, for example <u>#27522</u>, <u>#27520</u>, and <u>#31344</u>, to help identify the source of the noise.
 - If the part number revisions are not the same as those listed in this bulletin, nor a later revision, or the revisions are not discernable, continue to the next step.
