Replace Steering Column Control Module Connector Retaining Clip

Classification	Campaign Bulletin	Section/Group	32 - Steering	Country/Region	United States, Canada
Year	2017 - 2018	Model	Model 3	Version	All

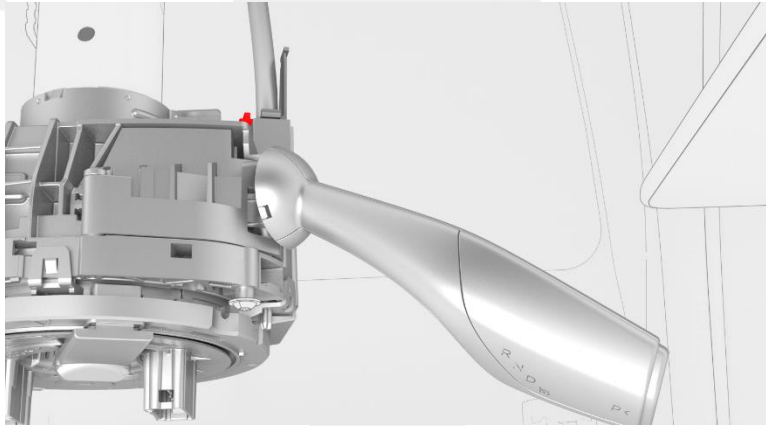
Figure 4

On some Model 3 vehicles, the steering column control module connector retaining clip may have been reused following repairs. This clip is one-time-use.

9. Remove and discard the retaining clip from the steering column control module electrical connector (Figure 4), and then disconnect the connector (Figure 5).
