Retrofit 1st Generation Charge Port or Charge Port Doors in 3-Phase Markets

Classification	Repair Bulletin	Section/Group	44 - High Voltage System	Country/Region	Europe, Middle East, Africa and Asia-Pacific
Year	2012-2016	Model	Model S	Version	All

This Service Document supersedes SB-18-44-007 R1, dated 28-May-19. Each content change is marked by a vertical line in the left margin. Discard the previous version and replace it with this one.

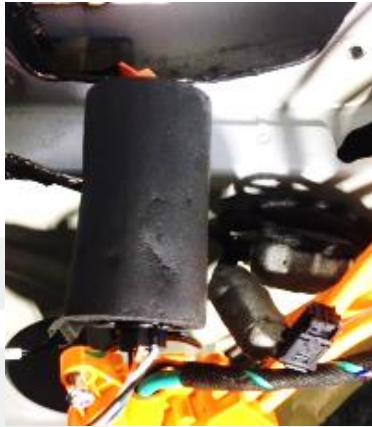
Figure 1

5. Install Noise, Vibration, and Harshness (NVH) foam on the connector that attaches the charge port to the charge port door (Figure 1).
