# Reduce Clicking Noise From Lower Windshield And Dash Area

<b>Classification</b>	Repair Bulletin	<b>Section/Group</b>	45 - Noise, Vibration & Harshness	<b>Country/Region</b>	All
<b>Year</b>	All	<b>Model</b>	Model S	<b>Version</b>	All

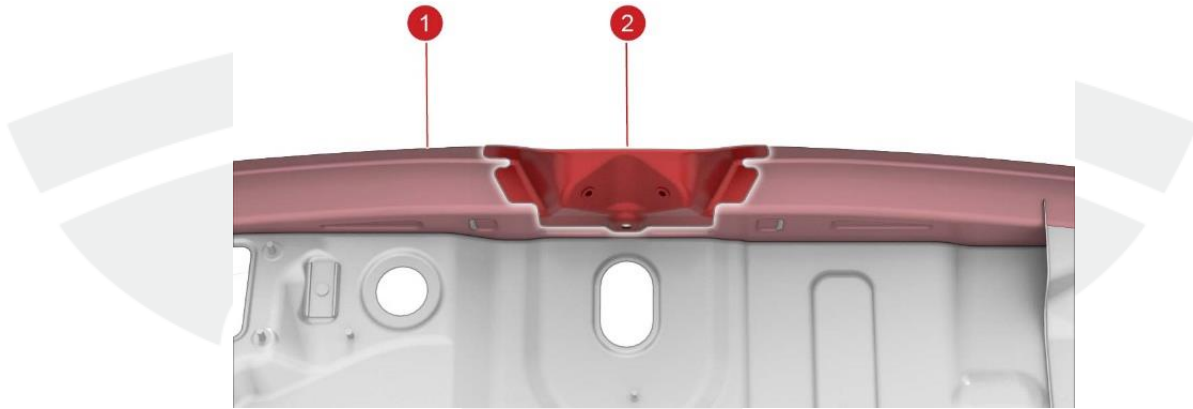
**Figure 1**

On some Model S vehicles, the shock tower brace mounting reinforcement (“reinforcement”) might loosen with time, causing an unwanted clicking noise when the vehicle drives over uneven surfaces.

1. Perform a road test to check for cabin noise coming from lower windshield and dash area where the reinforcement (Figure 1, Item 2) attaches to the cowl plenum (Figure 1, Item 1):
  - If there is noise, continue to the next step.
  - If noise is not heard, discontinue this procedure and perform additional diagnosis.

1. Cowl plenum
2. Shock tower brace mounting reinforcement

If diagnosis confirms that the noise is coming from the lower windshield and dash area where the reinforcement attaches to the cowl plenum, install rivets to attach the reinforcement to the cowl plenum.
