Tesla, Inc. Service Bulletin		<h2>Remove Upper A-Pillar Trim Bulge</h2>	
SB-19-10-003 December 31, 2019			
Classification		Section/Group	Mobile Service
Repair Bulletin		10 - Body	Cannot Perform
Model Year	Model	Country/Region	Version
2017	Model 3	United States, Canada	All
<small>The model(s) and model year(s) listed are a general approximation of the affected VIN list. Refer to the VIN/Bulletin Tracker or Customer/Vehicle profile to determine applicability of this bulletin for a particular vehicle.</small>

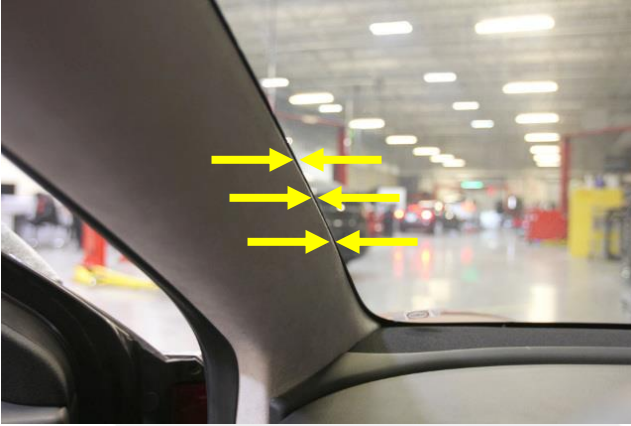
Some Model 3 vehicles might have a slight bulge at either or both upper A-pillar trims. This is strictly a cosmetic issue, and does not affect the operation or safety of the A-pillar or windshield in any way.

1. Inspect the LH and RH upper A-pillar trim for a bulge that is unsightly, or extends beyond the windshield black mask (Figures 1 and 2).
 - If there is no bulge visible on either upper A-pillar trim, discontinue this procedure.
 - If there is a bulge visible on one or both upper A-pillar trims, continue to the next step.

Figure 1 – Bulge from inside

Upon customer complaint, inspect the vehicle for symptoms related to the condition. If symptoms are present, replace the affected upper A-pillar trim with an updated component. If the bulge still remains, rework the upper A-pillar sheet metal.

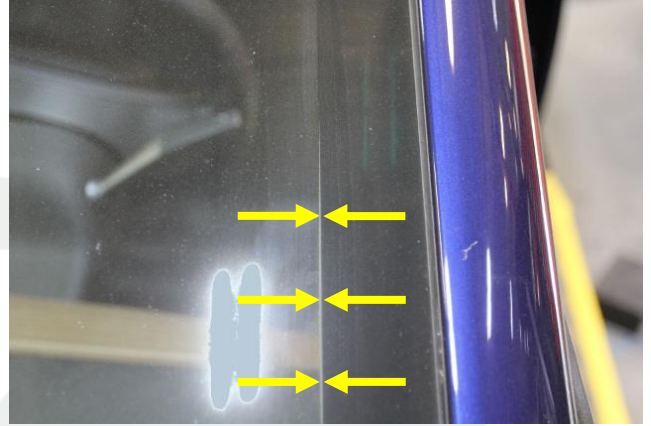
Figure 2 – Bulge from outside

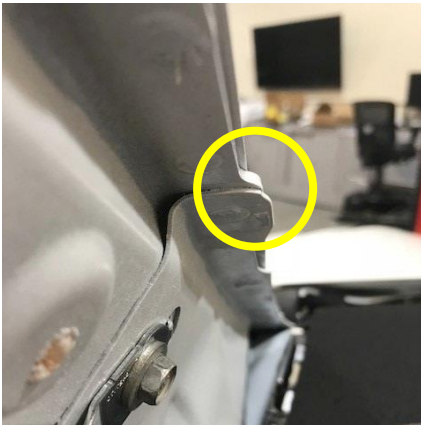
2. Remove the affected upper A-pillar trim (refer to Service Manual procedure 15184002).
3. Inspect the upper A-pillars for uneven sheet metal overlap at the location of the bulge (Figures 3 and 4).
 - If the sheet metal overlap is substantial, skip to step 5.
 - If the sheet metal overlap is mild, continue to the next step.

**NOTE:** The sheet metal layers should be flush. If the sheet metal on the other upper A-pillar also looks suspect, it can be reworked as well.

Figure 3 – Uneven sheet metal overlap, edge view

7. Put on appropriate PPE, and then use a grinder or cutoff wheel to make the sheet metal layers flush at the location of the bulge (Figures 6 and 7).

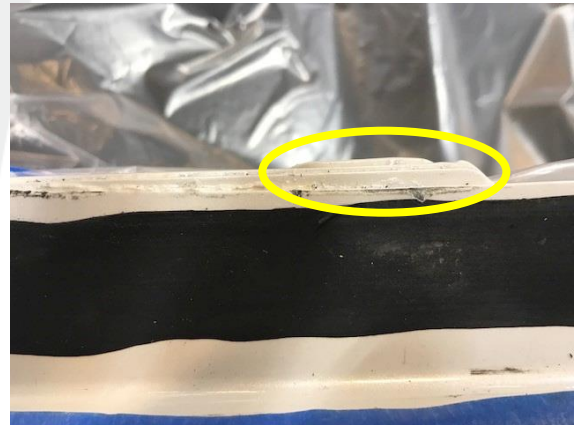
Figure 4 – Uneven sheet metal overlap, overhead view (windshield removed)

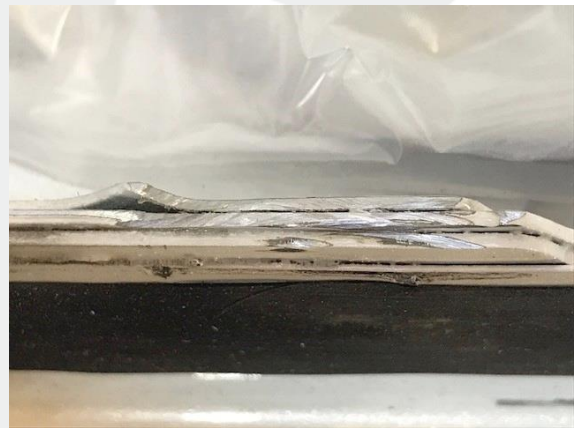
Figure 7 – Sheet metal layers ground flush
