# Secure Triple Camera Windshield Bracket

<b>Classification</b>	Campaign Bulletin	<b>Section/Group</b>	15 - Interior Trim	<b>Country/Region</b>	Asia Pacific, Europe
<b>Year</b>	2019	<b>Model</b>	Model 3	<b>Version</b>	All

*This Service Document supersedes SB-19-15-002, dated 12-Jun-2019. Each content change is marked by a vertical line in the left margin. Discard the previous version and replace it with this one.*

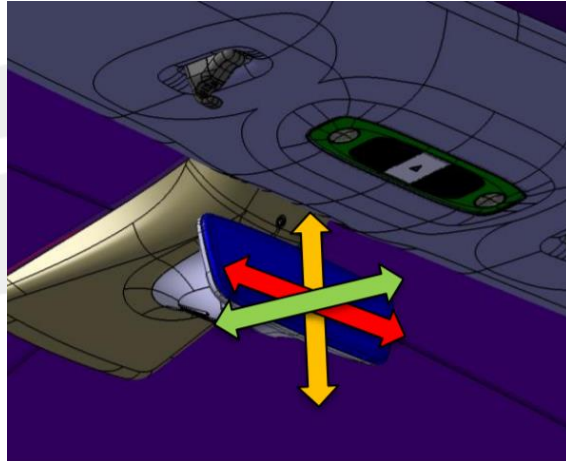
Figure 1

1. Carefully pull on the rear view mirror with approximately 10 lbs (4.5 kg) of force in the directions illustrated (Figure 1): up/down, left/right forward/backward.
  - If any looseness or excessive movement is detected, continue to the next step.
  - If the rear view mirror feels secure, go to Toolbox Article [52599](#), follow the instructions in the “Steps to fix” section, and then discontinue this procedure.
