Tesla, Inc. Service Bulletin		<i>Install Ferrites to Reduce Static Noise From A-pillar Tweeters</i>	
SB-19-17-014 December 13, 2019					
Classification		Section/Group		Mobile Service	
Repair Bulletin		17 - Electrical		Available (where permitted)	
Model Year	Model	Country/Region		Version	
2016 - 2018	Model S, Model X	All		Autopilot HW2 or later with Tegra MCU	
The model(s) and model year(s) listed are a general approximation of the affected VIN list. Refer to the VIN/Bulletin Tracker or Customer/Vehicle profile to determine applicability of this bulletin for a particular vehicle.

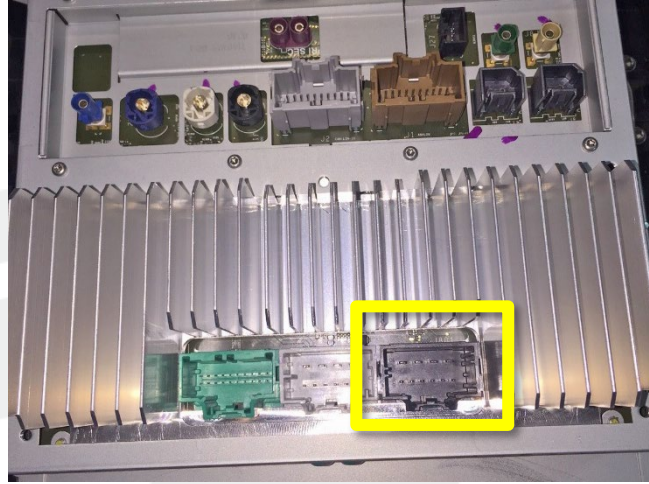
Figure 1

1. Remove the MCU from the vehicle (refer to Service Manual procedure 21060101).
2. Gently place the MCU on the foam ESD container with the touchscreen facing down.
3. Identify the affected connector (X425 on Model S, X175 on Model X) that was plugged into the MCU (Figure 1).

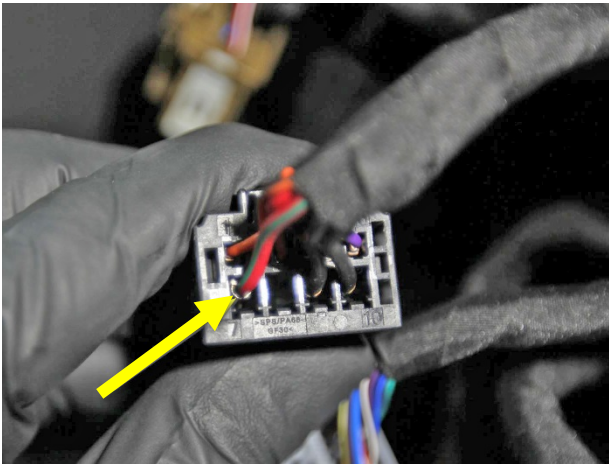
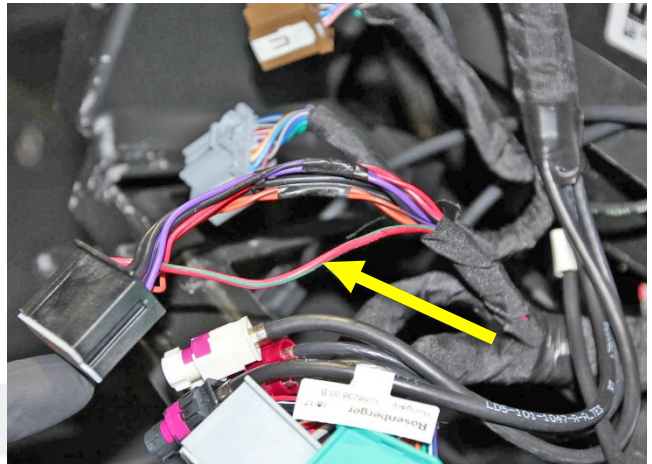
5. Identify the wire that connects to pin 7 on the connector (Figures 3 and 4).
