Replace Statutory Plate

Classification Campaign Bulletin **Section/Group** 19 - Labels **Country/Region** EMEA

Year 2019 **Model** Model 3 **Version** LHD

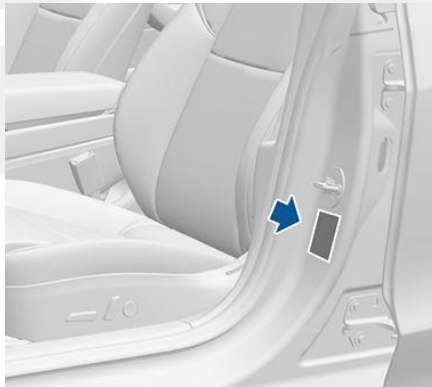
Figure 1

Certain Model 3 vehicles were manufactured with incorrect information on the statutory plate near the base of the driver side B-pillar.

1. Order the new statutory plate, noting the customer's VIN in the Part Request "VIN" field.
2. Upon receipt of the new statutory plate, check that the VIN on the statutory plate matches the VIN on the vehicle's dashboard VIN plate.
3. Open the driver's side door.
4. Starting from one corner, carefully peel the statutory plate off the B-Pillar. Discard the statutory plate (Figure 1).

⚠ CAUTION: Take care not to damage the body paint.
