Repair Model S and Model X Rear Node to Subframe Mounting Area Damage

Classification	Repair Bulletin	Section/Group	30 - Chassis	Country/Region	All
Year	2018	Model	Model S and Model X	Version	All

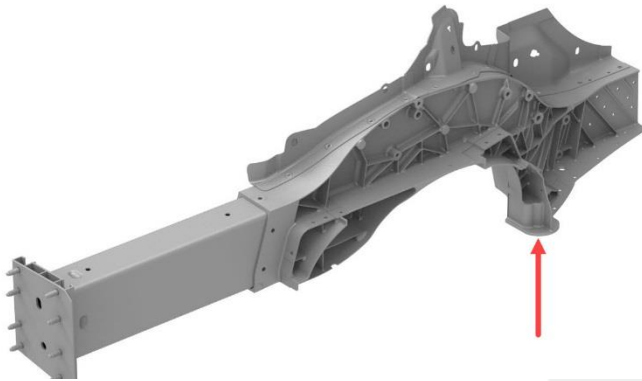
Figure 1 Model S Rear Node

The rear node of some Model S and Model X vehicles might have damage in the forward mounting location of the rear subframe, resulting in noise, vibration, or harshness coming from that location.

2. Inspect the forward subframe attachment points to both rear nodes (Figure 1 and Figure 2):

Inspect the vehicle for the condition described. If the condition is present, add a repair plate to the damaged subframe mounting area and add spacer plates to undamaged subframe mounting areas of the rear node.

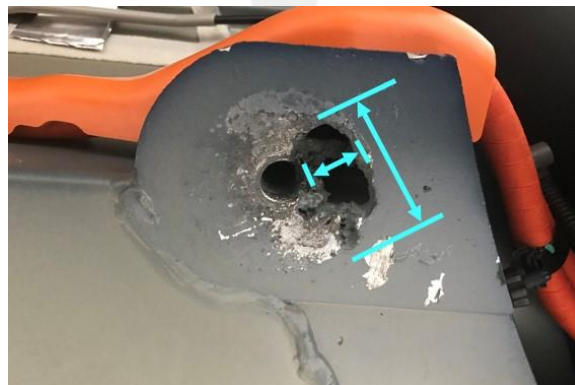
Figure 3

- If no damage is present on the forward subframe attachment points on the LH or RH rear nodes, no repair is required. Discontinue this procedure and install the rear subframe assembly (refer to Service Manual procedure 30010201).
 - If damage is present, continue to the next step.
3. Measure the damaged area:
 - a. Measure the length and the width of the damaged area on the bottom face of the node (Figure 3).

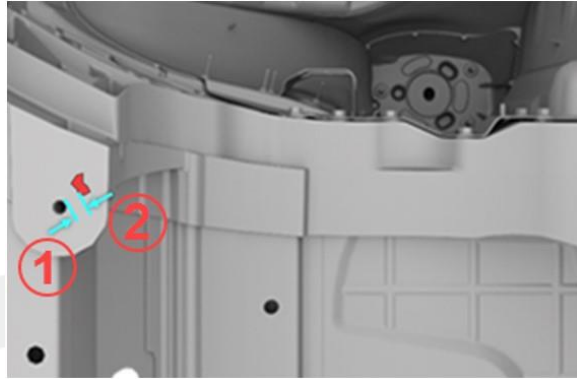
Figure 4

- b. Measure the distance between the edge of the subframe mounting bolt hole closest to the damaged area (① in Figure 4) and the edge of the damaged area (② in Figure 4).
