Replace Rear Drive Unit Inverter 55 Degree Fluid Coupling

Classification	Campaign Bulletin	Section/Group	40 - Rear Drive Unit	Country/Region	United States, Canada
Year	2019	Model	Model 3	Version	All

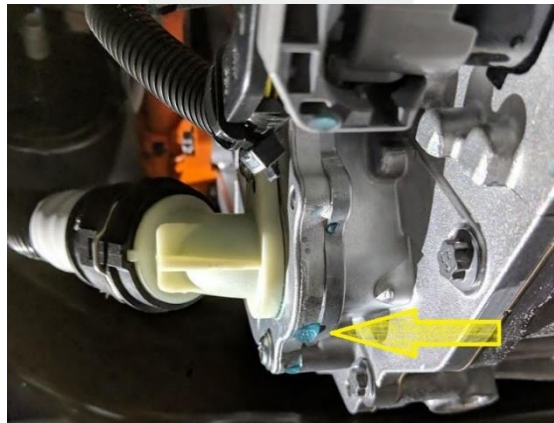
Figure 1

9. Inspect the 55 degree fluid coupling for residual coolant or an active coolant leak (Figure 1):
 - If no residual coolant or active coolant leak is detected, discontinue this procedure.

- If residual coolant or an active coolant leak is detected, continue to the next step.

10. Fully lower the vehicle.
11. Disconnect 12V power (refer to Service Manual procedure 17010200).
12. Remove the outer HVAC plenum duct (refer to Service Manual procedure 18109102).
13. Fully raise the vehicle to a comfortable working height.
14. Remove and replace the rear drive unit inverter 55 degree fluid coupling (refer to Service Manual procedure 40014002).
15. Perform the cooling system vacuum refill procedure (refer to Service Manual procedure 18300400).
16. Reconnect 12V power (refer to Service Manual procedure 17010200).
