Tesla, Inc.
Service Bulletin

Remove B-Pillar Applique Gore Patches

SB-20-12-002
March 17, 2020

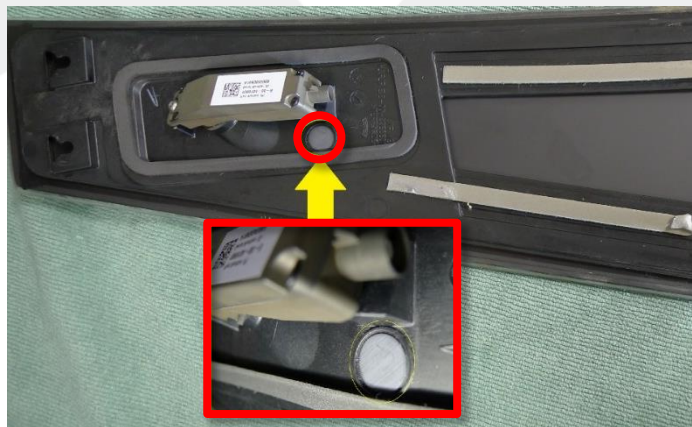
Figure 1 – Model S

On some Model S, Model X, and Model 3 vehicles, condensation might build up inside of the B-pillar applique, potentially obscuring the B-pillar camera. This condition might cause some Autopilot features to be temporarily unavailable until the condensation goes away, such as Auto Lane Change, Blind Spot Detection, and Lane Departure Warning.

4. Place the B-pillar applique face down on a soft cloth and look for the gore patch (Figures 1, 2, and 3).
