esla, Inc. ervice Bulletin	Inspect Steering Column Dust Cover	
SB-20-3	32-006		
April 2,	2020		
Classification		Section/Group	Mobile Service
Campaign Bulletin		32 - Steering	Cannot Perform
Model Year	Model	Country/Region	Version
2019 - 2020	Model 3	China	Giga Shanghai
		ral approximation of the affected VIN list. Refer to the VIN/Bulletin 1	racker or Customer/Vehicle profile to determine

On some Model 3 vehicles built at Giga Shanghai, the steering column dust cover might have been improperly installed.

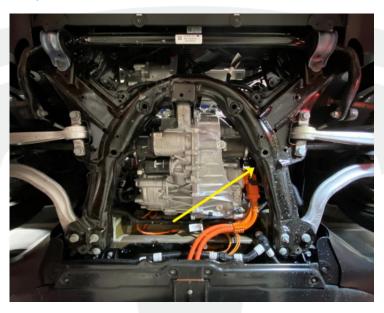
Figure 1

- 1. Remove the front aero shield panel (refer to Service Manual procedure 12030102).
- 2. Look behind the LH side of the front subframe (Figure 1) and inspect the steering column dust cover:
  - If the steering column dust cover is not installed on the steering column shaft joint (Figure 2), continue to step 3.
  - If the steering column dust cover is already installed on the steering column shaft joint (Figure 3):
    - a. Push the cover against the joint to ensure that the cover is fully seated.
    - b. Reinstall all components that were removed for access, and then discontinue this procedure.

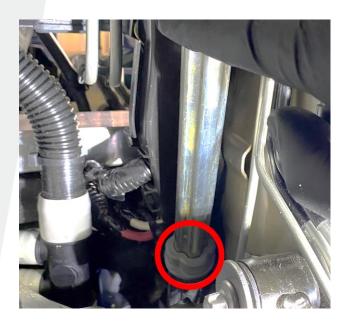
Figure 3 – Steering column dust cover installed on the steering column shaft joint

3. Slide the steering column dust cover up (Figure 4) and fully seat the cover against the steering column shaft joint (Figure 3).
