Tesla, Inc. Service Bulletin		<i>Inspect Charge Port Busbar Safety Cap And Protective Earth Busbar</i>	
SB-20-44-002 July 24, 2020			
Classification		Section/Group	Mobile Service
Campaign Bulletin		44 - High Voltage System	Can Perform (where permitted)
Model Year	Model	Country/Region	Version
2020	Model Y	North America	All
<small>The model(s) and model year(s) listed are a general approximation of the affected VIN list. Refer to the VIN/Bulletin Tracker or Customer/Vehicle profile to determine applicability of this bulletin for a particular vehicle.</small>

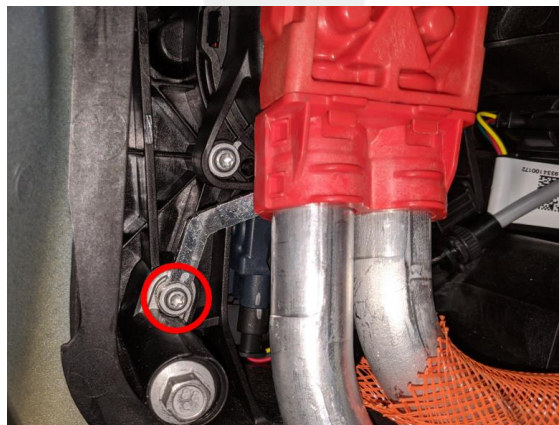
Figure 2

3. Remove the LH C-Pillar bracket (refer to Service Manual procedure [15186402](#)).
4. Perform a torque check on the screw that attaches the PE busbar to the charge port carrier (torque 3.0 Nm) (Figure 2).

- If the screw cannot be properly torqued, or if there is damage to the PE busbar/charge port bolt threads:
 - a. Replace the charge port (refer to Service Manual procedure [44011602](#)), but return to this procedure after performing the resistance test between the charge port busbar lead and charge port busbar stud.
 - b. Skip to step 11.
- If the screw can be properly torqued, and there is no damage to the PE busbar/charge port bolt threads, continue to step 5.

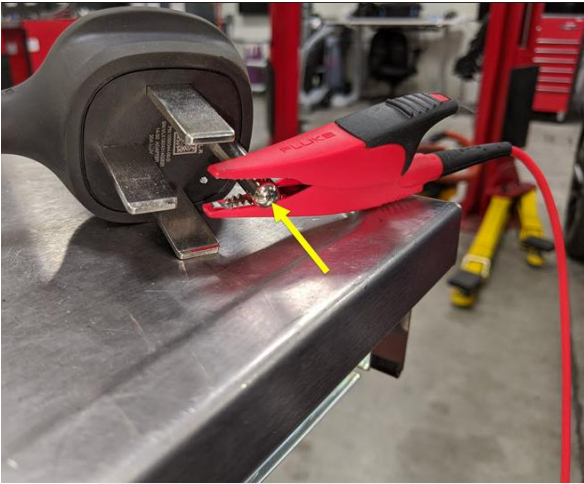
Figure 3

5. Connect the handle of a known working UMC (Universal Mobile Connector) with a NEMA adapter to the vehicle charge port. Do not plug the other end of the UMC into a wall outlet.
6. Set the multimeter to resistance measurement mode, and then using alligator clips, attach the multimeter to the UMC NEMA adapter ground pin (Figure 3) and charge port PE busbar (Figure 4).

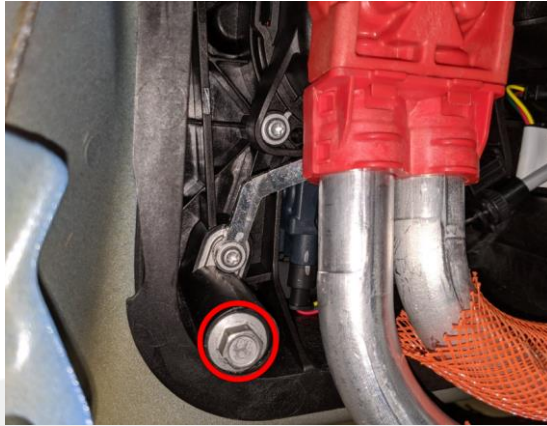
Figure 5

10. Perform a torque check on the bolt that attaches the charge port carrier ground to the body (torque 5.5 Nm) (Figure 5).

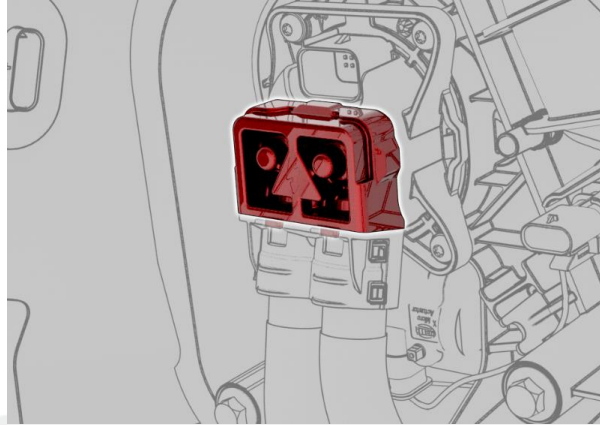
Figure 7

14. If not already removed, remove the charge port busbar safety cap from the vehicle (Figure 7).

16. Install the charge port busbar safety cap (Figure 7).

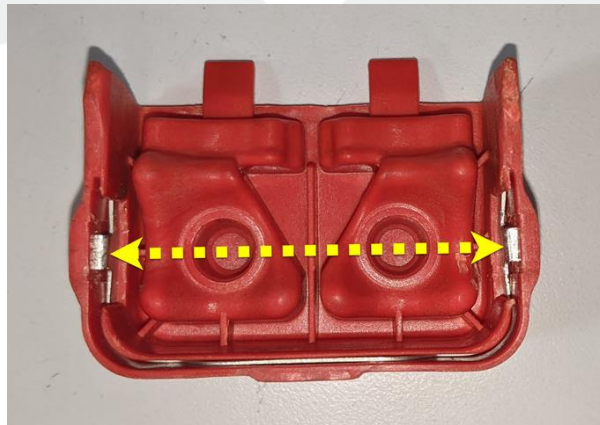
Figure 8

15. Using digital calipers, measure the distance between the electrical terminals on the underside of the charge port busbar safety cap (Figure 8).

- If the distance between the two terminals is less than 45.94 mm, remeasure the distance. If the measurement is still less than 45.94 mm, continue to step 16.
- If the distance between the two terminals is between 45.94 mm and 46.24 mm, continue to step 16.
- If the distance between the two terminals is greater than 46.24 mm:
 - a. Use needle nose pliers and a pocket screwdriver to equally bend both terminals toward the center of the charge port busbar safety cap.
 - b. Remeasure the distance between the terminals and continue to step 16 when the measured distance is between 45.94 mm and 46.24 mm.

**NOTE:** If the terminals are damaged, or if unable to properly rework the terminals, procure a new charge port busbar safety cap, and then continue to the step 16.
