Tesla, Inc. Service Bulletin		Seal Roof Rail To Upper Header Gap To Prevent Water Ingress	
SB-21-10-001 R1 July 30, 2021					
Classification		Section/Group		Mobile Service	
Campaign Bulletin		10 - Body		Can Perform (where permitted)	
Model Year	Model	Country/Region		Version	
2021	Model 3	Europe, Middle East		All	
The model(s) and model year(s) listed are a general approximation of the affected VIN list. Refer to the VIN/Bulletin Tracker or Customer/Vehicle profile to determine applicability of this bulletin for a particular vehicle.

On certain Model 3 vehicles, there might be a gap between the roof rail and upper header, which might permit water ingress into the cabin.

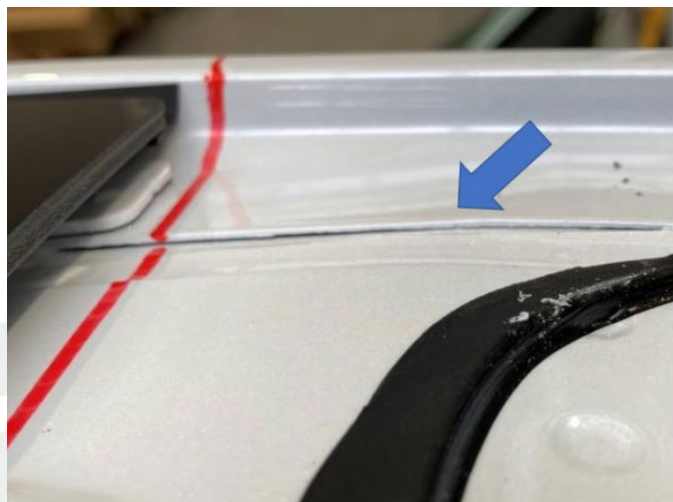
Figure 2 - Roof glass removed for clarity

Water ingress can occur at the roof rail and upper header joint (Figure 2, roof glass removed for clarity), and then can flow down into the cabin.

Inspect and test the vehicle for the symptom related to the condition. If the symptom is present, seal the roof rail to upper header gap.

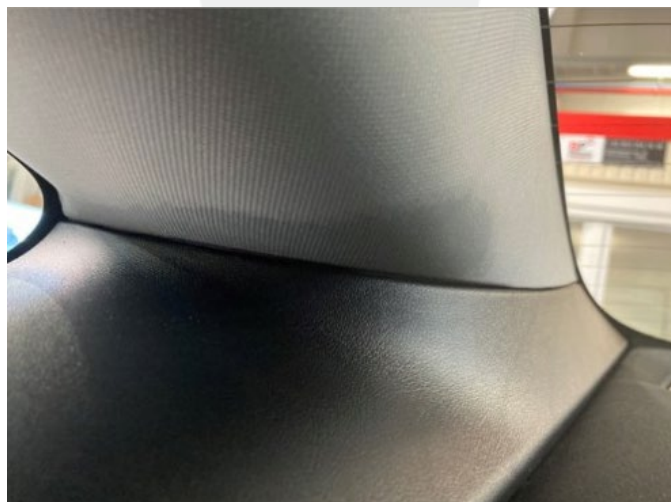
Figure 3

Water ingress may be identified by the presence of wet or damp patches at the interior roof trims and/or C-pillar trims (Figure 3). Follow the Inspection and Repair Procedure in this bulletin procedure to verify water ingress.
