Tesla, Inc. Service Bulletin		<h2>Seal Roof Rail To Upper Header Gap To Prevent Water Ingress</h2>	
SB-21-10-004 July 30, 2021			
Classification		Section/Group	Mobile Service
Repair Bulletin		10 - Body	Can Perform (where permitted)
Model Year	Model	Country/Region	Version
2021	Model 3	Europe, Middle East	All
<small>The model(s) and model year(s) listed are a general approximation of the affected VIN list. Refer to the VIN/Bulletin Tracker or Customer/Vehicle profile to determine applicability of this bulletin for a particular vehicle.</small>

On some Model 3 vehicles, there might be a gap between the roof rail and upper header, which might permit water ingress into the cabin.

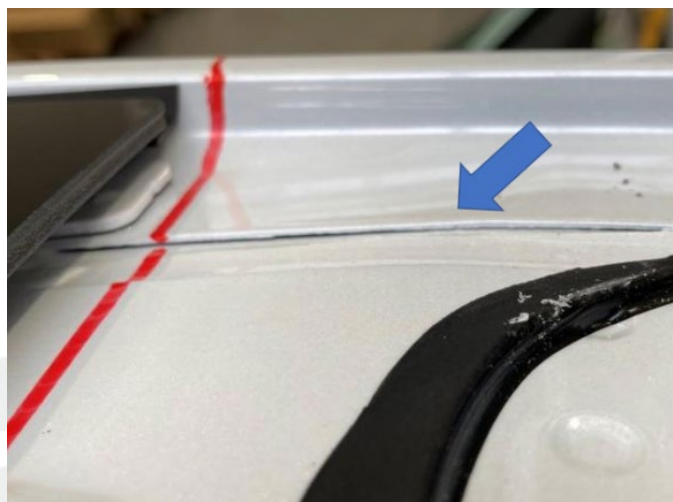
Figure 2 – Roof glass removed for clarity

Water ingress can occur at the roof rail and upper header joint (Figure 2) and then can flow down into the cabin.

Upon customer complaint, inspect and test the vehicle for the symptom related to the condition. If the symptom is present, seal the roof rail to upper header gap.

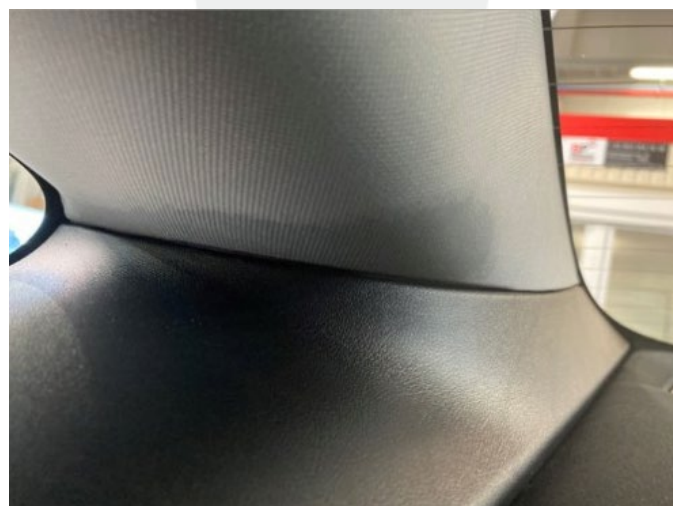
Figure 3

Water ingress may be identified by the presence of wet or damp patches at the interior roof trims and/or C-pillar trims (Figure 3). Follow the Inspection and Repair Procedure in this bulletin procedure to verify water ingress.
