| | esla, Inc. ervice Bulletin | Inspect Outer Rear Quarter Panel Body | | |
| SB-21-11-001 | | Joint Sealant For Trunk Water Ingress | | |
| January 22, 2021 | | | | |

On some Model 3 vehicles, the body joint sealant on the outer rear quarter panels are missing or were not properly applied, causing water ingress to the trunk compartment.

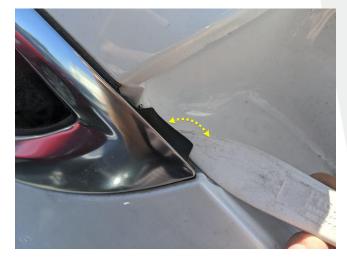
Figure 1

- 1. Remove the trunk garnish (refer to Service Manual procedure 15111102).
- 2. Remove the trunk sill trim (refer to Service Manual procedure <u>15244802</u>).
- 3. Move the LH quarter glass seal aside (Figure 1), and then insert a trim tool between the body and quarter glass for access (Figure 2).

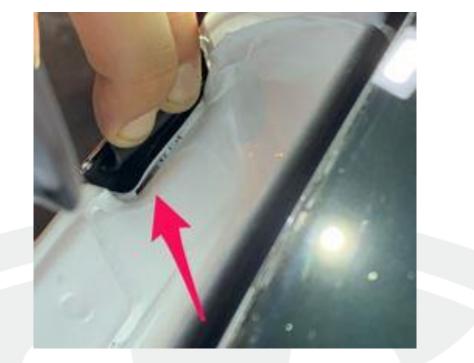
Figure 3

4. Visually inspect the area between the body panels under the seal lip (Figure 3).

- If there is no visible gap, continue to the next step.
- If there is a visible gap, skip to step 6.
- 5. Apply a small amount of soapy water to the body joint sealant area, and then blow the area with shop air (Figures 4 and 5).

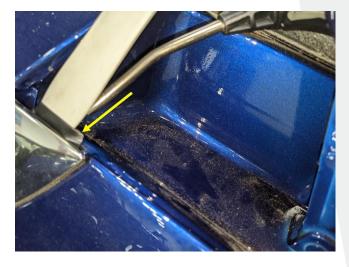
Figure 4

- If a leak is detected, continue to the next step.
- If no leak is detected, repeat from step 3 for the RH side of the vehicle.
- If no leak is detected on the LH and RH sides of the vehicle, skip to step 11.
