'esla, Inc. ervice Bulletin	Replace Speaker Grilles Due To Corrosion	
SB-21-15-004			
May 7, 2021			
Classification		Section/Group	Mobile Service
Repair Bulletin		15 - Interior Trim	N/A
Model Year	Model	Country/Region	Version
2020	Model 3	China	All
	odel year(s) listed are a ger sulletin for a particular vehicl	eral approximation of the affected VIN list. Refer to the VIN/B	ulletin Tracker or Customer/Vehicle profile to determine

Some Model 3 vehicles built by Giga Shanghai are found corrosion in the speaker grille on parcel shelf and the headliner due to material and craft limitations.

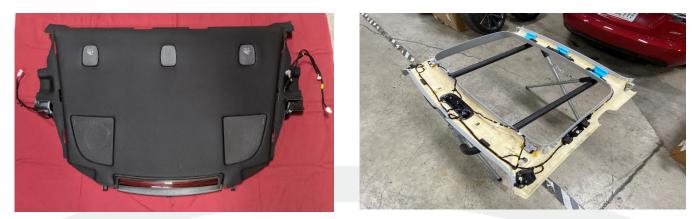
Figure 1 – Package Tray Trim

Inspect the speaker grilles on the package tray trim and headliner. (Figures 1 and 2).

- If corrosion is present on *any* of the speaker grilles, perform both of the following substeps:
 - Replace both package tray speaker grilles (refer to section "Replace Package Tray Speaker Grilles" in this document).
 - Replace the headliner (refer to Service Manual procedure <u>15203002</u>).
- If corrosion is not present on any of the speaker grilles, cancel the bulletin activity so that it is available for future possible application.
