Tesla, Inc. Service Bulletin		<h2>Replace Front Body Controller Module Grounding Screws</h2>	
SB-21-17-002 February 04, 2021			
Classification		Section/Group	Mobile Service
Repair Bulletin		17 - Electrical	Can Perform (where permitted)
Model Year	Model	Country/Region	Version
2019 - 2020	Model Y	North America	All
<small>The model(s) and model year(s) listed are a general approximation of the affected VIN list. Refer to the VIN/Bulletin Tracker or Customer/Vehicle profile to determine applicability of this bulletin for a particular vehicle.</small>

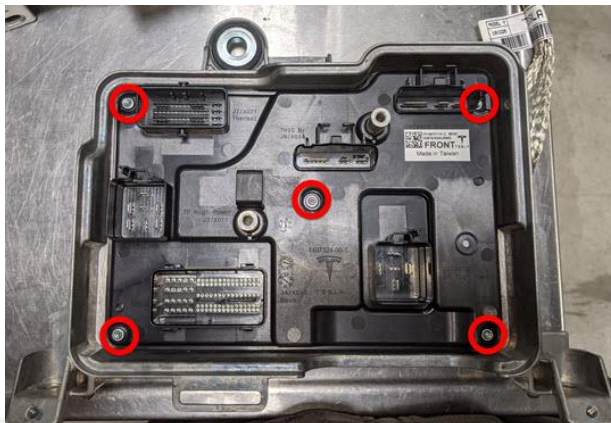
Figure 1

4. Remove and discard the screws (x5) that enable grounding from within the front body controller module (Figure 1).

5. Install a new washer onto each new replacement screw, and then install the replacement screw-washer pairs (x5) into the front body controller module (Figure 1) (torque 1.5 Nm).
6. Install the front body controller module (refer to Service Manual procedure [17152912](#)).
