Tesla, Inc. Service Bulletin		<h2><i>Replace RH Taillight Due To Color Mismatch</i></h2>	
SB-21-17-003 April 19, 2021			
Classification Repair Bulletin		Section/Group 17 - Electrical	Mobile Service Can Perform (where permitted)
Model Year 2021	Model Model Y	Country/Region North America	Version All
<small>The model(s) and model year(s) listed are a general approximation of the affected VIN list. Refer to the VIN/Bulletin Tracker or Customer/Vehicle profile to determine applicability of this bulletin for a particular vehicle.</small>

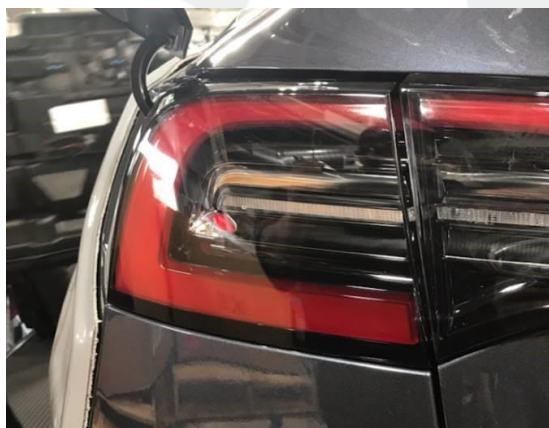
On some Model Y vehicles, the color of the red band that surrounds the LH and RH taillights do not match because the vehicle has Revision D for the LH taillight (Figure 1) which has a darker tint, and the right side has Revision C (Figure 2) which has a lighter tint. This is only a cosmetic issue that does not affect the performance of the taillights.

✓ **Figure 1 – Revision D LH Taillight**

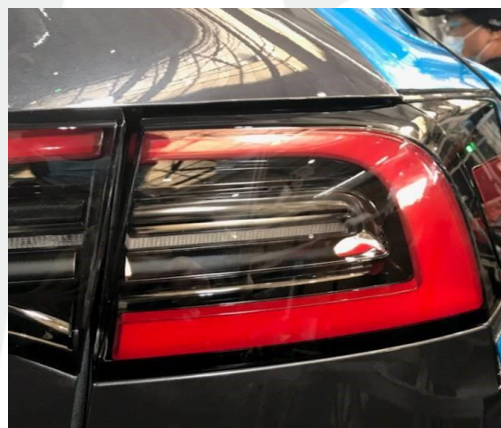
✗ **Figure 2 – Revision C RH Taillight**

Inspect the vehicle for a color mismatch of the taillights. If a color mismatch is present, replace the RH taillight with Revision D.

Replace the RH taillight (refer to Service Manual procedure [17402002](#)).
