Tesla, Inc. Service Bulletin		<i>Reseal Front Panels Due To Water Leak</i>	
SB-22-10-003 May 2, 2022			
Classification		Section/Group	Mobile Service
Repair Bulletin		10 - Body	Cannot Perform
Model Year	Model	Country/Region	Version
2012 - 2020	Model S	All	All
<small>The model(s) and model year(s) listed are a general approximation of the affected VIN list. Refer to the VIN/Bulletin Tracker or Customer/Vehicle profile to determine applicability of this bulletin for a particular vehicle.</small>

Condition

On some Model S vehicles, the LH and/or RH shotgun panel and A pillar area might have water ingress issues that cause wet front footwell carpets and electrical issues, such as intermittent or permanent loss of door functions.

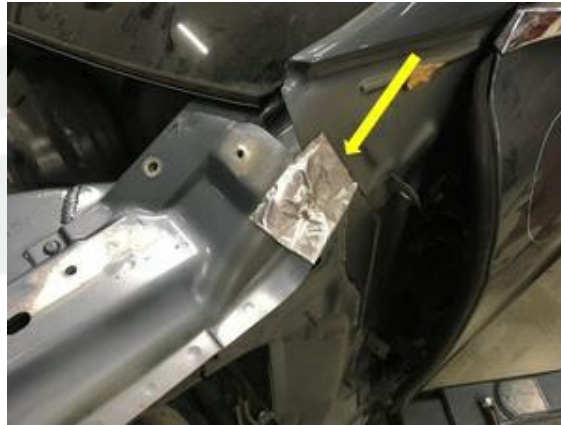
Figure 1 – LH shown; RH similar

1. Check for moisture in the footwell areas to determine which side of the vehicle (LH, RH or both) needs repair.
2. Remove the hood, with hinges attached to the hood (refer to Service Manual procedure [10100301](#)).
3. Remove the front fascia assembly (refer to Service Manual procedure [1010901](#)).
4. Remove the LH and/or RH front fender assemblies (refer to Service Manual procedure [10103002](#)).
5. For LH repair only: remove the windshield washer reservoir (refer to Service Manual procedure [17501102](#)).
6. Remove the butyl patches on the LH and/or RH upper end of the shotgun cover (Figure 1).

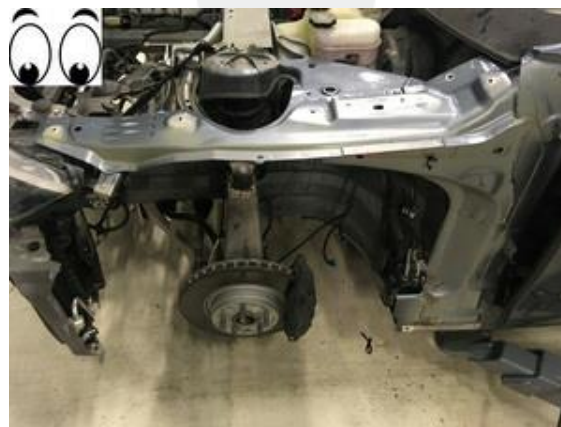
Figure 2

1. Inspect all panel joints in and around the shotgun and A-pillar area for gaps, splits and cracks (Figure 2).

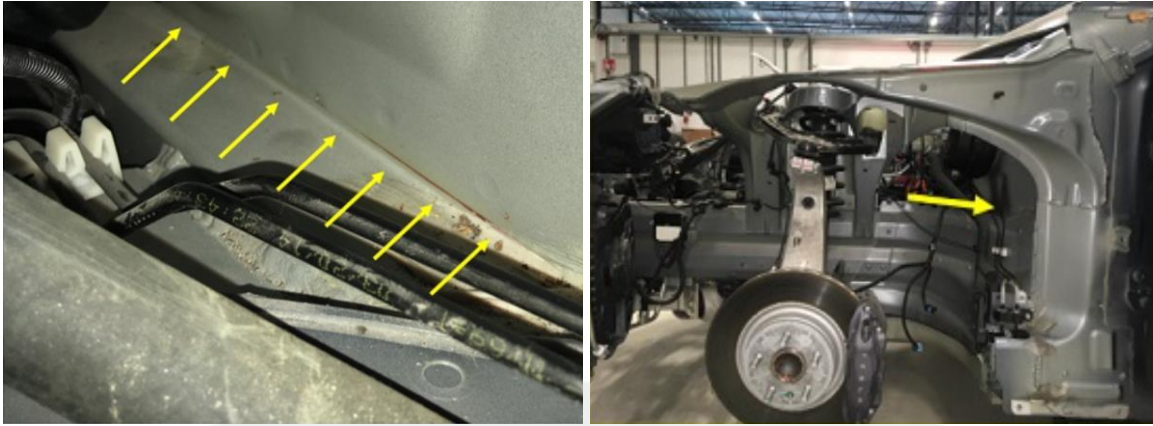
Figure 3 – LH side

2. Inspect the lower body joints in the bulkhead area for gaps or cracks in the sealant (Figure 3 and 4).

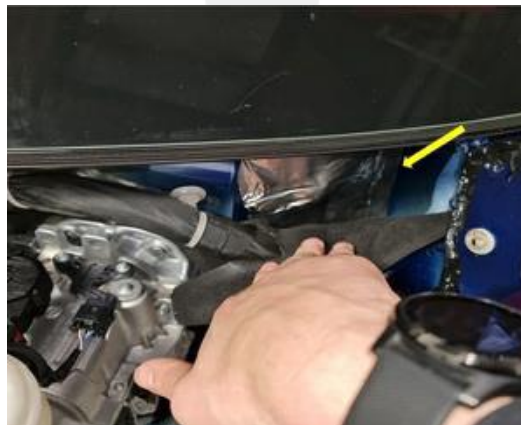
Figure 5

4. Check that the butyl patches at the top corner of the bulkhead (under the windshield and behind the foam) are all sealing as intended. If necessary, clean the area with IPA wipes, allow 1 minute to dry, and then apply new patches (Figure 5).
