<b>Tesla, Inc.</b> Service Bulletin		<b><i>UHF Antenna Wire Rework To Improve Charge Port Door Response To Charge Cable Button Press</i></b>	
<b>SB-22-17-005</b> April 29, 2022					
<b>Classification</b>		<b>Section/Group</b>	<b>Mobile Service</b>	<b>Configuration</b>	
Repair Bulletin		17 - Electrical	Cannot Perform	All	
<b>Model Year</b>	<b>Model</b>	<b>Country/Region</b>	<b>Build Location</b>		
2021	Model S	United States, Canada	Fremont		
The model(s) and model year(s) listed are a general approximation of the affected VIN list. Refer to the VIN/Bulletin Tracker or Customer/Vehicle profile to determine applicability of this bulletin for a particular vehicle.

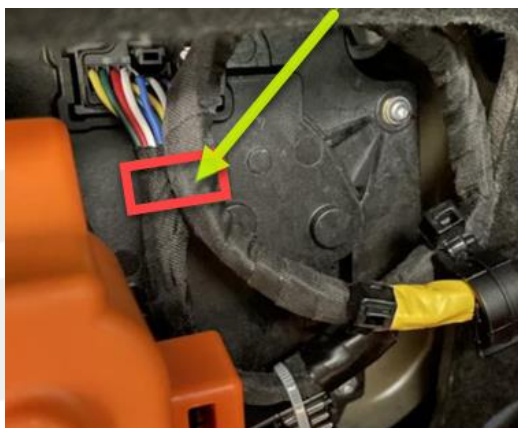
**Figure 1**

1. Remove the rear underhood apron (refer to Service Manual [12251102](#)).
2. Disconnect LV power (refer to Service Manual procedure [17010200](#)).
3. Remove the LH trunk side trim (refer to Service Manual procedure [15245002](#)).
4. Cut the cable tie that attaches the wiring harness loop to the inlet logic branch (Figure 1).

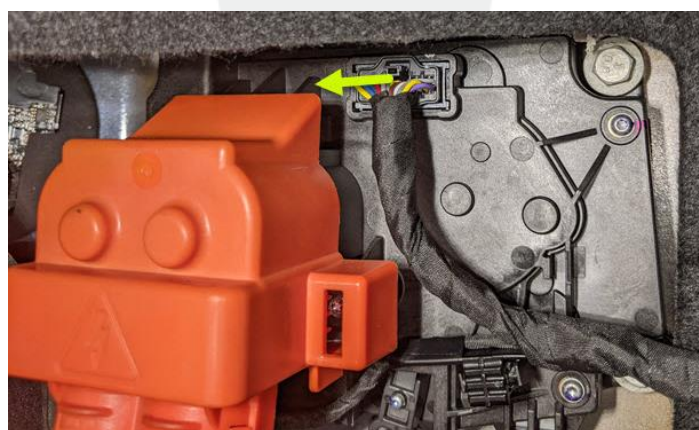
**Figure 2**

5. Disconnect charge port electrical connector X1400 (Figure 2).

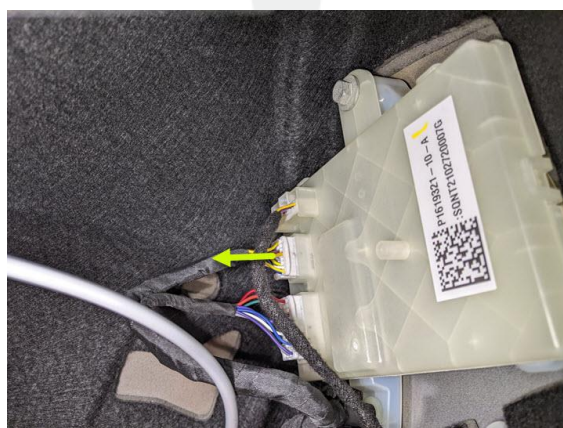
**Figure 3**

6. Disconnect charge port ECU electrical connector X1496 (Figure 3).

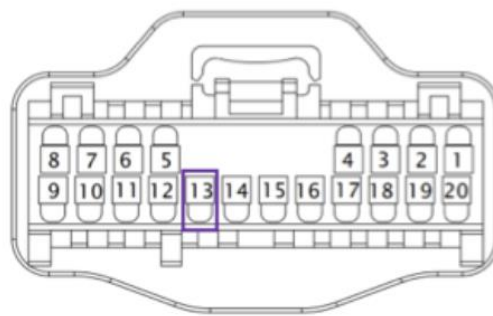
**Figure 4**

7. Unpin the purple UHF antenna wire at charge port inlet electrical connector X1400, cavity 13 (Figure 4) by releasing the connector lock.

11. Install the new wire terminal (1116824-00-A) from the UHF antenna overlay wire into electrical connector X1400, cavity 13 (Figure 4).

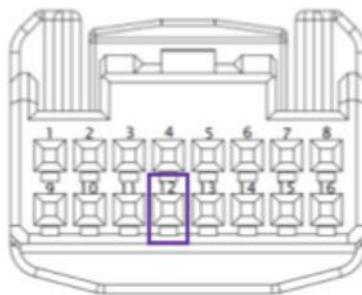
**Figure 5**

8. Unpin the purple UHF antenna wire at charge port ECU electrical connector X1496, cavity 12 (Figure 5) by releasing the connector lock.

12. Install the new wire terminal (1099424-00-A) from the UHF antenna overlay wire into electrical connector X1496, cavity 12 (Figure 5).

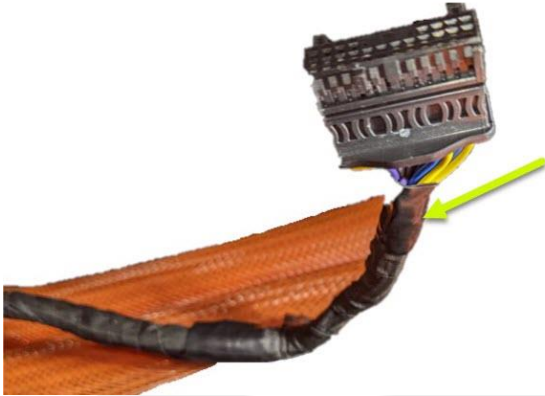
Figure 6

9. Cut off the wire terminals at both ends of the purple UHF antenna wire using diagonal cutters, and then use electrical tape to cover the leftover wire (Figures 6 and 7).

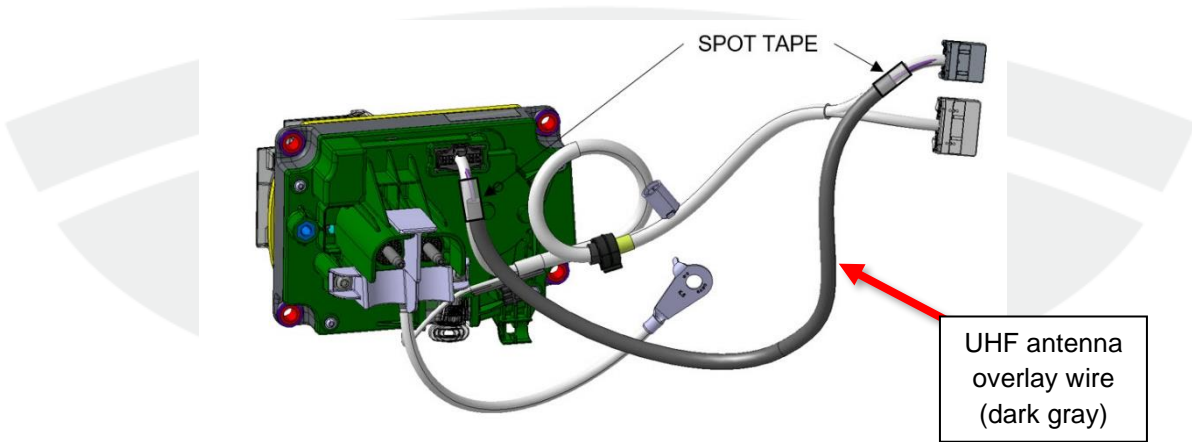
**Figure 8**

13. Add electrical tape at each end of the new UHF antenna overlay wire to the existing harness, and then position the UHF antenna overlay wire relative to connector positions as shown in Figure 8.

**⚠ CAUTION:** Failure to route the UHF antenna overlay wire as instructed may cause lower than expected UHF performance.

**⚠ CAUTION:** The new UHF antenna overlay wire should be routed in front of the busbars and sit inboard of all the other inlet wiring.

**📄 NOTE:** The distance between the center of the electrical tape and the back side of each electrical connector should be approximately 30 mm (Figure 8).

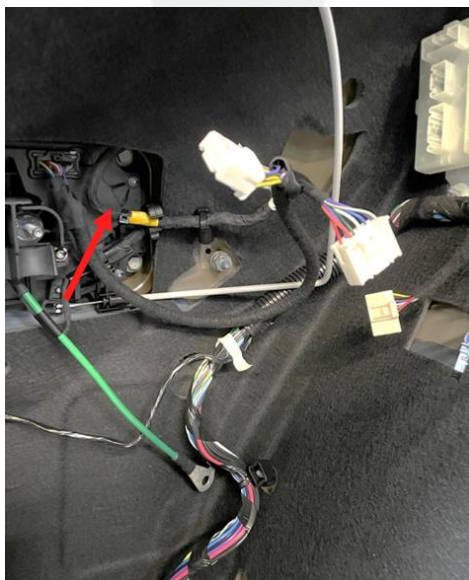
**Figure 9**

14. Route the remaining LV harness bundle so that the existing harness loop is tucked securely inside the trim cavity (Figure 9).

**⚠ CAUTION:** Failure to tuck the harness as instructed may cause lower than expected UHF performance.

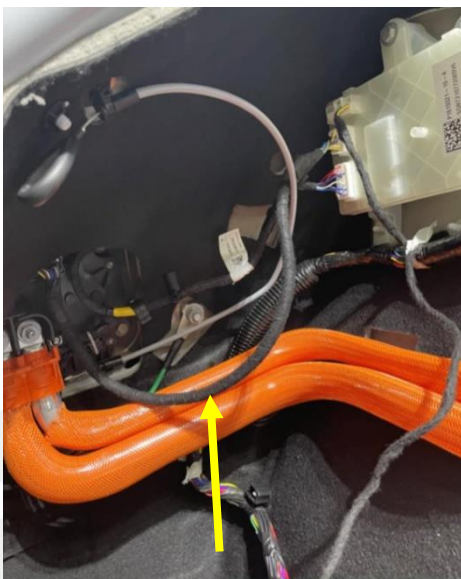
✓ **Figure 10 – Wiring harness is correctly routed in front of busbars**

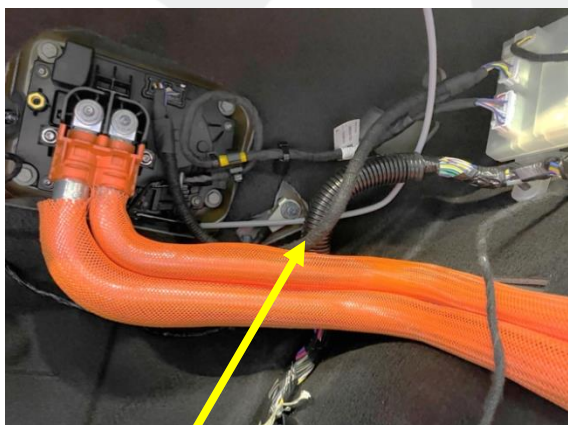
✗ **Figure 11 – Wiring harness is not correctly routed (behind busbars)**

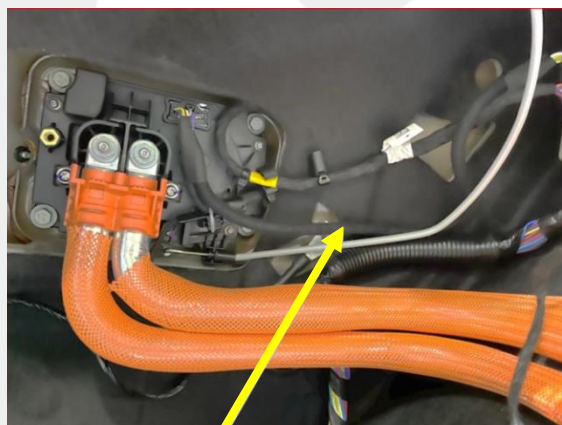
✗ **Figure 12 – Bring the wiring harness to the front of the busbars**

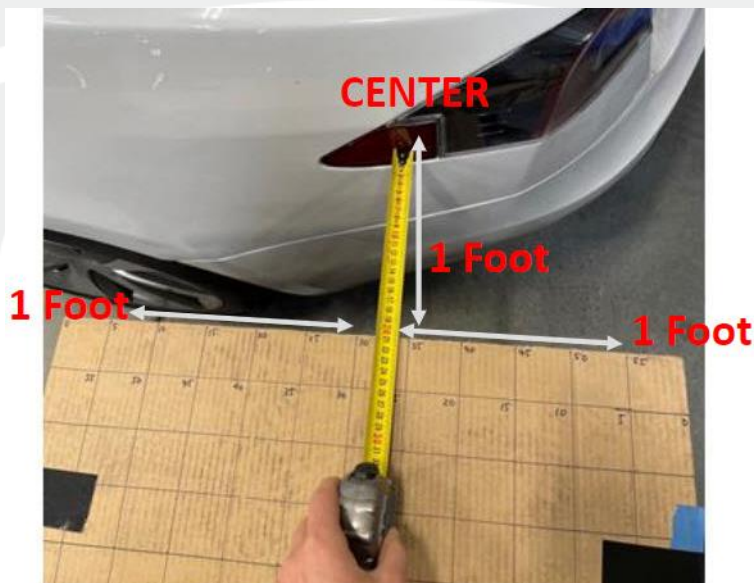
Figure 13

19. Verify that the charge port door opens using the charge port handle button at approximately 12 inches (30 cm) away from these locations (Figures 13 and 14):

- Center of the charge port door.
- Left of the charge port door.
- Right of the charge port door.

If the charge port door still does NOT function properly, replace the charge port ECU (refer to Service Manual procedure [44015002](#)).
