Tesla, Inc.
Service Bulletin

Inspect Coolant Hose For Proper Routing

SB-22-18-001

January 25, 2022

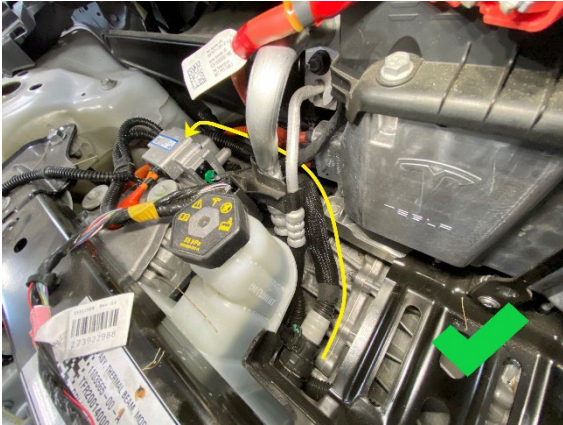
✓ Figure 1 – Hose routed on top of battery beam (12V battery removed for clarity)

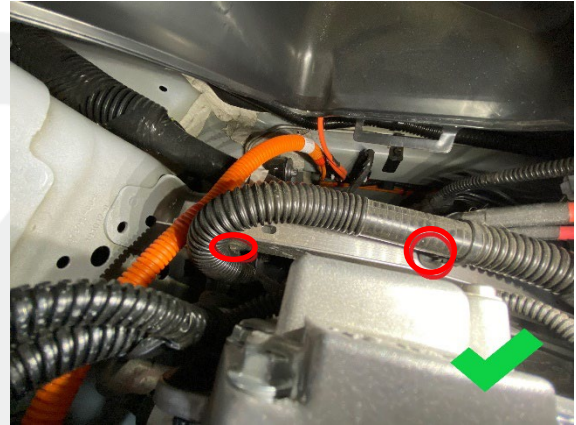
✓ Figure 2 – Hose routed on top of battery beam

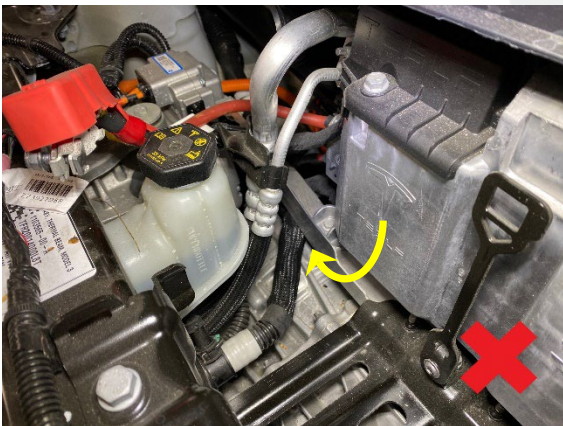
Certain Model 3 vehicles might have been manufactured with the Superbottle to powertrain coolant supply hose incorrectly routed under the battery beam and on top of the front drive unit (FDU). In this situation, the FDU might abrade the hose until it leaks, and the subsequent loss of coolant might cause the vehicle to enter limp mode.

✗ Figure 3 – Hose routed under battery beam (12V battery removed for clarity)

Inspect the routing of the coolant hose, and if incorrectly routed, or if the hose is visibly abraded, replace the hose.

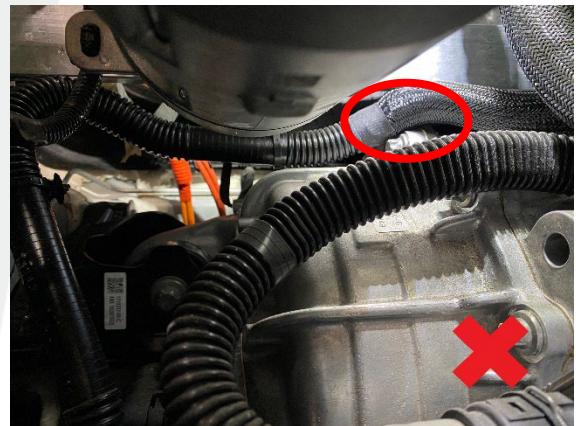
✗ Figure 4 – Hose routed under battery beam and on top of FDU
