Tesla, Inc. Service Bulletin		<h2>Retrofit A/C Compressor Pipes With Support Bracket</h2>	
SB-22-18-003 May 11, 2022			
Classification		Section/Group	Mobile Service
Campaign Bulletin		18 - Thermal Management	Can Perform (where permitted)
Model Year	Model	Country/Region	Build Location
2020 - 2022	Model 3, Model Y	UAE, Israel, China	Fremont, Giga Shanghai
<small>The model(s) and model year(s) listed are a general approximation of the affected VIN list. Refer to the VIN/Bulletin Tracker or Customer/Vehicle profile to determine applicability of this bulletin for a particular vehicle.</small>

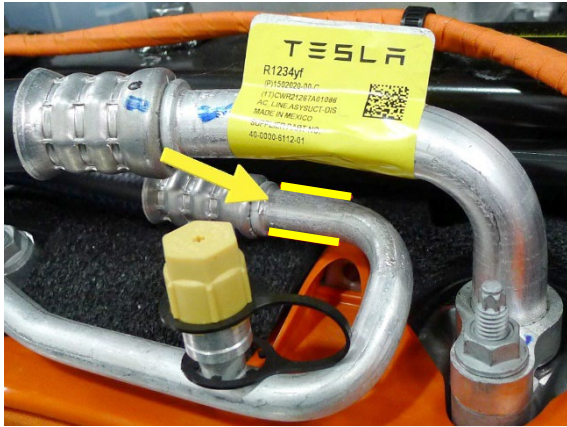
Figure 1 – Suction pipe without foam sleeve

3. Press the smaller clip of the support bracket onto the A/C compressor discharge pipe (Figures 1 and 2).

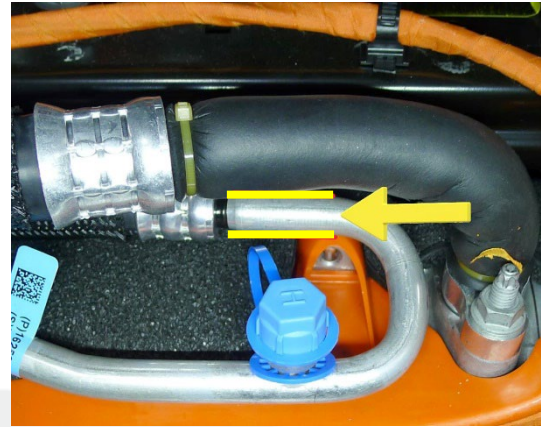
Figure 2 – Suction pipe with foam sleeve
