TN-14-16-004 R4 December 15, 2021	TESLA	Tesla, Inc. Technical Note
Model:	Vehicle System:	Region:
Model S Model X	16 - Battery System	All

Inspect the Model S and Model X HV Battery for Underside Damage

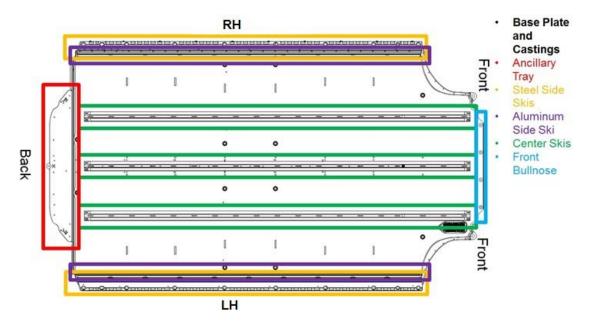
Figure 7 - HV Battery Assembly Components

The underside of the HV battery assembly has several key components, as shown in Figure 7.

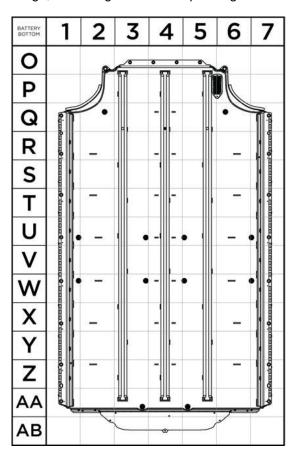
Figure 9

The location of the damage, according to the corresponding zone below.

4. Perform the appropriate repair according to the corresponding zone below.

- Recommend the replacement of the fastener if a fastener attaching the bullnose is damaged or stripped.
- Re-tap fastener hole if a fastener hole is damaged and the fastener cannot withstand full torque.

- Deburr the area with a hand deburring tool to remove the sharp edges if sharp edges are found.
- Recommend HV battery replacement if:
 - o The ski is detached or the HV battery is breached.
 - o The HV battery enclosure fails leak test due to impact.
 - The HV battery enclosure has low isolation due to impact.

- Deburr the area with a hand deburring tool to remove the sharp edges if sharp edges are found.
- Recommend HV battery replacement if:
 - o The section is breached.
 - o The HV battery enclosure fails leak test due to impact.
 - The HV battery enclosure has low isolation due to impact.

- Deburr the area with a hand deburring tool to remove the sharp edges if sharp edges are found.
- Recommend replacement of the fastener if a fastener attaching the ski is damaged or stripped.
- Re-tap the fastener hole if a fastener hole is damaged and the fastener cannot withstand full torque.
- Recommend steel side ski replacement if
 - The ski, or part of the ski, is detached from the HV battery and an umbrella valve is exposed.
 - o The ski is touching an umbrella valve.
- Recommend HV battery replacement if:
 - o The HV battery enclosure fails leak test due to impact.
 - The HV battery enclosure has low isolation due to impact.

- Deburr the area with a hand deburring tool to remove the sharp edges if sharp edges are found.
- Recommend aluminum side ski replacement if the ski, or part of the ski, is detached from the HV battery assembly.
- Recommend replacement of the fastener if a fastener is damaged.
- Re-tap the fastener hole if a fastener hole is damaged and the fastener cannot withstand full torque.
- Recommend HV battery replacement if:
 - The HV battery enclosure fails leak test due to impact.
 - o The HV battery enclosure has low isolation due to impact.

- Deburr the area with a hand deburring tool to remove the sharp edges if sharp edges are found.
- Recommend HV battery replacement if:
 - o A dent is **6 mm** or more in depth.
 - o If the HV battery enclosure fails leak test due to impact.
 - o If the HV battery enclosure has low isolation due to impact.
