Model: Model S

Vehicle System: 40 - Rear Drive Unit

## Tech Note: Noise Path for Motor Hum

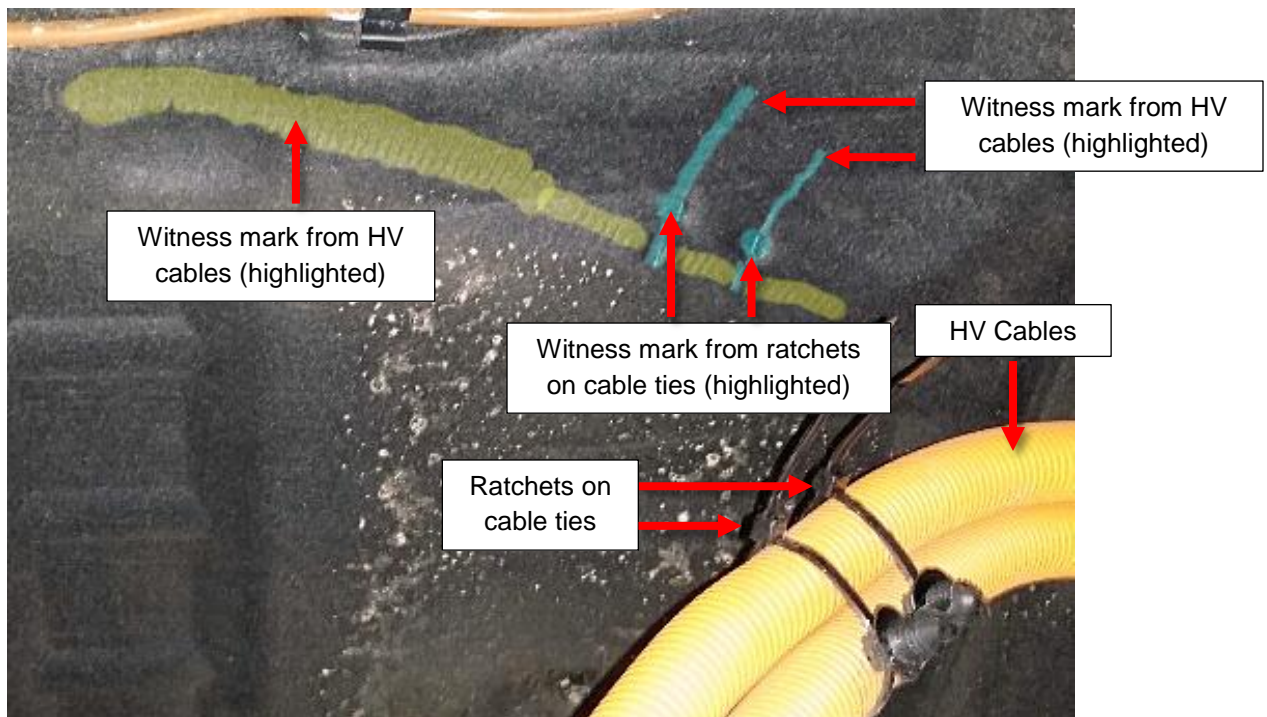
Figure 1

The acoustic padding above the rear subframe prevents most motor noise from entering into the cabin. However, sometimes cable ties or harnesses can press into the padding (Figure 1) or body (Figures 2 and 3), which provides a direct noise path from the motor into the cabin.

Refer to the "Installation" section of Service Manual procedure 30010201 when reinstalling the subframe to ensure that no components press into the acoustic padding.
