TN-18-16-001 R2 December 15, 2021

Tesla, Inc. Technical Note
<b>Model:</b>	<b>Vehicle System:</b>	<b>Region:</b>
Model 3 Model Y	16 - Battery System	All

## Inspect the Model 3 and Model Y HV Battery for Underside Damage

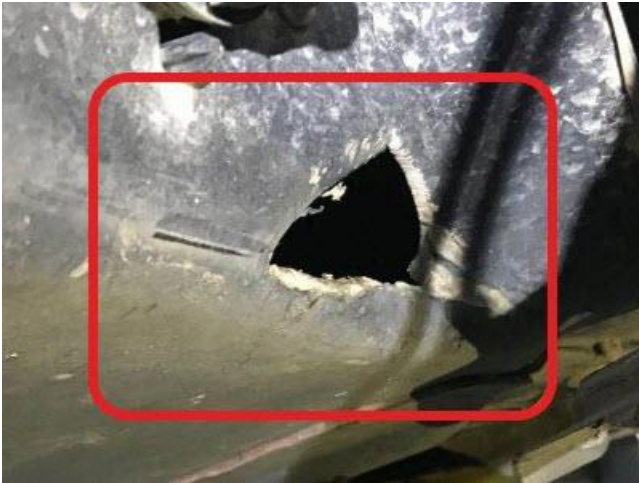
**⚠ WARNING:** If the HV battery enclosure is compromised with a **visible open hole, crack, or tear** (Figures 1 and 2), the Service Center should not perform any additional inspections, and recommend the customer replace the HV battery. No further diagnosis is needed as Tesla recommends an HV battery replacement for any visible open hole, crack, or tear to meet Tesla's standards of quality and safety.

**Figure 1 – Visible open hole**

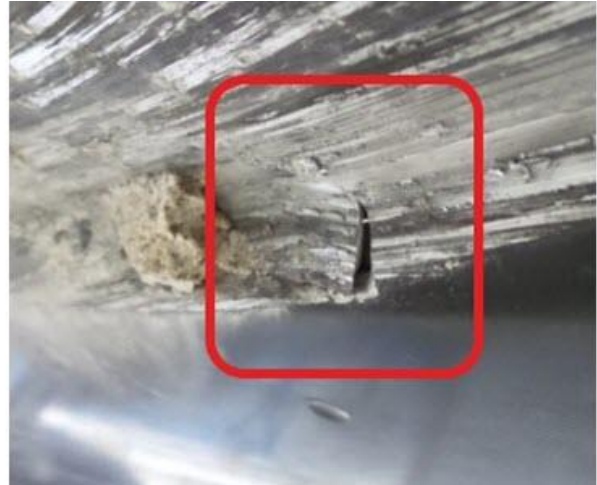
**Figure 2 – Visible open crack**

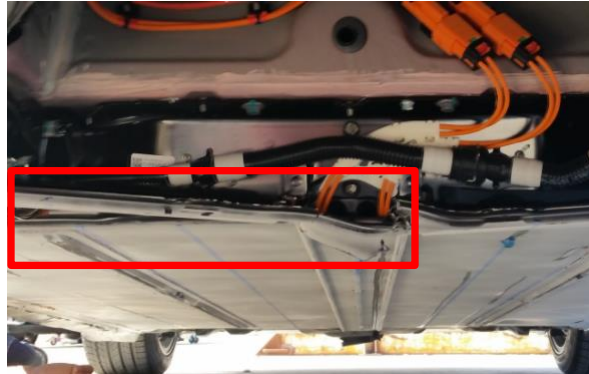
1. Visually inspect the front skid plate for tears, dents, or breaches (Figure 9).

**NOTE:** Replace the front skid plate if it does not cover front baseplate or its leading edge is dented, torn, or breached.

**Figure 9 – Torn front skid plate**

- Recommend replacement of the fastener if a fastener attaching the front skid plate to the doubler is damaged or stripped.
- Re-tap the fastener hole if a fastener hole is damaged and the fastener cannot withstand full torque.
- Recommend the replacement of the front skid plate if the front skid plate, or part of the skid plate, is detached, or not covering the baseplate.
- Recommend the replacement of the HV cables if the HV cables are damaged above the front skid plate.
- Recommend HV battery replacement if:
  - A passthrough is damaged above the front skid plate.
  - The HV battery enclosure fails leak test due to impact.
  - The HV battery enclosure has low isolation due to impact.

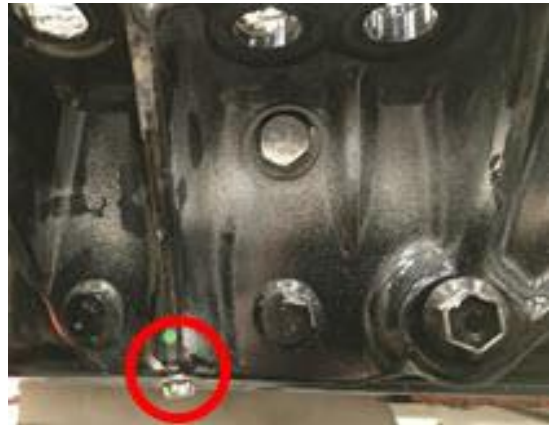
**NOTE:** The bolt that threads into the doubler is circled in Figure 11 and Figure 12. There is another bolt symmetrically on the other side of the vehicle. These bolts are prone to shearing in the event of front skid plate damage (Figure 12).

Figure 12 – Skid plate to doubler fastener sheared/bent

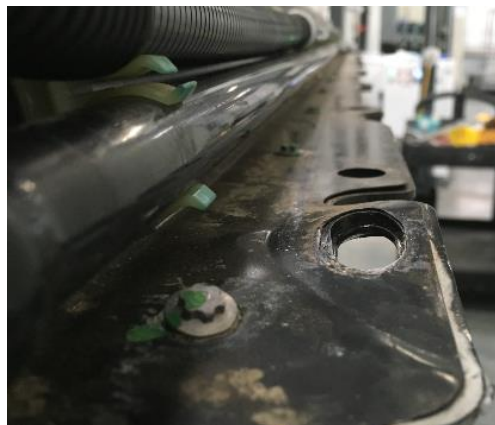
Figure 14 – Deburr the area to remove sharp edges

- Recommend HV battery replacement if:
  - The ski, or part of the ski, is detached from the HV battery.
  - A jack point has extensive damage where it cannot be used to safely lift the vehicle.
  - The HV battery enclosure fails leak test due to impact.
  - The HV battery enclosure has low isolation due to impact.
- Recommend the replacement of the fastener if a fastener attaching the HV battery to the vehicle is damaged or stripped.
- Re-tap the fastener hole if a fastener hole is damaged and the fastener cannot withstand full torque.
- Deburr the area with a hand deburring tool to remove the sharp edges if sharp edges are found (Figure 14).

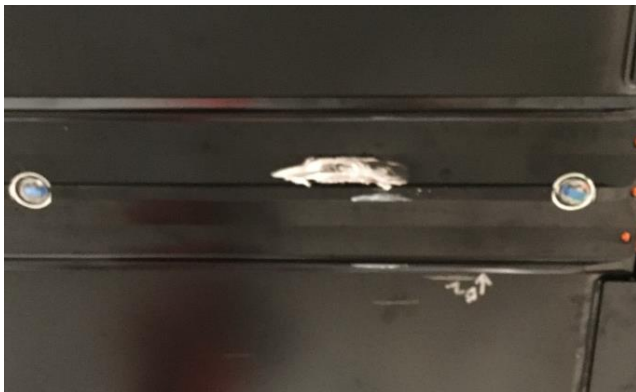
**Figure 16 – Gouged center ski**

**NOTE:** Figure 16 shows an example of torn center ski that also damaged the HV cables (Figure 17). It is important to inspect for damage to the HV cables and baseplate underneath the ski.

- Recommend the replacement of the center ski if the center ski, or part of the ski, is detached from the HV battery.
- Recommend the replacement of the HV cables if the HV cables are damaged.
- Recommend the replacement of the fastener if a fastener attaching the center ski to the HV battery enclosure is damaged or stripped.
- Re-tap the fastener hole if a fastener hole is damaged and the fastener cannot withstand full torque.
- Recommend HV battery replacement if:
  - The HV battery enclosure fails leak test due to impact.
  - The HV battery enclosure has low isolation due to impact.

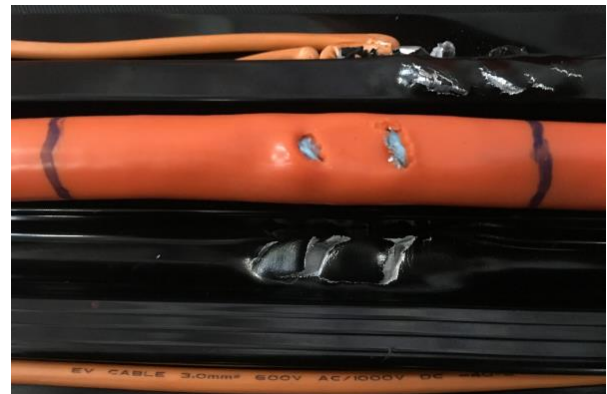
**Figure 17 – Damaged cable under center ski**

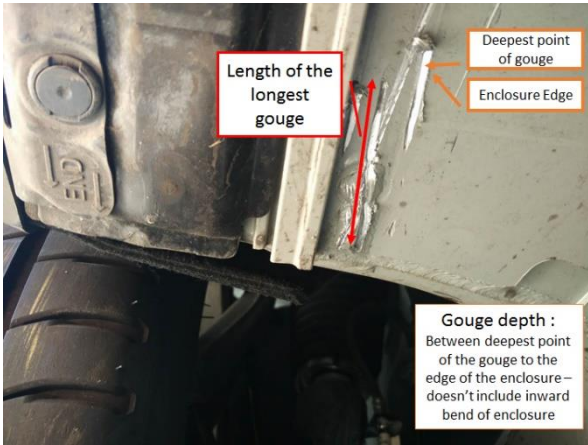
Figure 21 – Gouges in the baseplate

- Deburr the area with a hand deburring tool to remove the sharp edges if sharp edges are found.
- Recommend HV battery replacement if:
  - A dent is **8 mm** or more in depth (Figures 21 and 22).
  - If the HV battery enclosure fails leak down test due to impact.
  - If the HV battery enclosure has low isolation due to impact.

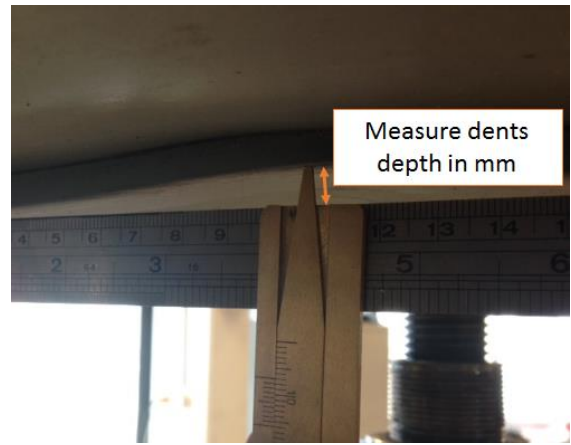
Figure 22 – Dents in the baseplate

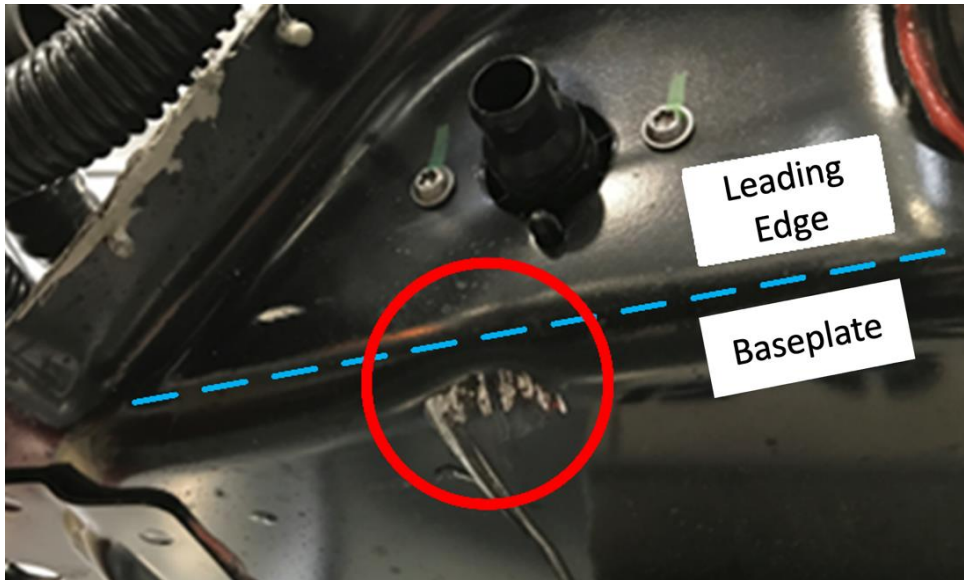
Figure 23 – Leading edge

**NOTE:** The dent inside the red circle within Figure 23 is not considered to be on the leading edge. The leading edge of the baseplate is forward of (or above) the dashed line. Anything behind or below the dotted line is in the Baseplate section.

- Deburr the area with a hand deburring tool to remove the sharp edges if sharp edges are found.
- Recommend the replacement of the HV cables if the HV cables are damaged.
- Recommend HV battery replacement if:
  - A passthrough is damaged.
  - The HV battery enclosure fails leak test due to impact.
  - The HV battery enclosure has low isolation due to impact.
