Model: All

Vehicle System: 17 - Electrical

Tech Note: Guidelines for Replacing Exterior Lights due to Water Ingress

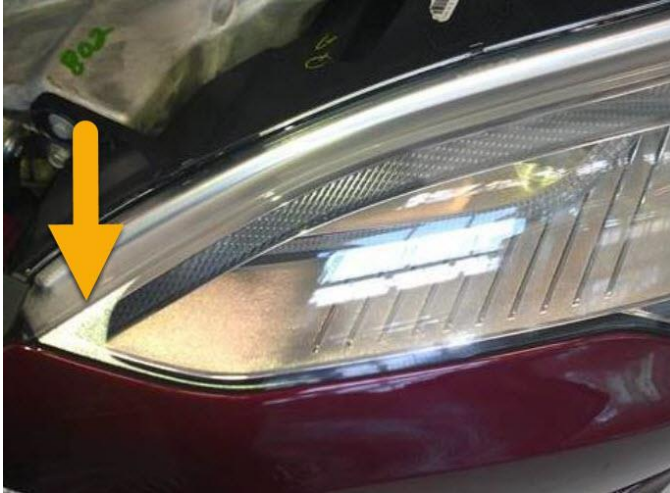
- No streaks are present.
- Limited water droplets, if any.

Figure 1 Acceptable headlight condensation

NOTE: If the headlight or taillight exhibits normal condensation, the headlight or taillight should not be replaced.

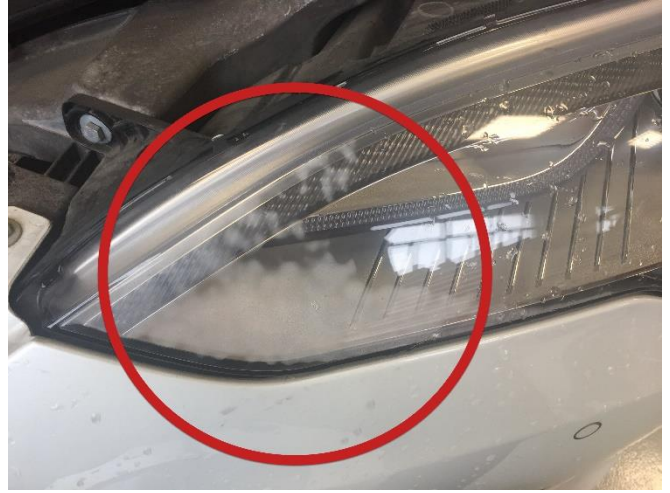
Figure 2 Acceptable headlight condensation

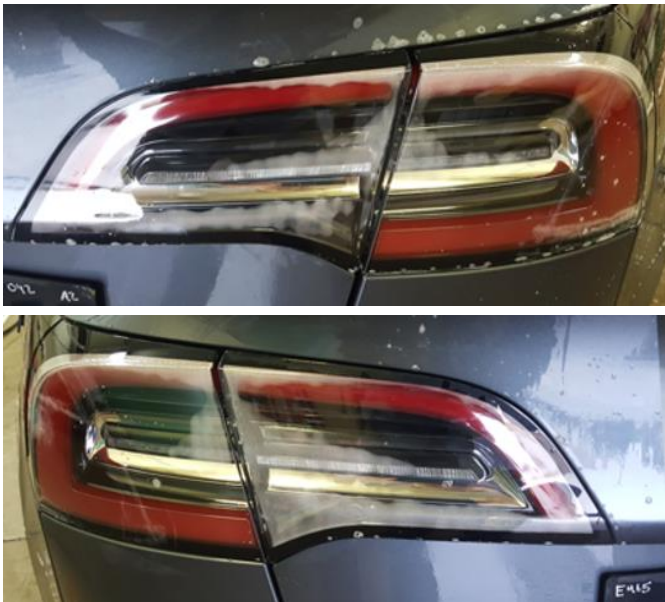
Figure 3 Acceptable taillight condensation

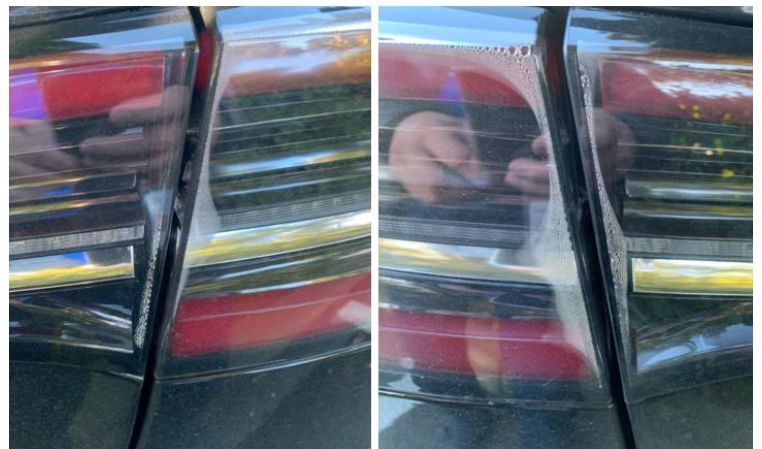
Figure 4 Acceptable taillight condensation

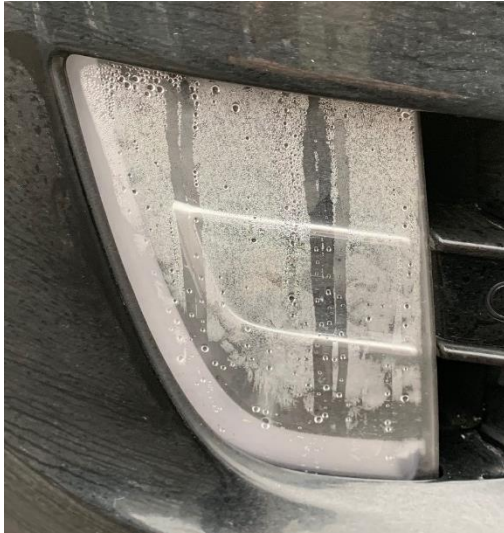
- Streaks are visible.
- Water droplets are large and widespread.

Figure 5 Unacceptable fascia (fog) light water ingress

If a headlight or taillight exhibits water ingress, replace the light assembly using the appropriate Service Manual procedure.

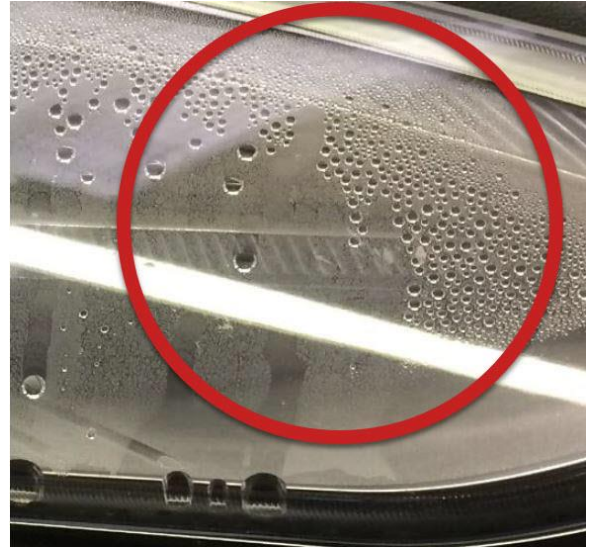
Figure 6 Unacceptable headlight water ingress

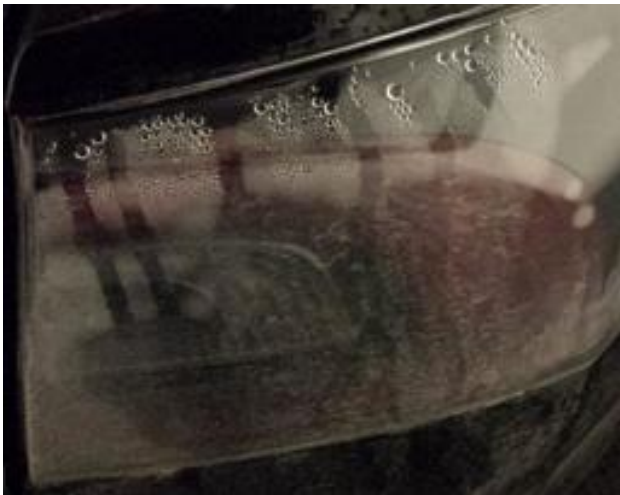
Figure 7 Unacceptable taillight water ingress

NOTE: For Model S taillights, investigate the root cause of the source of ingress before replacing the light.

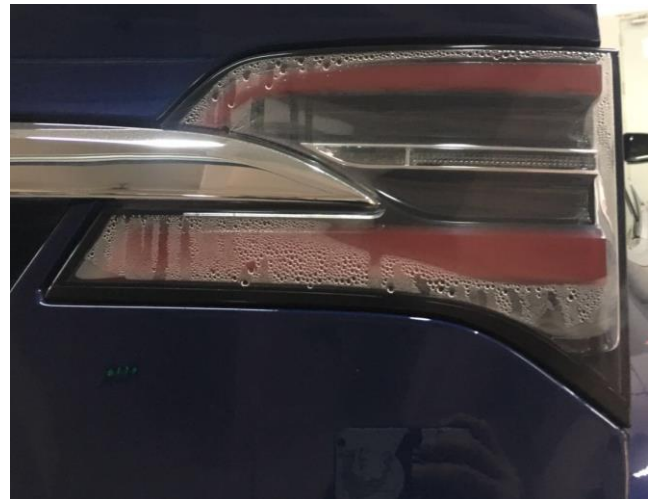
Figure 8 Unacceptable taillight water ingress

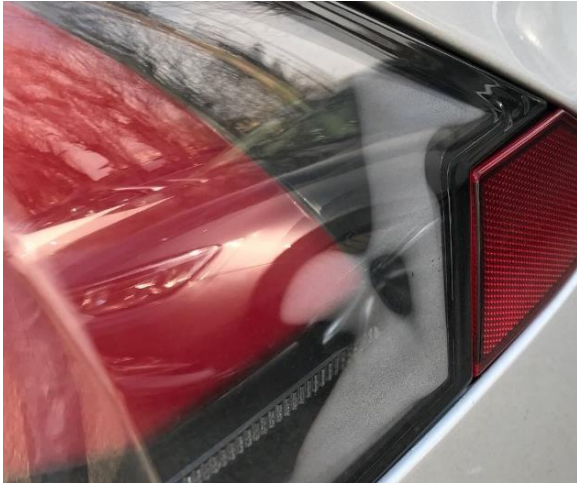
Figure 9 Normal condensation

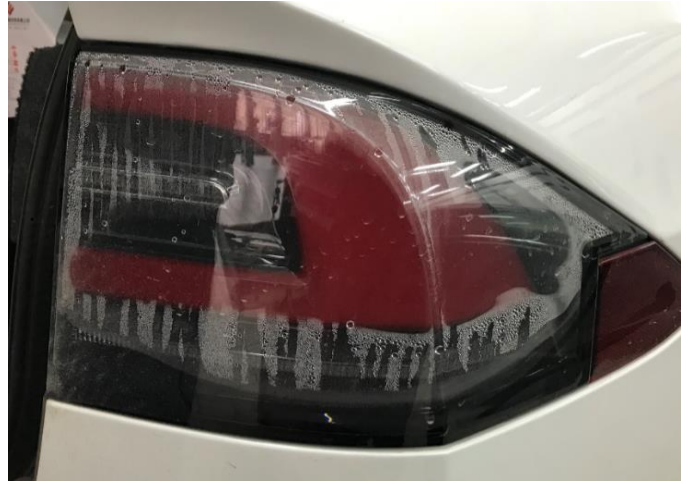
Figure 10 Water ingress
