2002	Toshiba America Consumer Products, Inc.	Date: 01/29/2002
Product	Technical Bulletin	TV0201
PJTV		Ref. No. 012902

2002	Toshiba America Consumer Products, Inc.	Date: 01/29/02
Product	Technical Bulletin	TV0202
PJTV		Ref. No. 012902

TECHNICAL BULLETIN

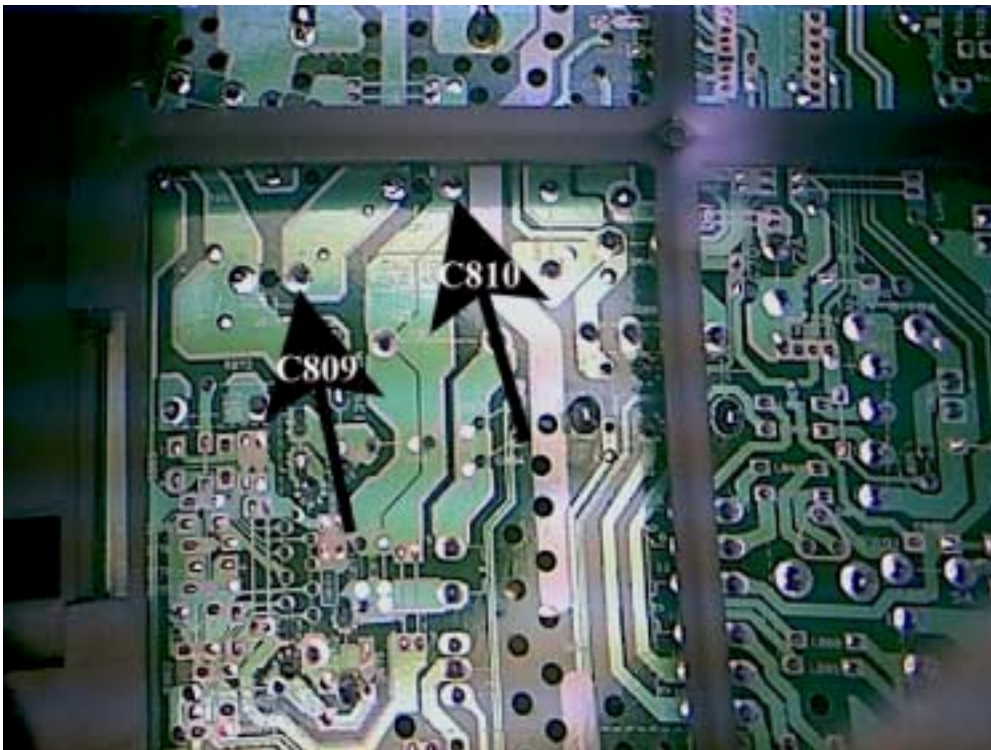
Symptom: Power LED lights. Power supply does not start.

Corrective Action: Check the solder connections at the negative side of both C809 and C810. Resolder if necessary. Poor connections could possibly open fuse F860. Check the fuse and replace if necessary.

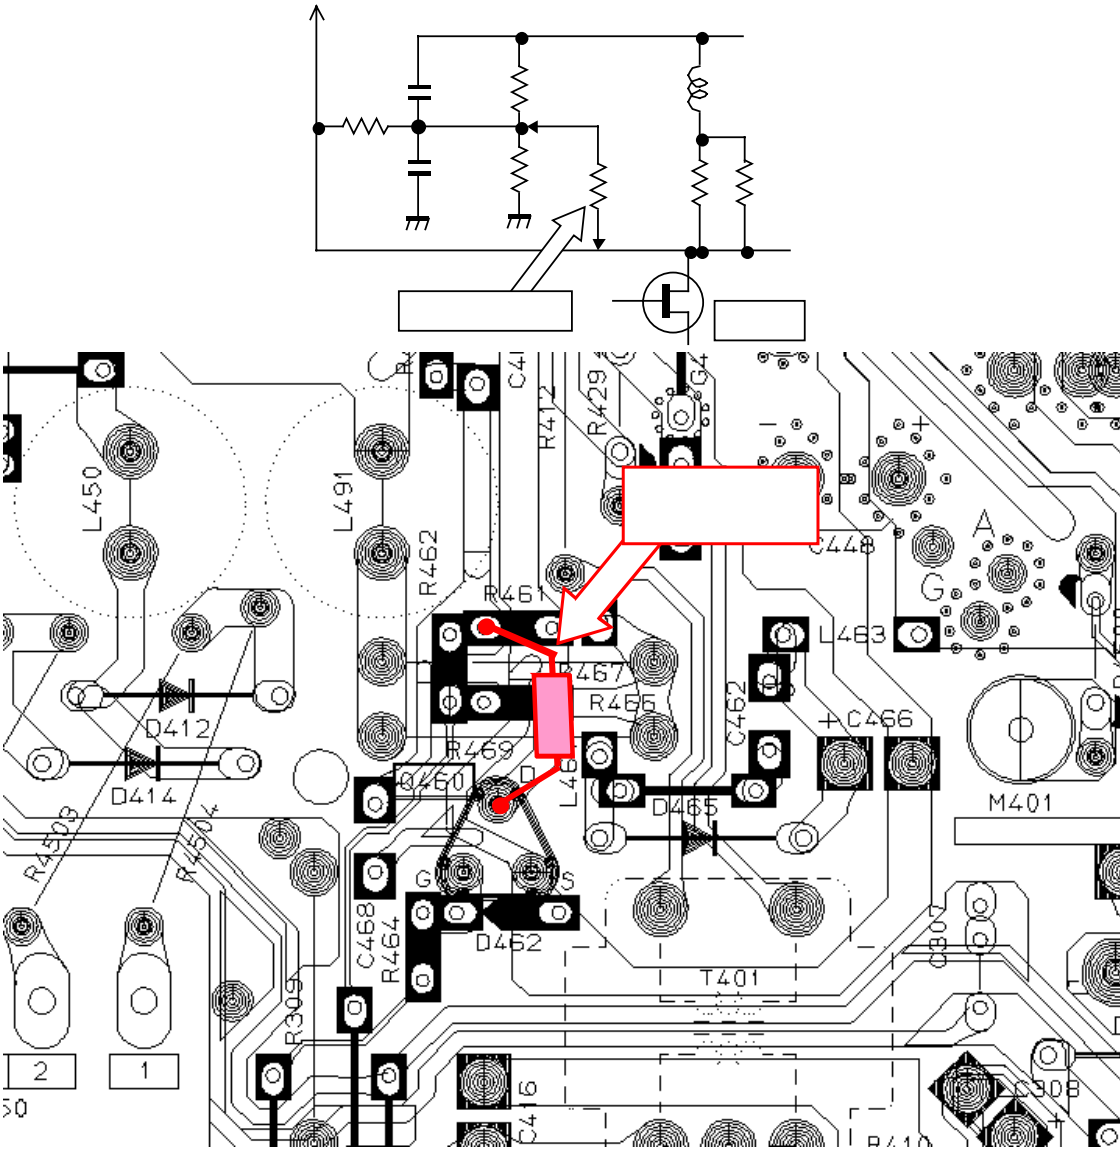
POW/DEF board

Symptom: Vertical line bends or doubles for 2 seconds after switching on set.

Add two resistors (R463, R4703) and change one capacitor (C4693) to stabilize Q302 feedback circuit.

Location	Part Number	Description
R463 (new)	24366473	Resistor, Carbon film, 47K Ω , 1/6 W
R4703 (new)	24366331	Resistor, Carbon film, 330 Ω , 1/6 W
C4693 (change to)	24591473	Capacitor, Plastic film, 0.047 MFD, 50V

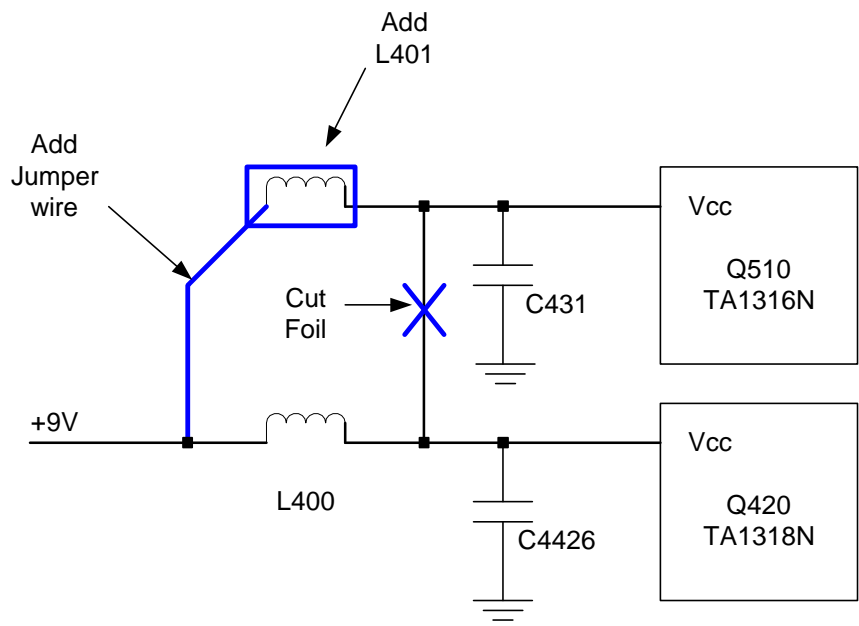
Symptom: Wavy vertical line when room temperature is below 32° F (0° C.)

Corrective Action: Add peaking coil (L401) into Vcc line of Q510 (TA1316N). Add jumper wire and cut foil pattern as shown below.

Location	Part Number	Description
L401 (New)	23280022	Coil, TRF4101AZ

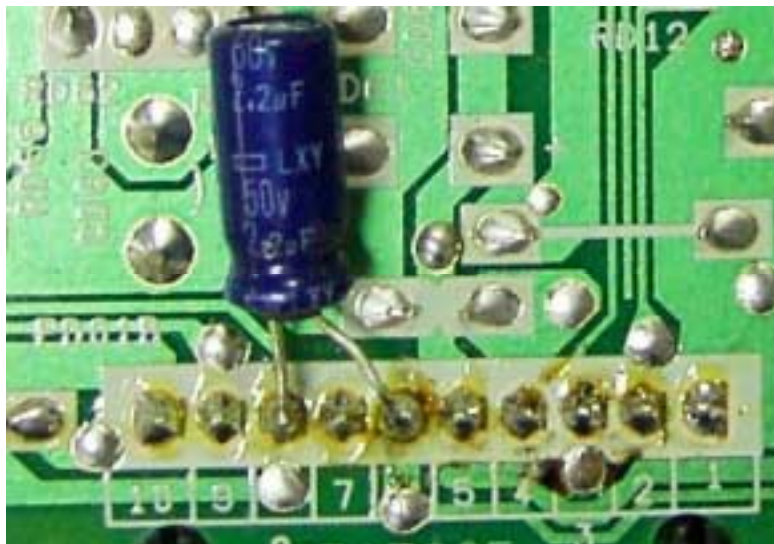
Symptom: Audible white noise (static hiss) at low volume levels.

Corrective Action: Add 2.2uf/50V electrolytic capacitor (PN 24617912) between Wout (pin 6) and GND (pin 8) of PD01B on SRS3D A-Pro/SRS WOW PCB (UD01).

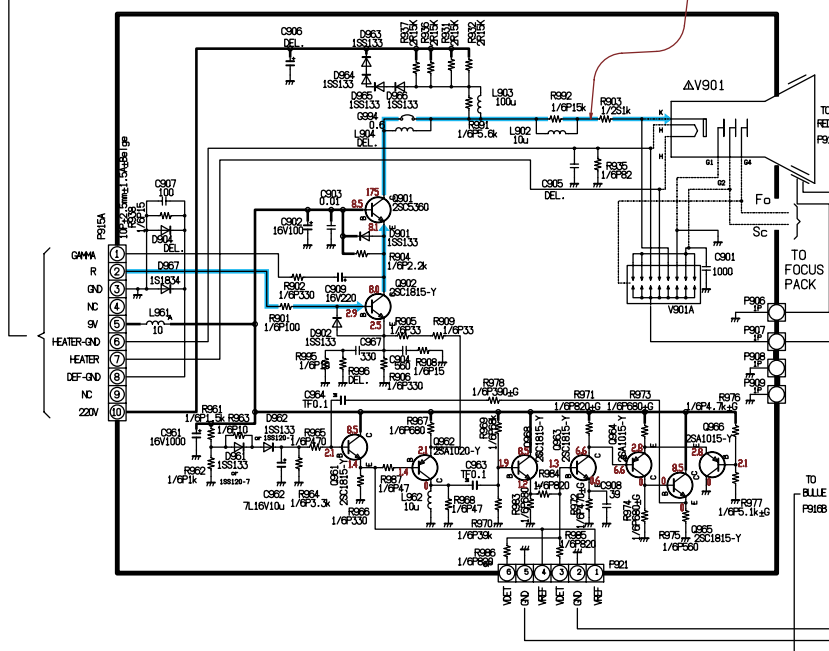
CRT-D/R

1. **HDX82 series:** Loss of red in video.
2. **HDX82 series:** Part number not included in Service Manual Replacement Parts list.
3. **H82 series:** The H82 series CRT drive boards differ from those shown in the schematic diagrams. Q9170 is not used in the series.

1. **HDX82 series:** Replace defective Q9170 on red CRT drive board. Type 2SA1015Y; Toshiba PN BZ510034.
2. **HDX82 series:** Update the appropriate Service Manual(s) Replacement Parts list to include the correct part number.
3. **H82 series:** Update the appropriate Service Manual to include the correct CRT drive board schematic diagram. The correct diagram is included as Pages 2 and 3 of this Technical Bulletin.
