TECHNICAL BULLETIN

No: DVD 200201R Product: DVD 1 page

Models: SD 1700, SD 1750, SD 2700

Subject: Parts Change Notice

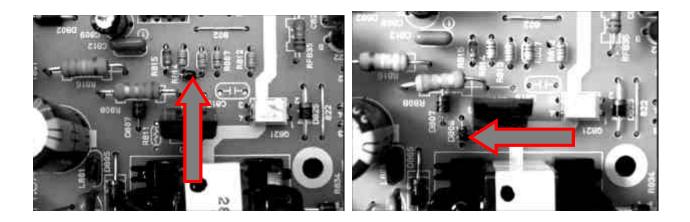
Symptom: DEAD – Defective Q801 (PN 79050088) and F801 (PN 79087008)

Note: Check the value of R808

Corrective Action: Replace Q801 and F801 as indicated. Replace D808 30 volt Zener (PN- 79060088) with D808 6.8 volt Zener (PN-79060029). The diode will be located in either of two locations as noted in the diagrams. Replace the diode in the same location and orientation as removed. Add a 56k Ω , $\frac{1}{4}$ watt, -/+ 2% carbon film resistor (generic part) between the gate and ground of Q801.
