# TECHNICAL BULLETIN

UNIVAC | CUSTOMER SERVICES DIVISION

## 1219 AND 1219A MAIN MEMORY ADJUSTMENT PROCEDURE

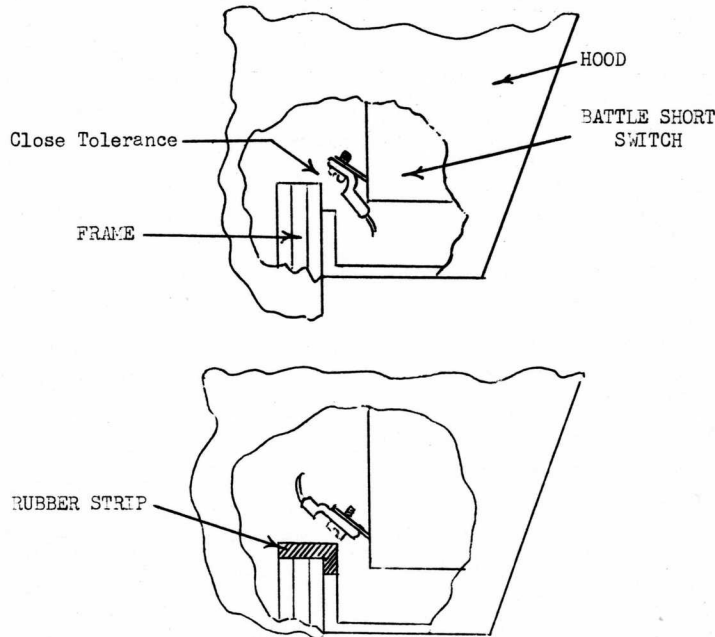
### POSSIBLE SHORTING PROBLEM

A possible shorting problem can exist in the 1219B computer. During assembly and wiring of the "BATTLE SHORT" switch, some 1219B computers could have a very close tolerance between the terminal lugs on the "BATTLE SHORT" switch and the frame. All 1219B computers should be checked for this condition. If a close tolerance is found, which could cause a short if the computer is subjected to heavy vibration, use one or both of the two recommended methods to cure the problem.

**CAUTION:** There is power at the "BATTLE SHORT" switch even though the computer power is turned off. Turn Motor Generator off before removing the switch panel (Hood).

1. Loosen terminal contacts on rear of "BATTLE SHORT" switch, loosen lacing, and turn lugs so they are pointing to the rear. This will allow more clearance between terminal lugs and frame.
2. There is a small kit, available from UNIVAC, which consists of an "L" shaped strip of rubber and adhesive which can be mounted on the frame. This will prevent the lugs from contacting the metal frame.
