GT Series – Inverter Offline Message

Technical Bulletin

GT Series Inverters

976-0156-01-01

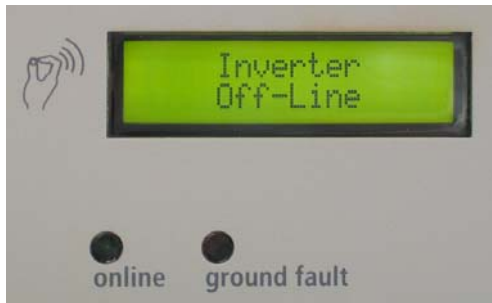
When the identified power board component fails, GT Inverters will incorrectly stay in offline mode during the day and not generate energy. Dealers or homeowners can identify this issue by observing "Inverter Off-line" on the inverter display during the day, when sufficient solar irradiance is available to generate energy (per inverter operating specification).

The "Inverter-Offline" message is normally displayed every night when the inverter is in standby mode and does not indicate a problem when observed during these hours.

**Inverter Off-Line is:**

* Normal when the message is displayed at night.

OR

* Abnormal when displayed during the day when sufficient solar energy is available.

Given that this issue affects a small population of inverters and can be remedied through our standard exchange/repair process, Xantrex is not recommending any immediate action. If an "Inverter Off-line" failure has occurred please contact Xantrex to request an expedited service exchange.
