J. AIRCRAFT

## Biotechnology Problems Relative to the Space Shuttle Vehicle

RICHARD CARPENTER\*

*NASA Flight Research Center, Edwards, Calif.*

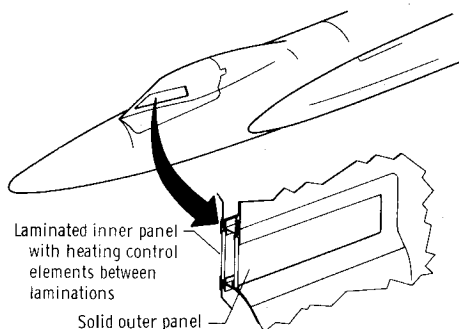
Fig. 4 X-15 windshield configuration.

Figure 4 is a schematic of the X-15 windshield configuration showing the inner and outer panels. The inner panel is laminated with a heating control between the layers. During several flights, thermal and structural problems resulted in damage to these windows. Table 1 summarizes five flights in which windshield failures occurred. The resultant damage is shown photographically in Figs. 5-9. Soda-lime glass windows were used in early X-15 flights, but this glass was never intended for high-temperature flights. The outer panels were replaced with an alumino-silicate glass window for later flights. This alumino-silicate panel was tested without failure to 1050°F outer-surface temperature, with a ratio of outer-to-inner surface of 790°F, which was 150% of the maximum predicted. The second failure listed in the table was with alumino-silicate glass; the other failures were with soda-lime glass. In each instance, the windows broke because of the interaction between the retaining structure and the glass, not because of the type of glass used. For large window areas, greater thermal expansion and distortion of the retaining structure can be expected, and the potential for glass failure is increased. Therefore, to minimize complexity and weight penalties, it is recommended that a small viewing surface be used in the shuttle vehicle. A large visual angle to the left and right may be provided by placing the pilot close to the viewing windows.

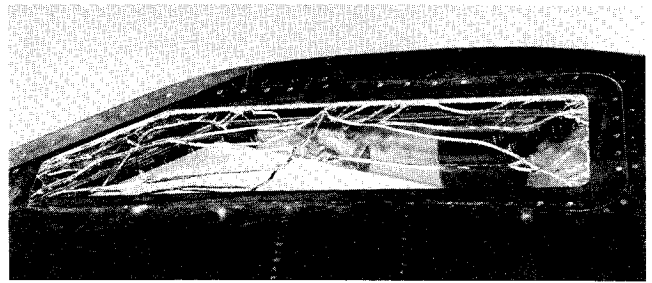
Fig. 5 X-15 severely cracked left-hand outer panel; outside view; flight 2-20.

Date	Aircraft and flight number	Incident	Cause	Remarks
10/11/61	2-20	Outside panel shattered on left-hand side	Thermally and pressure induced structural distortion	Soda-lime glass. Occurred at approximately 217,000 ft at Mach 5.21. See Fig. 5.
11/9/61	2-21	Right-hand outer panel shattered and became completely opaque	Thermal buckle of the windshield retainer frame during re-entry at Mach 6.04	Alumino-silicate glass. Pilot said, with the limited visibility "... I felt I must have been at least 2 sec behind in making corrective control inputs." See Fig. 6.
5/29/63	3-18	Inner panel cracked on left-hand side	Thermally induced stresses in retainer screws	Soda-lime glass. Heating rates at Mach 3 and low angle of attack. See Fig. 7.
12/5/63	1-42	Inner panel cracked on right-hand side	High structural temperature suspected as cause of structural distortion	Soda-lime glass. Glass broke during re-entry at approximately 100,000 ft. See Fig. 8.

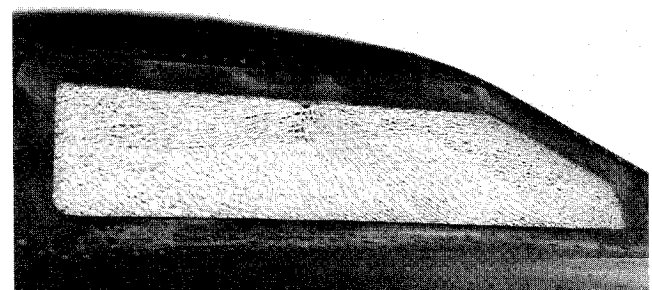
Fig. 6 X-15 cracked right-hand outer panel; outside view; flight 2-21.

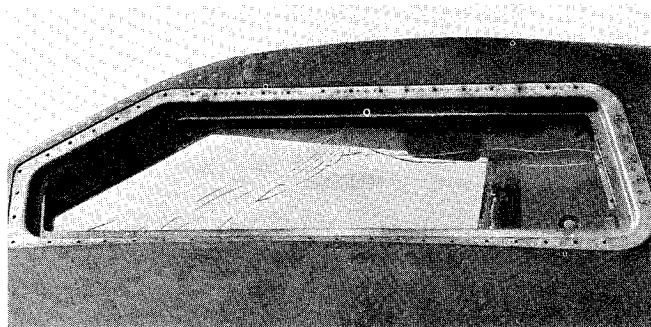
**Fig. 7 X-15 cracked left-hand inner panel; outside view; flight 3-18.**

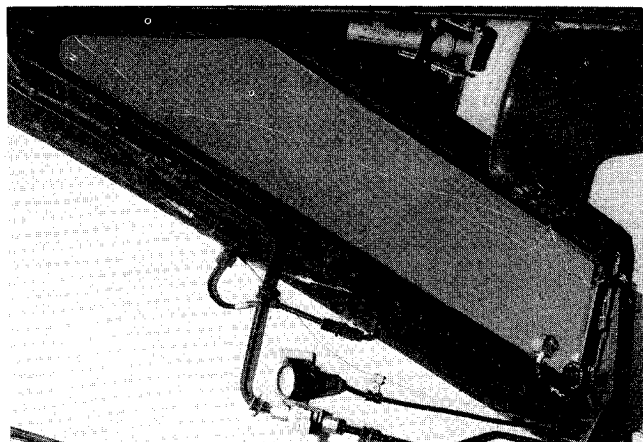
**Fig. 8 X-15 cracked right-hand inner panel; inside view; flight 1-42.**

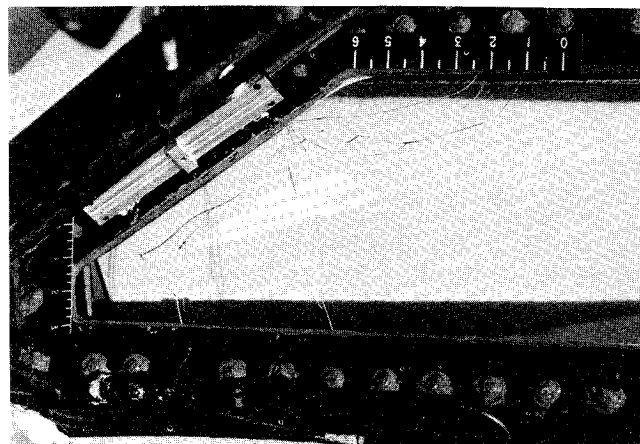
4/29/64	1-47	Inner panel cracked on right-hand side	Faulty heater control during high-temperature portion of flight	Soda-lime glass. An attachment mounted on inside of canopy retainer contributed to failure. See Fig. 9.

**Fig. 9 X-15 cracked right-hand inner panel; inside view; flight 1-47.**
