Pool Fire Induced Cockpit Degradation

Anthony San Miguel*
Naval Weapons Center, China Lake, Calif.

It is important to understand the effects of pool fire phenomena on Navy aircraft because of the aircraft carrier fire threat. An interdisciplinary test methodology was used to obtain synergistic data from an unarmed Navy A-4 cockpit engulfed in a pool fire. The study was designed to gather data useful for fire-protection modeling, as well as to identify where emphasis should be placed for design of future laboratory small-scale tests. A description is given of the underground laboratory (located below the pool fire pan) used in this study. Data are presented of the thermal environment within the cockpit, the production of toxic gases, smoke generation, and animal response. A listing is given of quantized events that occurred during the test, together with a number of design recommendations to increase the survival time of fighter aircraft cockpits.

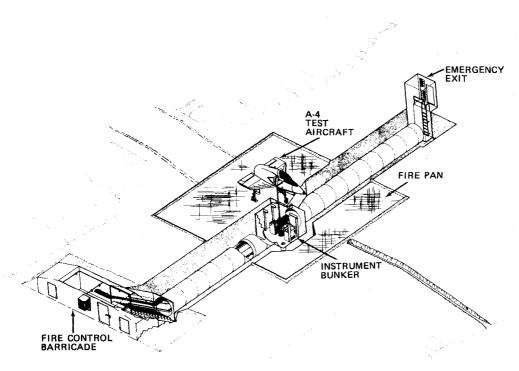
The underground fire facility constructed for this study is shown in Fig. 1. The facility features an instrument bunker located 1 m below the fire pan. A 2-m-diam tunnel some 66 m long provides double access to the instrument bunker. Located at one end of the tunnel is a fire control barricade. The other end terminates with an emergency exit. The fire facility is located in a remote desert area of the Naval Weapons Center, China Lake, Calif. Laboratory quality instruments are located in the constant-temperature instrument bunker. During a test, personnel confine themselves to the fire control barricade, which is protected from possible toxic fumes by a positive air pressure. Canaries are used in the

Fig. 1 Fire test facility with A-4 cockpit on fire pan.

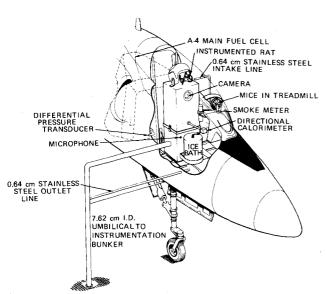
The A-4 cockpit was instrumented as illustrated in Fig. 2. Additions to the cockpit were a stainless steel box containing a water-jacketed 16-mm camera with a 3-mm wide-angle lens, a three-dimensional calorimeter, three mutually perpendicular accelerometers, an ice bath for thermocouples, a microphone, conditioning electronics, and a transmitter. Attached to the top of the box was a flight helmet containing a rat (instrumented for EKG and EEG) suspended in a sling. On the instrument panel was attached a smokemeter. A glass treadmill containing a free-running mouse was located on the top of the glare shield. A differential pressure transducer was located on the starboard side of the cockpit. Also protruding through the starboard side of the fuselage was a 7.6-cm-id umbilical tube, housing power, data, and water lines, that was connected to the instrument bunker. Separate 6.4-mm-diam stainless steel lines (some 6 m long) were used to circulate cockpit air between the cockpit and chemical analysis apparatus located in the instrument bunker. A detailed description of the transducers, instrumentation, and installation is given in Ref. 6.

Fig. 2 Cockpit instrumentation systems.

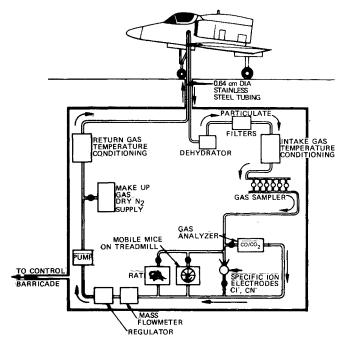
Toxic effects associated with fires⁷ are usually attributed to the presence of chlorine, cyanide, and carbon monoxide, and to the depletion of oxygen. Other toxic gases exist, but standards for acute human survivability have not been universally accepted. The means to measure toxic gases are numerous, each being a compromise of sorts. The system used in this study is shown in Fig. 3 and described in detail elsewhere.⁶

Fig. 3 Schematic of gas measurement system.

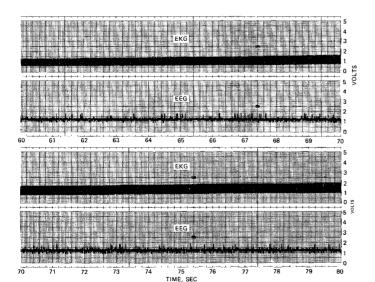
Fig. 6 Typical "apparent" EKG and EEG voltage signals from the cockpit rat.

The typical electrical signals recorded from the cockpit rat are shown in Fig. 6. Such data were obtained for the entire test time of 243 sec and are found in Ref. 6.

The significant changes in "apparent EEG" signals occurred at about 41 sec, when both amplitude and frequency bursts (spindle incidence) decreased. At 93 sec, the signal amplitude and spindle incidence increased. At about 133 sec, apparent activity of the kind that follows a sudden attack or seizure was indicated by low-voltage amplitude. At about 150 sec, animal revival was indicated. At about 161 sec, animal hyperexcitability ended with the signal moving off-seale. At about 238 sec, the signal returned to near normal, suggesting that the animal was still alive.

At about 34 sec, the "apparent EKG" amplitude decreased and the frequency increased. At 51 sec, the amplitude increased. The reference level initiated a shift (perhaps due to animal movement). At 69 sec, the amplitude stabilized and its frequency increased. At about 93 sec, the reference voltage increased dramatically (perhaps due to animal movement). At about 97 sec, the reference voltage peaked and started to decrease (perhaps due to the animal slowing down its movement). At about 120 sec, the reference voltage stabilized. At about 128 sec, the reference voltage increased again. At about 133 sec, a low-voltage amplitude was recorded. Animal revival occurred at about 153 sec. From there on the signal was off-scale until the end of the test. However, at about 238 sec, the signal returned to reference level to suggest that the animal was still alive.
