# Environmentally Controlled Fatigue Tests of Composite Box Beams with Built-in Flaws

J. D. Labor\* and R. M. Verette†

*Northrop Corporation Aircraft Group, Hawthorne, Calif.*

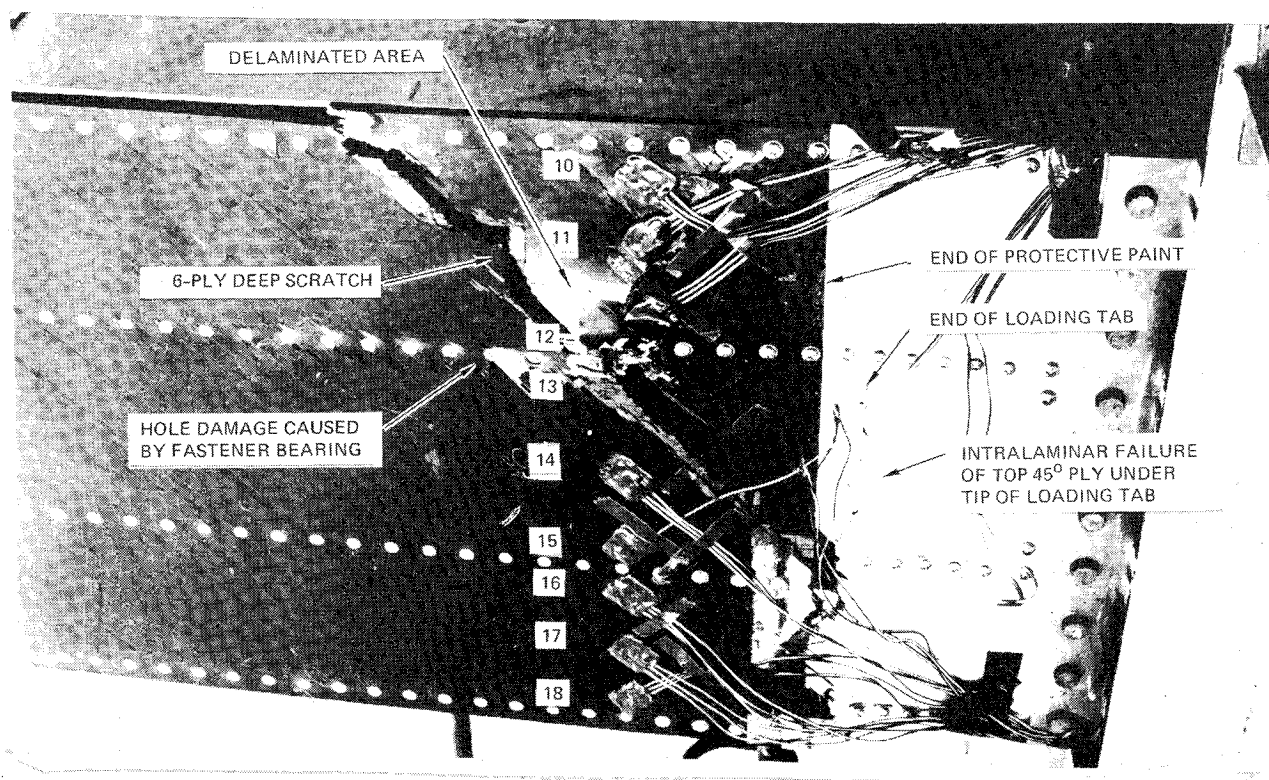
1) Much of the failure zone follows a line at 45 deg to the span direction, as shown in Fig. 3, indicating that shearing stresses became significant in the panel during the failure sequence. Two sources contribute to this: a) the small shear due to torsion became much larger as part of the skin panel failed so that the effective torque box was reduced; and b) as part of the panel failed, the bending load sheared laterally to the stiffer, unbroken part of the panel.

2) Considerable local damage exists at fastener holes adjacent to the break, as shown in Fig. 3. After disassembly, these holes showed local crushing due to fasteners bearing against the panel toward the break. This suggests that after the panel failed, the load in the panel was transferred through the fasteners to the spar until the spar failed.

3) The failure zone passed through a six-ply-deep surface scratch as shown in Fig. 3. The top six plies delaminated, and the failure line for the remaining plies ran straight by the area at a 45-deg angle, indicating that the scratch did not initiate failure, but was merely in the path of the failure zone that started elsewhere.

4) A triangular portion of the panel was displaced laterally, as shown in Fig. 3. The spar flange split longitudinally through the fasteners and the spar displaced laterally approximately  $\frac{1}{2}$  in. The heel of the flange and the web were not fractured. The lower flanges of the other three spars were broken and their webs were torn for their full depths.

Fig. 3 First large panel after failure.

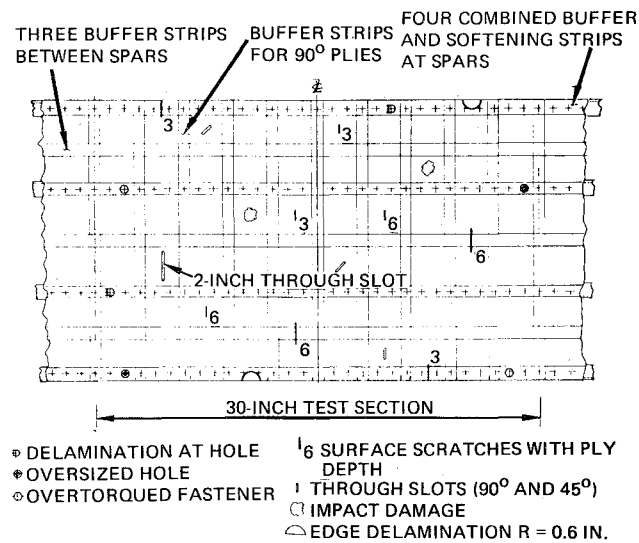
The buffer strip pattern and the flaws that were intentionally placed in the panel are shown in Fig. 4. Of all the flaws shown, three types, viz., surface scratches, through slots, and impact damage, had previously been investigated specifically using small panels with buffer strips. The other flaws were investigated for panels without buffer strips and were included on the first large panel. To provide continuity with the first panel, these other flaws were included in the second large-scale article. The flaw locations were selected to provide a uniform distribution of flaws. The more severe flaws (through slots and impact damage) were spaced apart by at least two rows of buffer strips to minimize their influence on each other during crack initiation and after crack arrestment. The most severe flaw, which was expected to

govern cracking, arrestment, and ultimate failure, was a 2-in.-long through slot toward the left end of the test section. After flaws were created and the fastener holes in the central 30 in. of the panel were drilled slightly undersize, the panel was moisture conditioned by immersion in 180°F deionized water for 102 days. The moisture content, determined by weighing small coupons cut from the same laminate, was approximately 1.7% by weight and varied from that only slightly during testing.

Fig. 4 Defect map for second large panel.

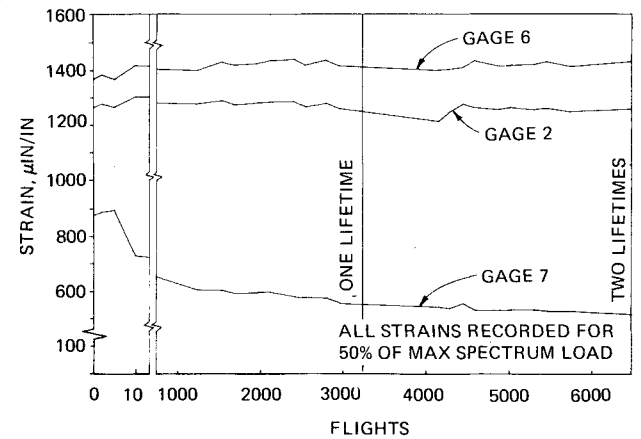
Fig. 7 Second large panel strains during specimen loading.

The changes in spanwise strain gage readings during spectrum loading are shown for three gages in Fig. 7. Gage number 7, in line with the slot, shows a significant drop in strain between five and ten flights and then shows a gradual decrease in strain during the remainder of two lifetimes. The correlation between the observed increase in surface cracks and this decrease in strain is significant to the growth and arrestment of damage during spectrum loading.

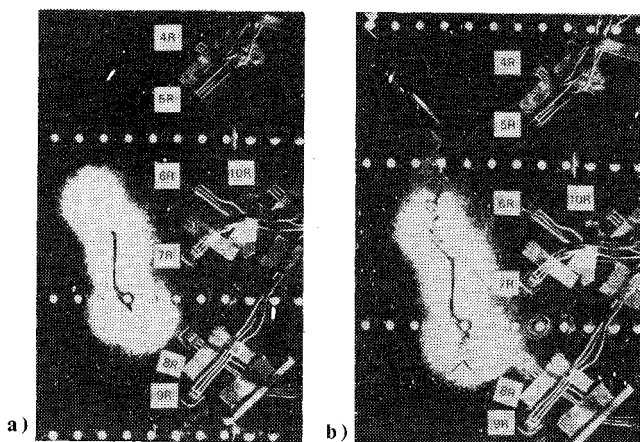
Fig. 8 Initial failure of large-scale panel with buffer strips: a) before initial failure; b) after initial failure.

At 107% of maximum spectrum load, initial failure occurred after the load had been held for approximately 5 seconds while gages were read. Initial failure was sudden with no visible extension of surface cracks prior to failure. The panel initially broke from only one end of the slot. Figure 8a shows the surface cracks before initial failure in which the cracks appear the same as they did at the end of spectrum loading. The photograph in Fig. 8b shows the initial failure from one end of the notch to the edge of the panel, but only slight crack extension from the other end of the notch.

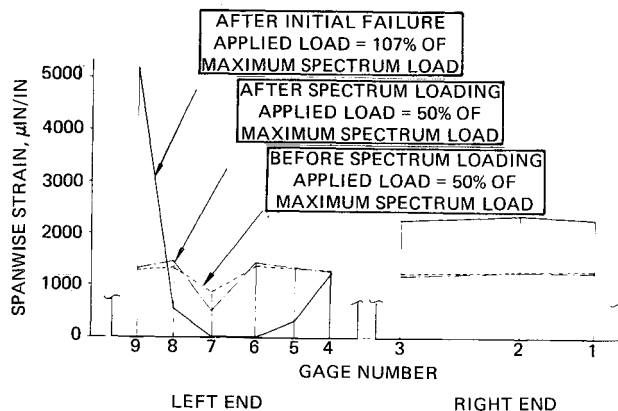
The strain distribution after initial failure indicates that although no load was carried through the central failed area of the panel around the crack, both edges of the panel, i.e., near gages 9 and 4, were carrying load. The panel at gage 9 appeared unfailed and most of the load was carried in that area as indicated by the high strain at gage 9. However, a significant strain remained at gage 4, indicating that some load was carried at that edge of the panel in spite of surface cracks. It appears that the buffer strips near gage 4 partially arrested the damage and prevented failure of some of the internal plies so that a load path remained even with surface plies broken. As shown in Fig. 9, the strains at the right end, away from the failure, remained uniform across the width.

Fig. 9 Strain distribution after initial failure.
