## Single-Mode Panel Flutter of a Wind Tunnel Flex-Wall

Larry L. Erickson,\* Donald L. Kassner,† Leroy R. Guist,† and Mladin K. Chargin‡  
NASA Ames Research Center, Moffett Field, Calif.

Twice during the spring of 1978, the two steel-plate "flex-walls" that form the variable-geometry nozzle of the 11- $\times$ 11-ft transonic wind tunnel at Ames Research Center experienced a severe dynamic instability. Both walls fluttered in the fundamental beam-bending mode and experienced stresses approaching the yield strength of the material. Both flutter incidents occurred at Mach numbers of about 1.15. The tunnel, operational for 24 years, had no history of such an instability. The cause of these flutter incidents, the steps taken to prevent a recurrence, and the requalification of the facility are described.

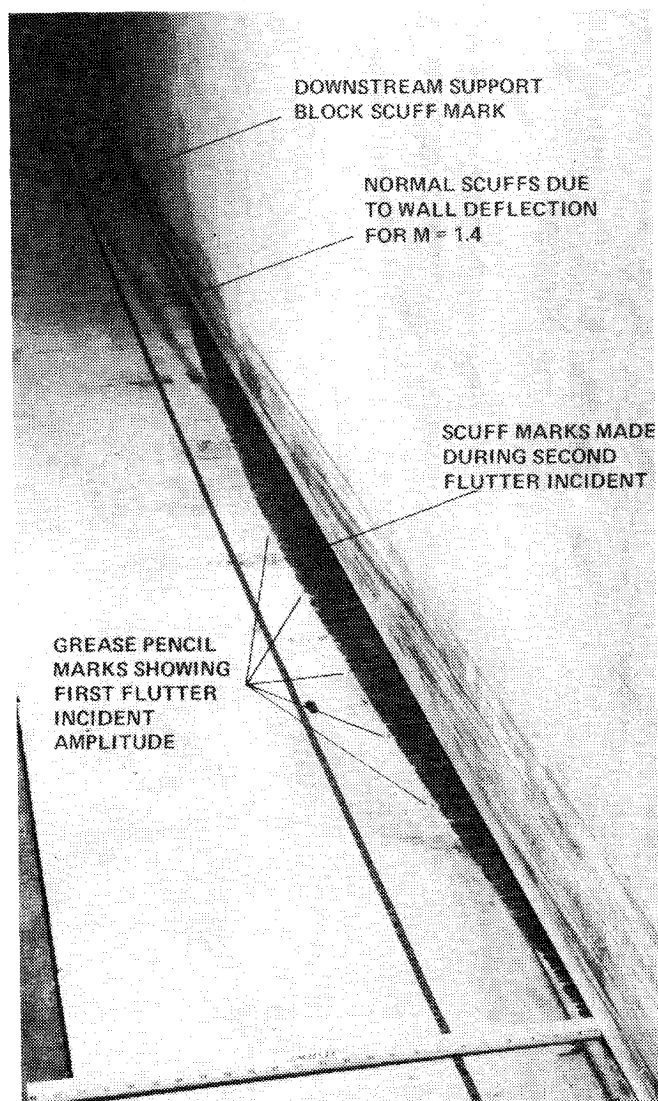
Fig. 4 South flex-wall scuff marks.

The most noticeable evidence of the flex-wall flutter was the dark scuff marks made on the nozzle floor and ceiling. Figure 4 shows the south flex-wall and nozzle floor, looking upstream from inside the tunnel. In this photograph, the flex-wall is in its flat position (zero jack counts). The dark scuff-mark pattern seen on the floor, and a similar one appearing on the ceiling, were made by the inflatable seal and Teflon boot located on the opposite side of the wall, spreading out a film of dry lubricant that was between the Teflon boot and the floor/ceiling. The pattern clearly suggests that the flex-wall flutter-mode shape was similar to that of the fundamental beam-bending mode.

The flutter pattern shown in Fig. 4 is the one caused by the second flutter incident; a very similar pattern had been left by the first incident. That pattern had been partially cleaned off prior to the second flutter incident, but several short grease-pencil marks had been made on the floor to indicate its amplitude. These are also visible in Fig. 4. They show that the wall amplitude reached in the second flutter incident was slightly less than that reached in the first incident.

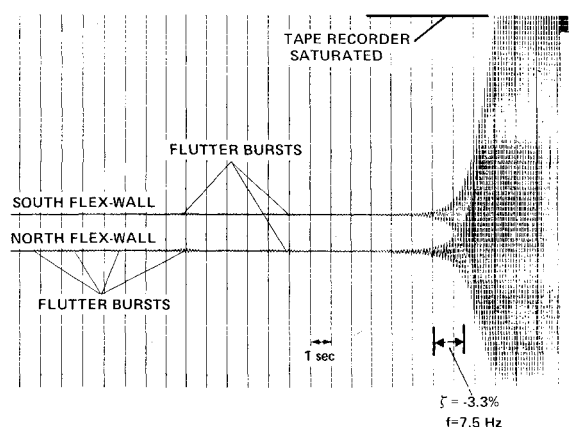
Fig. 5 Growth of flutter amplitude.

Time histories of the north- and south-wall motion during the second flutter incident were obtained from accelerometers at station 101 and are shown in Fig. 5. The sudden growth in amplitude is quite apparent. The leveling off of this amplitude is due to the tape recorder being saturated by the accelerometer signal; therefore, it is not possible to determine whether the flutter reached a limit amplitude. Breaks in the electrical leads to both accelerometers, which occurred sometime during the flutter, presumably caused the sudden drop in signal at the end of the time history (as opposed to its being due to the flutter stopping when the compressor drive power was cut). Approximately 5 s before the end of the north-wall signal, the amplitude was increasing at a rate corresponding to a negative viscous damping ratio of  $\zeta = -3.3\%$ . The frequency at this point was about 7.5 Hz, a value nearly identical to the flex-wall fundamental bending-mode frequency in still air. In the time interval between 8 and 1 s before the end of the signal, the frequency increased from about 7.1 to 7.75 Hz. Also, notice that several small-amplitude flutter bursts took place in the interval of about 15

s before the final high-amplitude growth occurred. (These small bursts are not a normal wall response to the tunnel flow since they do not appear earlier in the time history.)

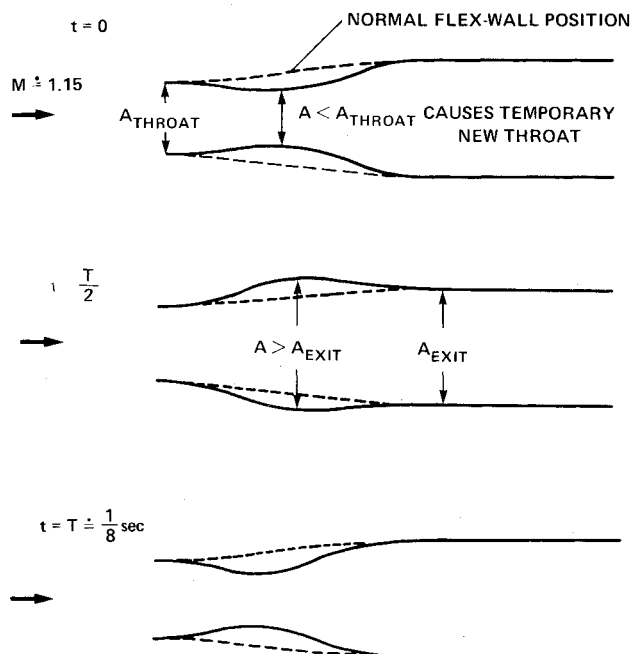
Fig. 6 Relative motion of flex-walls during second flutter incident.

Figure 5 also reveals the relative phasing of the two flex-walls. Because of the way the accelerometers were oriented, the trace in Fig. 5 gives the correct phasing, that is, the walls move together and then apart, as do the tines of a struck tuning fork. This is illustrated in Fig. 6.

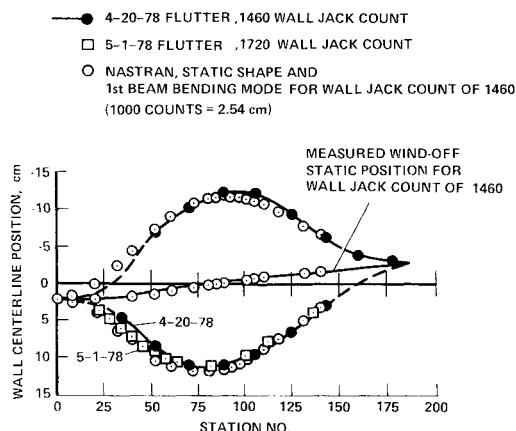
Fig. 7 South flex-wall deformation.

Measurements of the flutter-produced scuff-mark patterns on the nozzle floor and ceiling were corrected for the seal width and the variable wall thickness to obtain estimates for the flutter-mode shape of the wall centerline (i.e., the plate middle surface). The results for the south flex-wall are shown in Fig. 7 where positive values are toward the tunnel centerline. The solid lines are for the first flutter incident and are averages of the floor and ceiling values; the solid circles indicate the station number at which the measurements were made. The measured static position curve is for wind-off with the jack setting at 1460.

The mode shape for the second flutter incident is also shown for the floor scuff marks on the tunnel side of the flex-wall. In this case, squares denote the station numbers where measurements were made.

The NASTRAN-predicted wind-off static position of the wall due to the 1460 wall-jack count is seen to be in a very good agreement with the measured position. Superimposed on this static position are the plus and minus amplitudes of the NASTRAN-predicted fundamental beam-bending mode, scaled to the 24.0-cm flutter peak-to-peak amplitude that was measured at the station 101 rollers. The resulting free-vibration-mode shape is seen to be in fairly close agreement with the measured flutter-mode shape.

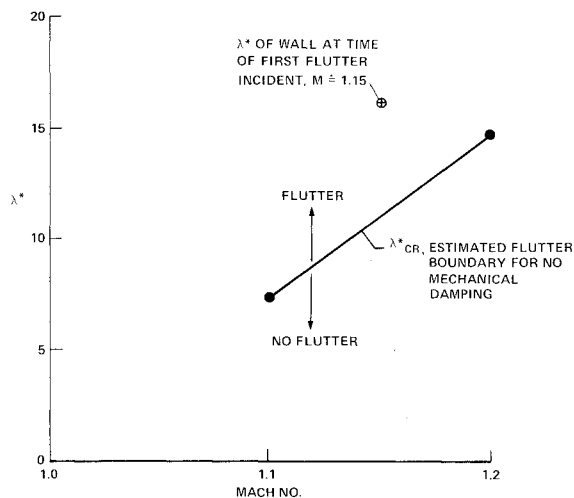
Fig. 8 Estimated flutter boundary of flex-wall,  $\mu \approx 0.016$ .

Such SDoF panel flutter is predicted theoretically.<sup>5-7</sup> Therefore, to determine if the flex-wall flutter incidents might have been cases of panel flutter, the dimensionless dynamic pressure parameter  $\lambda^* = 2qa^3/D$  was computed for the flex-walls and compared to theoretically predicted flutter values

$\lambda_{cr}^*$  that were estimated from results available in the literature.<sup>6-9</sup> This comparison is presented in Fig. 8, which shows the variation in  $\lambda^*$  with Mach number. The solid line gives the theoretical flutter boundary  $\lambda_{cr}^*$  for the case of no mechanical damping; flutter occurs for  $\lambda^* > \lambda_{cr}^*$ . The flex-wall value  $\lambda_{wall}^*$ , at the time of the first flutter incident, is above the theoretical flutter boundary. Thus, even though several approximations are inherent in the results shown in Fig. 8 (see Ref. 1), the results strongly suggest that the flex-walls had been operating above the zero mechanical-damping flutter boundary for over 20 years.

Theoretical SDofF flutter boundaries at low supersonic Mach numbers and low mass ratios are very sensitive to small changes in structural damping. For example, at a mass ratio of  $\mu = 0.01$ , an increase in structural damping from  $g = 0$  to  $g = 0.05$  increases  $\lambda_{cr}^*$  for an  $a/b = 0.46$  clamped panel by factors of about 2.3 and 4.3 for  $M = 1.1$  and 1.2, respectively (Fig. 5 of Ref. 7). This then raises the question "Were there any recent changes made to the flex-walls that caused a significant loss in damping?"

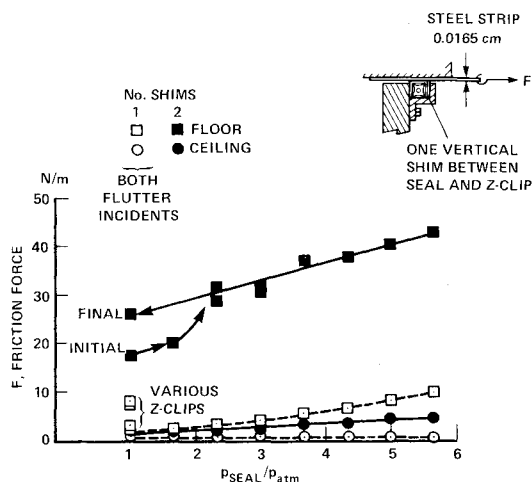
Fig. 9 Variation in friction force with seal inflation pressure; south flex-wall.

Figure 9 shows the variation in south flex-wall "friction force" with seal inflation pressure. The friction force  $F$  is the force required to overcome the static friction exerted on a thin strip of steel sheet inserted between the Teflon-covered seal and the nozzle floor/ceiling, per unit width of the strip.

The open symbols give floor and ceiling results for the vertical shims that were in place during both flutter incidents. The friction force at the ceiling (open circles) is nearly zero at all pressures, indicating that the gap between the seal and ceiling is not closed by the seal inflation. At the lowest pressure, the friction force at the floor (open squares) is greater than at the ceiling and increases with inflation pressure. There is also a random variation in Z-clip height with station number. The corresponding variation in floor friction force is shown at the lowest inflation pressure.

The solid symbols in Fig. 9 show the effect of adding a 0.16-cm-thick, horizontal shim between the seal and Z-clips. There is a slight increase in friction force at the ceiling (solid circles) and a large increase at the floor (solid squares). With both the vertical and horizontal shims in place, the smaller size of the new seals is compensated for; thus, the results given by the solid symbols in Fig. 9 are probably close to what the old seals would have produced.

The sixfold or greater increase in friction force produced by the addition of the shim would be expected to produce a corresponding increase in wall damping, which was approximately  $\zeta = 2.5\%$  for the unshimmed wall with seals vented. For SDofF flutter,  $g \approx 2\zeta$ .<sup>10</sup> Thus, recalling the discussion of Fig. 8, the  $\zeta \approx 2.5\%$  damping ratio of the flex-walls with the new seals would approximately double the value of  $\lambda_{cr}^*$  at  $M = 1.1$ , still leaving  $\lambda_{wall}^*$  very near the flutter boundary. A sixfold increase in damping, however, would most probably raise  $\lambda_{cr}^*$  considerably above  $\lambda_{wall}^*$ , in which case the flex-walls would be flutter-free. So, as stated earlier, both flutter incidents were probably caused by the loss in flex-wall damping that resulted from the January 1978 seal replacement.

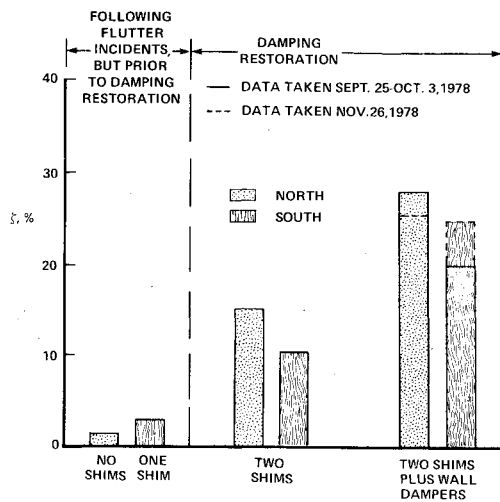
Fig. 11 Restoration of flex-wall damping.

The effects of the seal shims and piston dampers on the wind-off flex-wall damping are shown in Fig. 11. The first pair of results was obtained after the second flutter incident but prior to the damping restoration. The second pair shows the effect of the shims, and the third pair shows the additional effect of the wall dampers. The results given by the solid lines indicate that the shims and wall dampers provide greater damping for the north wall than the south wall. Just prior to the requalification runs on November 25-27, 1978, wall decays for the combined shims plus wall damper case were repeated. The damping for these decays is given by the dashed lines and does not repeat the earlier results, the north wall apparently having lost some damping and the south wall having gained some. The reason for the change is not known, but it is perhaps due to the cable breaking at different values

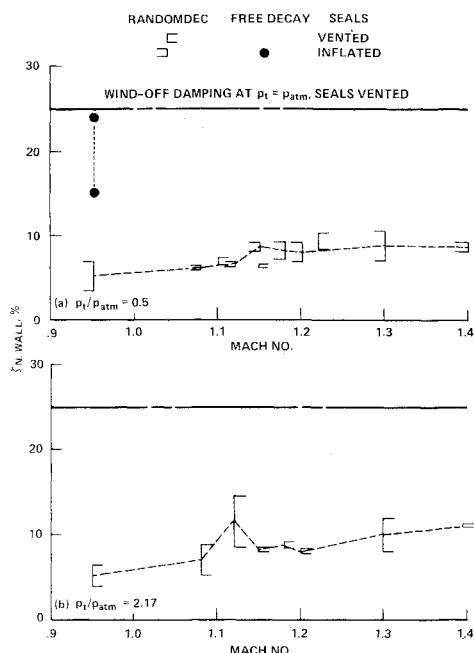
Fig. 13 Variation in north flex-wall damping with Mach number.

Figure 13 shows the variation in  $\zeta$  with Mach number at two total pressures for the north flex-wall. The range in  $\zeta$  as determined from half-cycles "a" and "b" of the Randomdec signatures is given by the vertical brackets. The damping is nominally between 5 and 10% of critical, considerably below the seals-vented wind-off values shown by the horizontal lines. Similar results were obtained for the south wall.

A loss in damping at supersonic Mach numbers was expected, since single-mode panel flutter is associated with negative aerodynamic damping.<sup>5</sup> Panel flutter normally occurs only at supersonic Mach numbers, however, so the loss in damping at  $M=0.95$  is puzzling. The two solid circles in Fig. 13a give the seals-inflated segment "a" and "b" damping range at  $M=0.95$ , as obtained from a wind-on free decay, using the cable-pull technique described in Sec. VII. These results are also lower than the wind-off value.
