AIAA 80-0776R

# Repair of Advanced Composite Structures

S.H. Myhre\* and J.D. Labor†  
*Northrop Corporation, Hawthorne, Calif.*

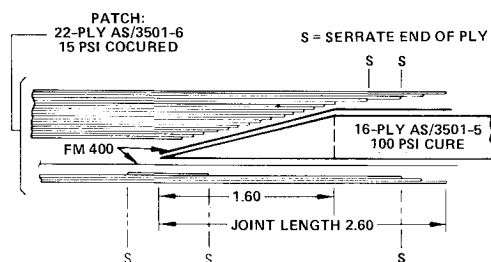
The Northrop bonded-cocured scarf repair is shown in Fig. 1. The shortest patch ply overlaps the end of the parent laminate by 0.20 in. with each subsequent ply end 0.10 in. or more longer. The two longest 0-deg ply ends are extended to a 0.30-in. step and serrated with standard pinking shears a depth of  $1/8$  in. In addition to replacement plies arranged in the same stacking order as the parent laminate, one ply in each of three directions (0, 45,  $-45$  deg) has been added to each side. The added plies make up for the lower strength in the vacuum pressure cured patch laminate, about 84% of the parent. The added  $\pm 45$  deg plies are essential for shear strength restoration. The inner surface plies keep the patch aligned with the load and assure adequate load transfer from the end of the parent laminate, which in reality may not be well scarfed. The short ply on the inner patch appears in retrospect to be unnecessary.

**Fig. 1 Northrop bonded-cocured scarf joint repair.**

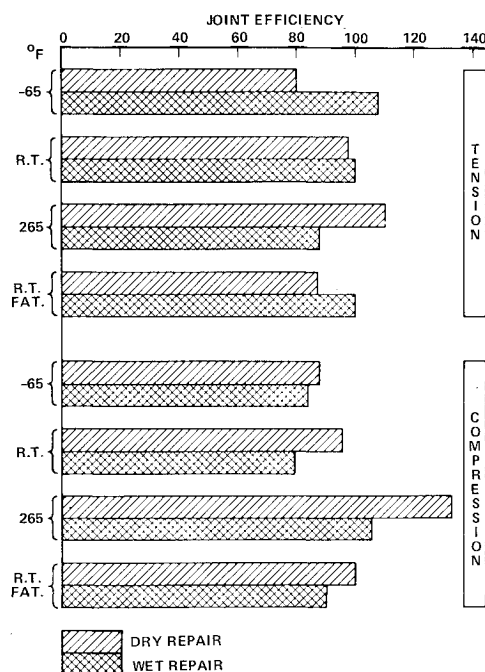
**Fig. 2 Northrop bonded-cocured scarf joint results.**

The results are shown graphically in Fig. 2 where each bar represents the average of three tests. Those with fatigue history are represented by the lower result of the two groups. No indication of failure was seen during fatigue loading. The prior fatigue history appears to have little effect on the static strength of the repair in either tension or compression.

Moisture conditioning of the repaired assembly deteriorated the splice somewhat as shown by the compression results. Splice-related failures were more frequent among the wet specimens, both tension and compression, also indicating deterioration. Failure load results of both wet and dry repairs are compared to the same allowable from Table 1. The lowest result in Fig. 2 is 79% for the compression loaded, room temperature wet group.

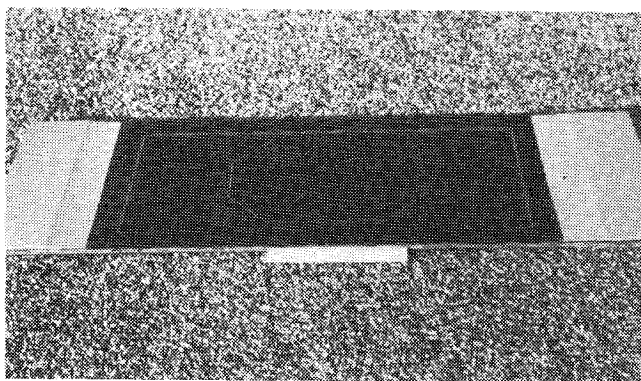
Fig. 4 Repaired panel 1, external surface.

An oval hole 6.6×12.0 in. completely through panel 1 was repaired with access to both sides. The panel faces were scarfed adjacent to the hole on 36/1 slopes using a portable drum sander. The core was replaced and spliced. Then each face was repaired with a bonded and cocured patch that replaced the removed material  $(\pm 45/0/90)_s$  and added five additional plies  $(\pm 45/0/\pm 45)$ . The patch was designed to restore axial load and shear capability. The completed repair is shown in Fig. 4.

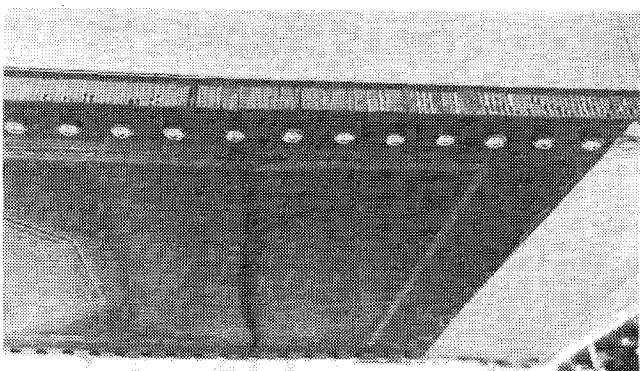
Fig. 5 Panel 1 tension failure at 139% of design ultimate allowable.

Bending was again applied to the box beam until tension failure of the panel occurred. Failure loading in the 8-ply outer face occurred at 139% of the panel design ultimate tension allowable. The maximum axial strain at failure was  $9670 \mu\text{in./in.}$  The failure location is remote from the patch, as shown in Fig. 5, initiating at a fastener hole where the measured strain level was  $7000 \mu\text{in./in.}$  away from the local concentration at the edge of the hole.

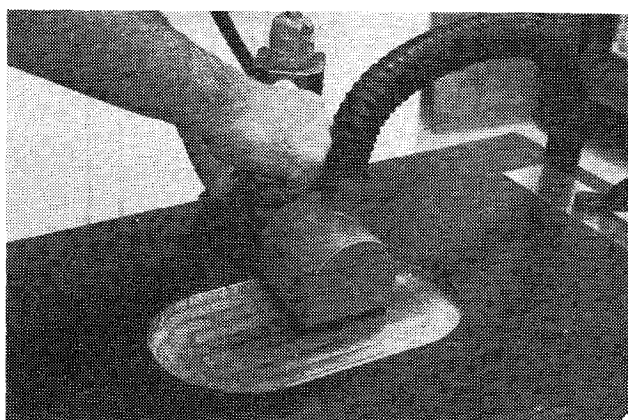
Fig. 6 Scarfing the inner face of panel 2.

Panel 2 was identical to panel 1 except for the repair of the inner face. The penetration of the inner face was a longitudinal hole  $1.0 \times 6.4$  in. The outer face and core were removed to a  $6.6 \times 12.0$ -in. hole (as on panel 1). The inner face was scarfed with the drum sander guided by the hole in the outer face, as shown in Fig. 6. The outer face was scarfed with the drum sander guided by an oval template, completing the preparation of the panel for repair.

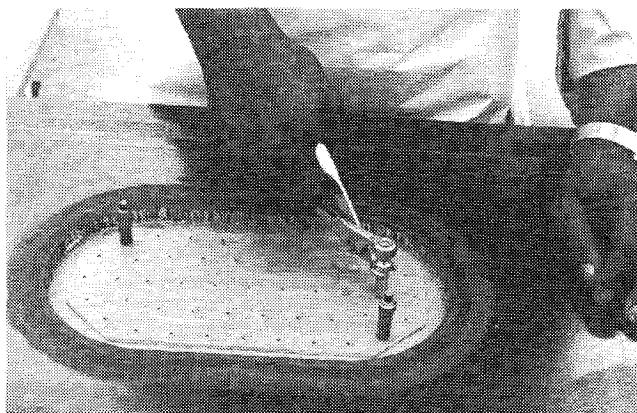
Fig. 7 Installation of clecos for bonding of blind side doubler.

Once the patch was located the drill template was repositioned over the holes using the wire to hold the patch. Clecos were then installed in all holes, as shown in Fig. 7, to provide pressure during the bonding of the blind side patch. The clecos had been coated with Freecoat 33 and baked at

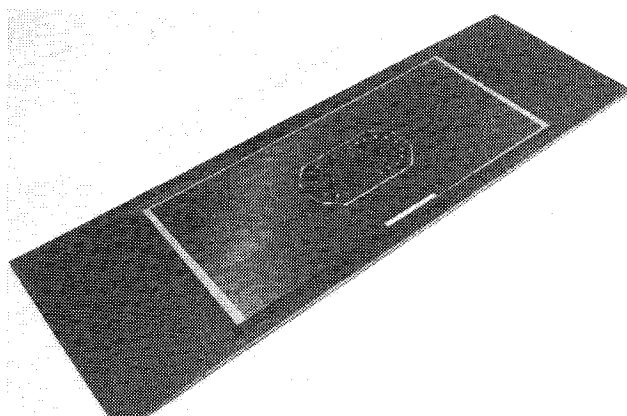
Fig. 8 Repaired panel 2, inner surface.

shown in Fig. 8. The edges of the blind side patch detail were imperfectly bonded at best. Inspection of this patch from the inside is a luxury not available to an airplane repairman. The repair was therefore tested as is with no attempt to improve it.

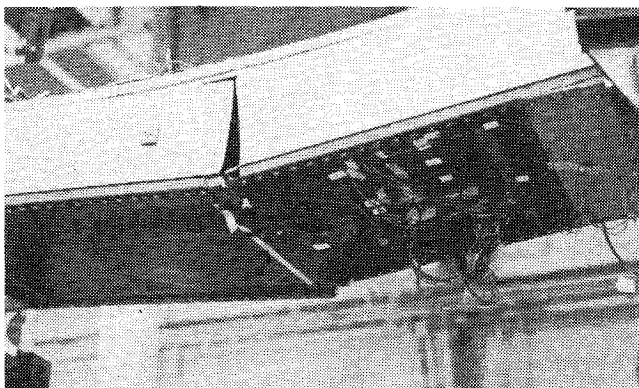
Fig. 9 Panel 2 failure of 122% of design ultimate allowable.

Panel 2 was loaded to failure in tension at 122% of design ultimate allowable. Maximum strain at failure was  $8925 \mu\text{in./in.}$  on the parent laminate just off the end of the patch. Noises and strain gage readings during loading indicate some deterioration of the bond of the blind side patch. However, the failure occurred outside this area and the bond deterioration appears to have had no effect on the ultimate failure. A photo of the failure, viewed from the outside is shown in Fig. 9. The test results and the mode of failure demonstrate that even an imperfectly bonded repair, made simulating on-aircraft conditions with access from one side only, can restore strength well beyond ultimate design load requirements. By using a repair method that is capable of high strength restoration, a considerable margin is available to allow for reduced quality standards.

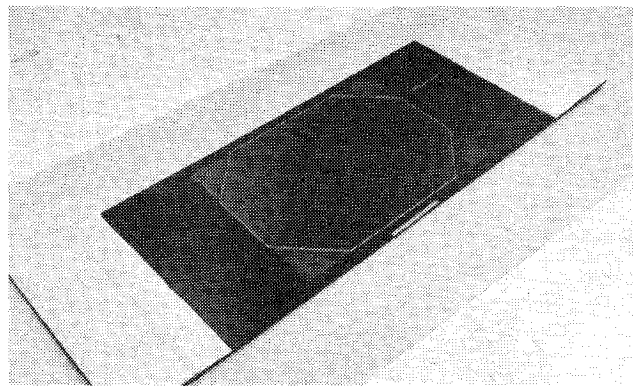
Fig. 10 Panel 3 completed partial thickness repair.

sanded outer surface. The patch laminate  $[\pm 45/0_3/\mp 45/0_5/\mp 45/90/\mp 45/\pm 45/90/(\mp 45)_2]$ , listed from inside outward, replaced all cut plies plus one extra ply in the 0, +45, and -45 deg directions. The order was slightly changed from the parent only so that the 0-deg groups would be attached more closely to those groups in the parent laminate. The completed repair, oven cured under vacuum pressure at  $350^\circ\text{F}$ , is shown in Fig. 10.

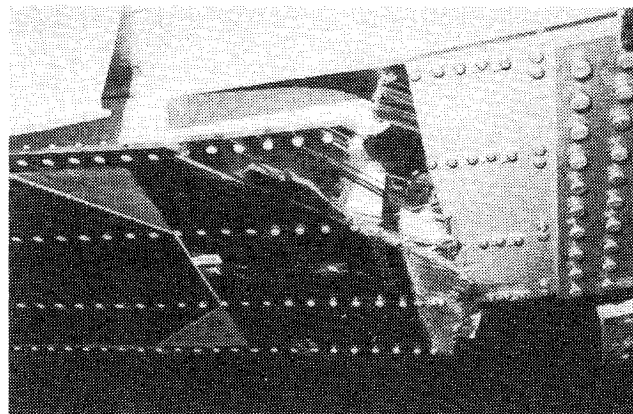
Fig. 11 Panel 3 failure at 155% of design ultimate allowable.

Testing of panel 3 proceeded first by applying the limit loads of Table 2 (neglecting  $N_y$ ) with no indication of failure. Load condition four was positive bending to failure, which occurred at an average tension panel loading of  $N_x = 14,200$  lb/in. The maximum axial strain recorded in the panel and projected to failure was  $7720 \mu\text{in./in.}$  Failure occurred remote from the repair, as shown in Fig. 11. Again using the 50% strength reduction factor for the skin/spar attachment holes the panel ultimate allowable would be 9135 lb/in. Hence, the repair sustained 155% of the panel design ultimate allowable strength.

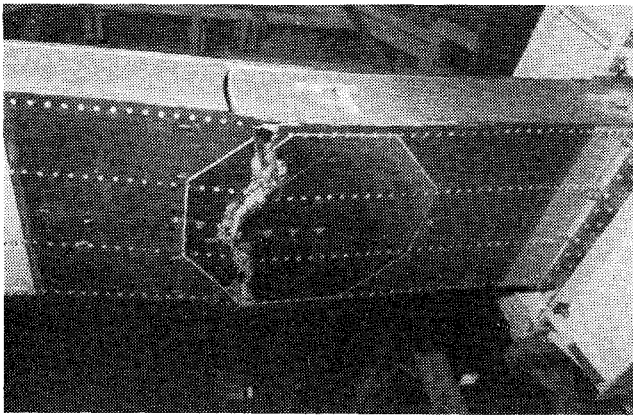
Fig. 12 Panel 4 failure at 155% of design ultimate allowable.

failure was 6920,  $\mu\text{in./in.}$  with a more uniform distribution than in panel 3. Failure occurred through the repair, as shown in Fig. 12. In spite of some irregularity in this repair the results were quite satisfactory.

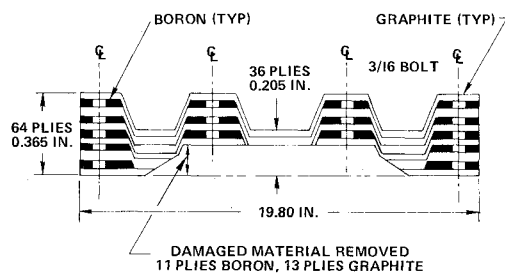
Fig. 13 Cross section of panel 5 as damaged.

Panel 5 was an exact representation of a section of the horizontal stabilizer skin of the B-1 airplane with local buildup over spar caps using unidirectional boron/epoxy strips. The typical cross section is seen in Fig. 13. The damage extended 24 plies deep removing 11 of the 28 plies of boron over the two interior spar caps plus all the associated graphite between the spar caps. The scarf in this section involved two slopes to minimize cutting of shear plies in the panel. Ideally, only 13 plies of graphite were to be cut by the transverse scarf on a slope of 0.10 in. per ply. The longitudinal scarf length is 7.20 in. or 0.30 in. per ply. The panel after material removal is shown in Fig. 14.

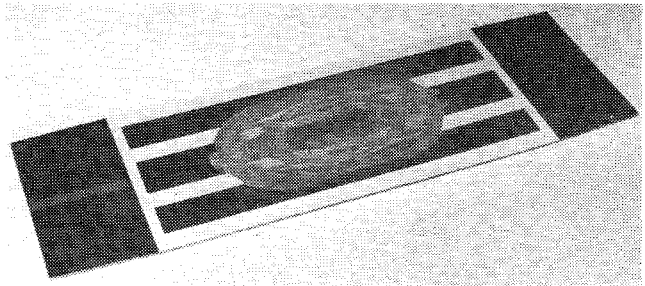
Fig. 14 Panel 5 after material removed.

The embedded boron fibers in this panel complicated the material removal significantly. A diamond-coated end grinder was used to make the 9.44 -in.-diam 24-ply damage cutout and a diamond-coated drum grinder was used on the scarf surface. A metal track was made to guide the drum grinder.

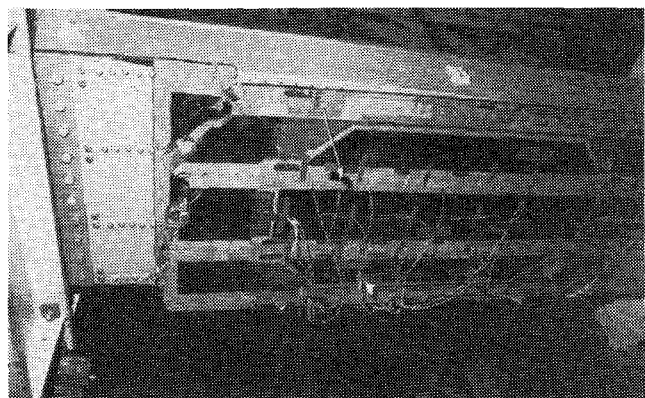
Fig. 15 Panel 5 failure at 151% of design ultimate allowable.

The panel design ultimate allowable was defined by Grumman Aerospace<sup>6</sup> as that load resulting in a strain of  $4171 \mu\text{in./in.}$  The failure load condition imposed uniform bending on the box resulting in tension in the repaired panel. Failure occurred at a panel load intensity of 19,300 lb/in. at a location remote from the repair as shown in Fig. 15. On a typical section outside the repair the mean measured strain was  $6300 \mu\text{in./in.}$  Hence the panel failure occurred at 151% of design ultimate load. The maximum parent laminate strain was  $7912 \mu\text{in./in.}$  The maximum strain level near a fastener hole was estimated  $6900 \mu\text{in./in.}$

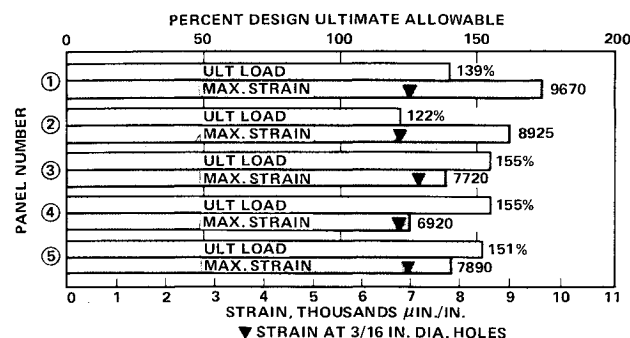
Fig. 16 Summary of demonstration panel results.

A summary of the test results of panels 1-5 is shown in Fig. 16 giving the percent of design ultimate allowable and the maximum strain at failure. The mark on the strain bar indicates the strain extrapolated or interpolated to the spar attachment hole centerline not including the local effect of the holes. Since each failure apparently originated at a hole, this strain appears to be the best correlating parameter. In any case, the failure loads, strains, and failure modes of these five repaired panels demonstrated that it is possible to restore a badly damaged mechanically attached graphite structure to its original strength which is well above current design ultimate allowables.

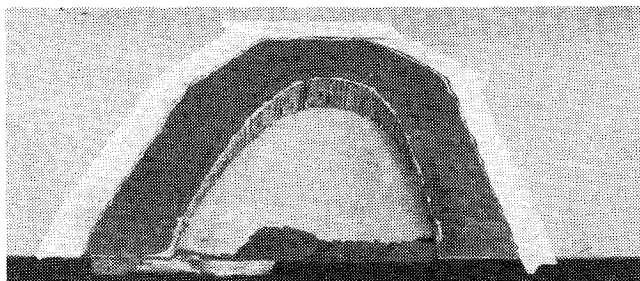
Fig. 17 Repair area of F-15 speedbrake.

Several speedbrakes for F-15 aircraft were fabricated with T300/5208 graphite/epoxy skins.<sup>6</sup> The speedbrake is approximately 10-ft long and  $3\frac{1}{2}$ -ft wide and contains machined titanium actuator fittings and hinge arms which are integrally bonded with the graphite/epoxy skins and aluminum honeycomb core. Damage on one speedbrake consisted of an indentation on the outer face approximately  $6 \times 7$  in. in area and 0.25 in. deep, located near the edge of the part about 3 ft forward at the aft end. Fibers were not broken, but the edge was split, the inner surface was bulged slightly, and radiographic inspection showed the core to be locally crushed.

At the edge of the opening that had been cut in the outer skin, the skin was scarfed over a width of approximately an inch using a small belt sander. The scarfed surface was cut to end at a scribed line on the surface. The repair area with the core removed and the scarf surface prepared is shown in Fig. 17.

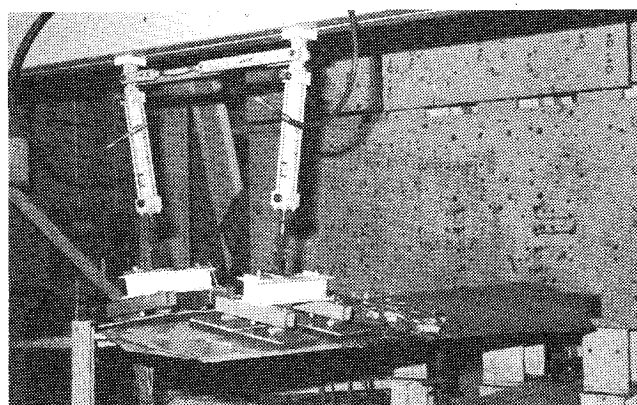
Fig. 18 F-15 speedbrake test arrangement.

Fifteen strain gages were used to monitor the test loading. The peak strain recorded was  $5583 \mu\text{in./in.}$  adjacent to the patch at 120% of the limit load. No indication of failure was observed.

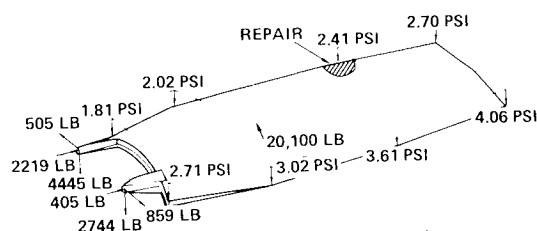
Fig. 19 F-15 speedbrake proof test limit load case.
